Project Number 3113

Management  
Asbestos Survey Report

Kennet Centre, Market Street, Newbury,  
Berkshire, RG14 5EN

1-3 The Mall

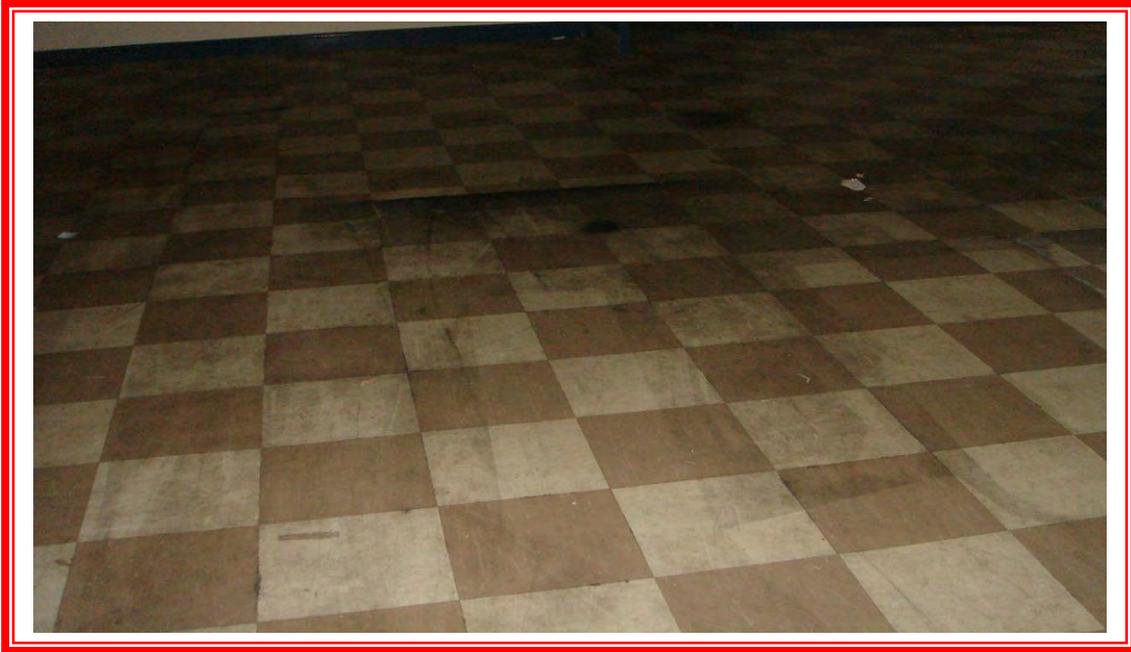
Location: 1/001 Store

Material Description:	Vinyl Floor Tiles	
Identification:	Sampled – Asbestos Detected	
Approx. quantity:	64M2	
Accessibility	Low	Assessment Score
Product type:	Vinyl	1
Extent of Damage:	Minor	1
Surface Treatment:	Non-Friable	0
Asbestos type:	Chrysotile	1
Material Assessment Score:		3
Priority Assessment Score:		Negligible
Action:	Manage	
Comments:	N/A

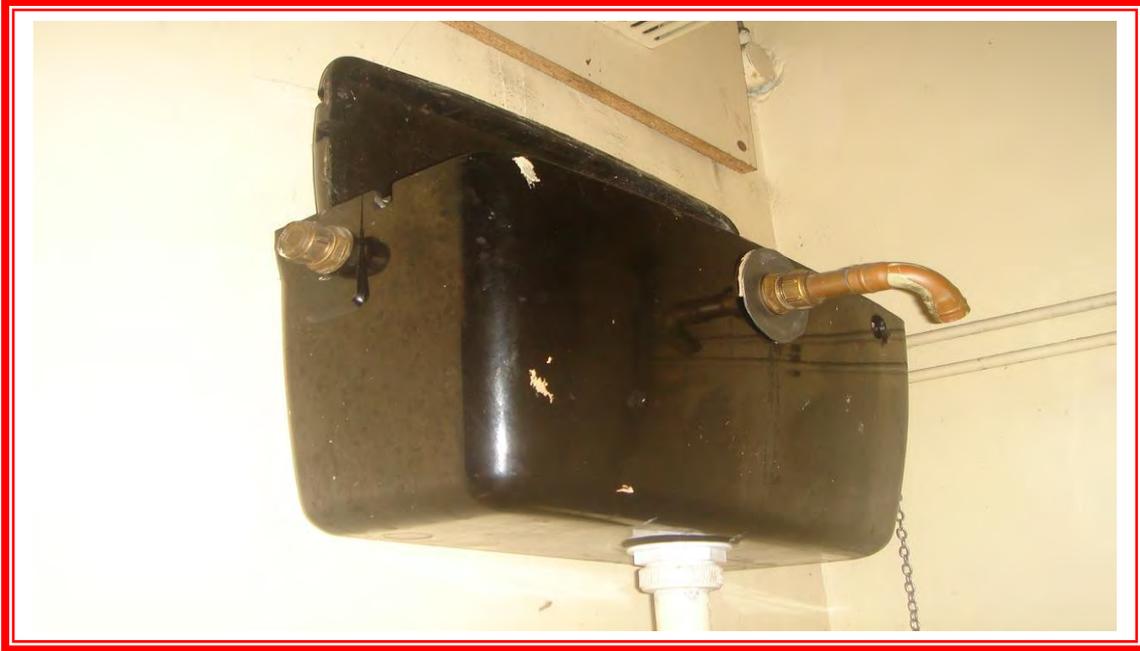
Location: 1/004 WC

Material Description:	Toilet Cistern	
Identification:	Sampled - Asbestos Detected	
Approx. quantity:	1 X Item	
Accessibility	Low	Assessment Score
Product type:	Composite	1
Extent of Damage:	Good	0
Surface Treatment:	Non-Friable	0
Asbestos type:	Amosite	2
Material Assessment Score:		3
Priority Assessment Score:		Negligible
Action:	Manage	
Comments:	N/A

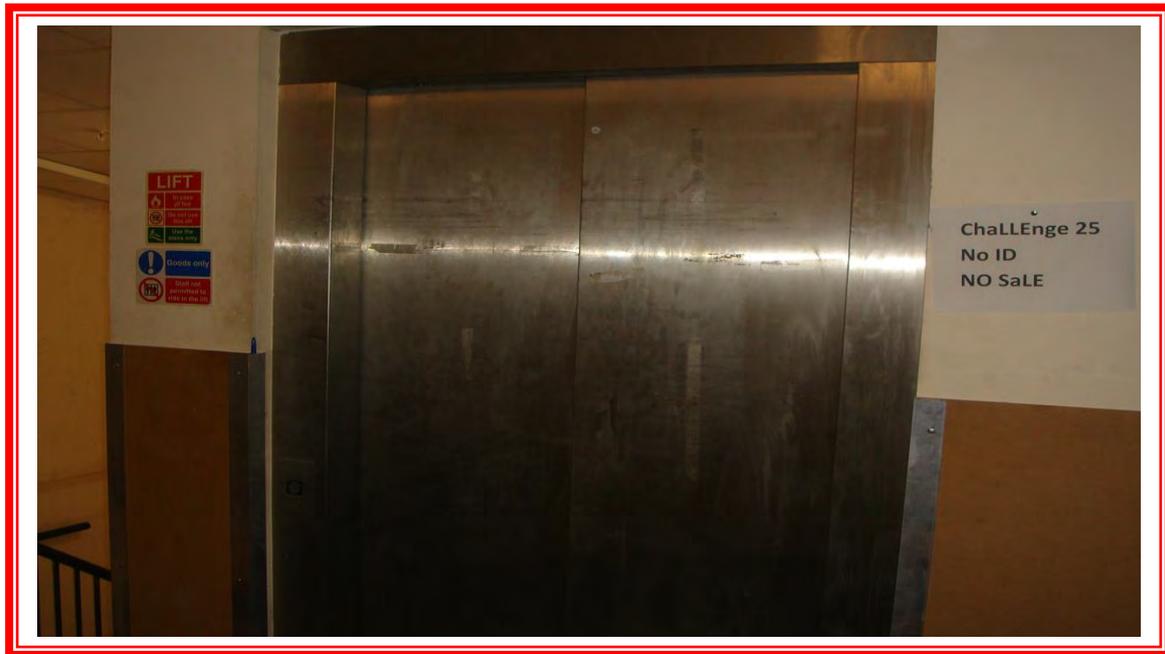
Item No: 12	Sample No: N/A
Location: 1/012 Lift and Shaft

Material Description:	No Access	
Identification:	Presumed to Contain Asbestos	
Approx. quantity:	Unknown	
Accessibility	Low	<i>Assessment Score</i>
Product type:	No Access	3
Extent of Damage:	No Access	3
Surface Treatment:	No Access	3
Asbestos type:	No Access	3
Material Assessment Score:		12
Priority Assessment Score:		High
Action:	Further Inspection Required	
Comments:	No access as no lift engineer onsite

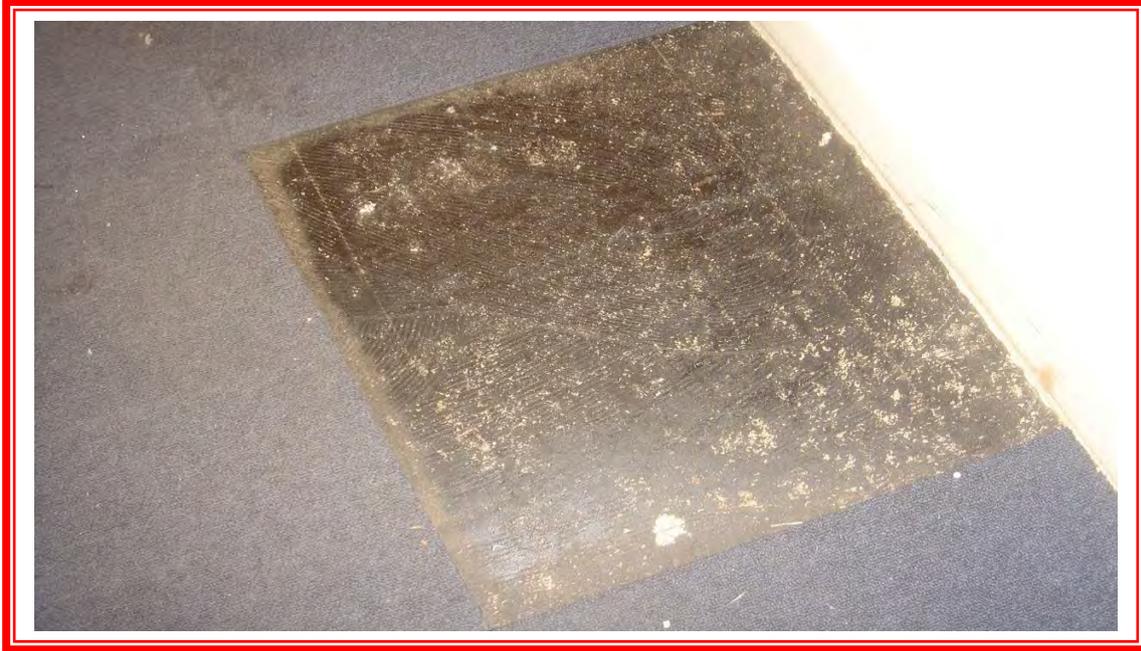
Material Description:	Bitumen Adhesive	
Identification:	Sampled - Asbestos Detected	
Approx. quantity:	6M2	
Accessibility	Low	Assessment Score
Product type:	Bitumen	1
Extent of Damage:	Good	0
Surface Treatment:	Non-Friable	0
Asbestos type:	Chrysotile	1
Material Assessment Score:		2
Priority Assessment Score:		Negligible
Action:	Manage	
Comments:	N/A

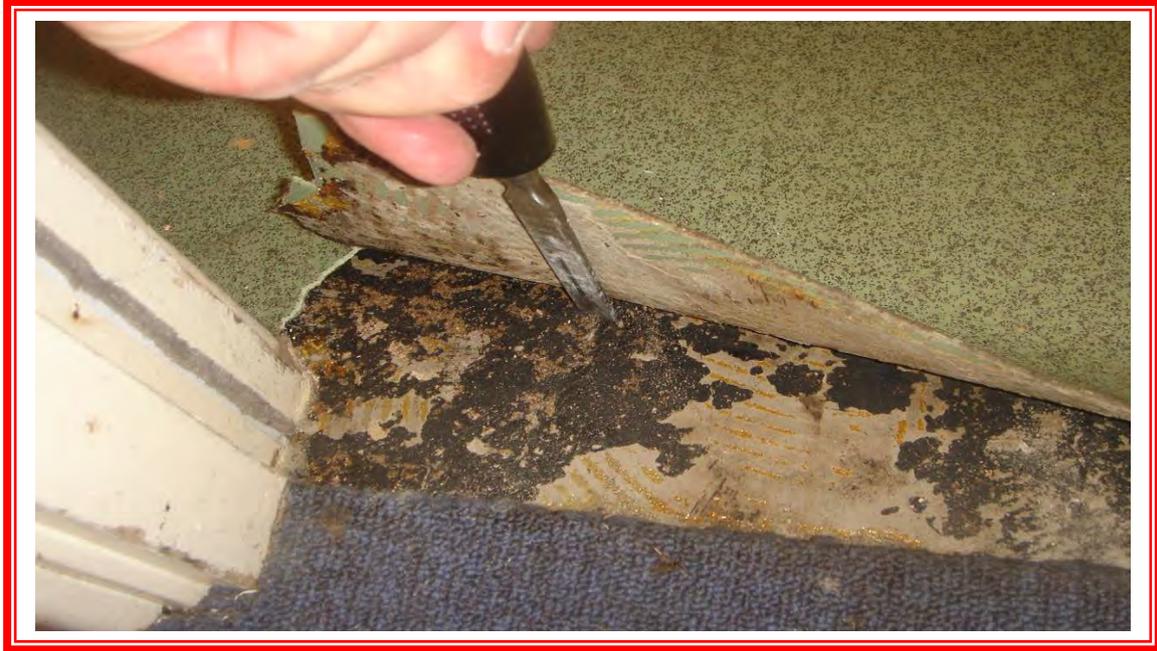
Material Description:	Bitumen Adhesive	
Identification:	As Per Sample NE/2 - Asbestos Detected	
Approx. quantity:	3M2	
Accessibility	Low	Assessment Score
Product type:	Bitumen	1
Extent of Damage:	Good	0
Surface Treatment:	Non-Friable	0
Asbestos type:	Chrysotile	1
Material Assessment Score:		2
Priority Assessment Score:		Negligible
Action:	Manage	
Comments:	N/A

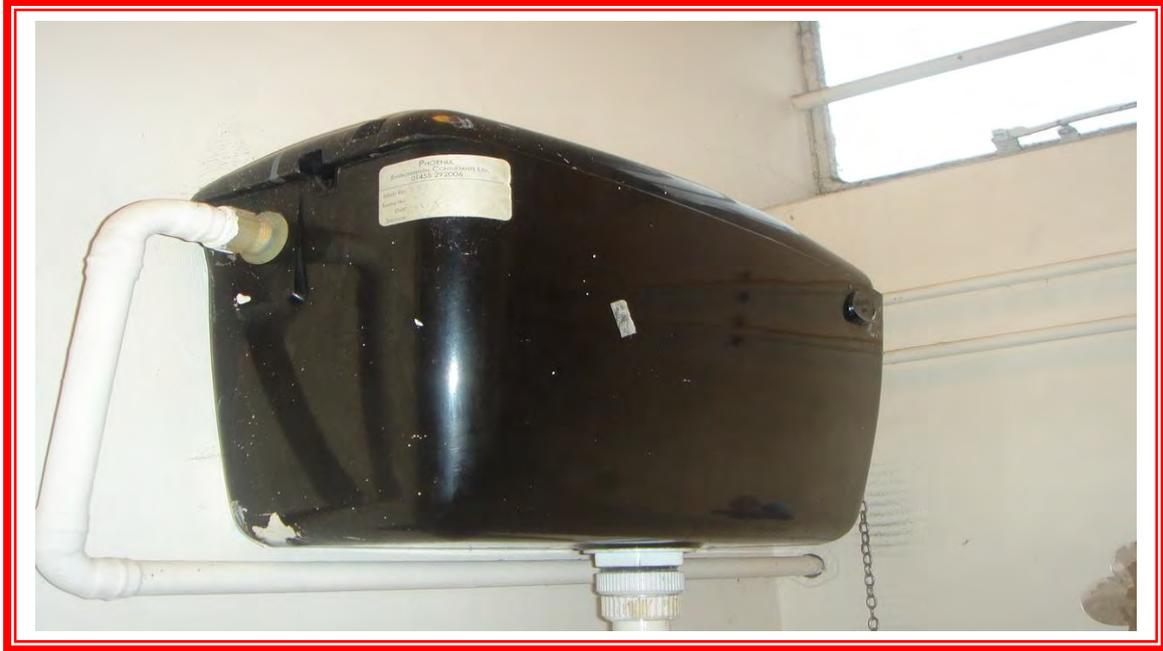
Material Description:	Toilet Cistern	
Identification:	Sampled – Asbestos Detected	
Approx. quantity:	1 X Cistern	
Accessibility	Low	Assessment Score
Product type:	Bakelite	1
Extent of Damage:	Good	0
Surface Treatment:	Non-Friable	0
Asbestos type:	Amosite	2
Material Assessment Score:		3
Priority Assessment Score:		Negligible
Action:	Manage	
Comments:	N/A

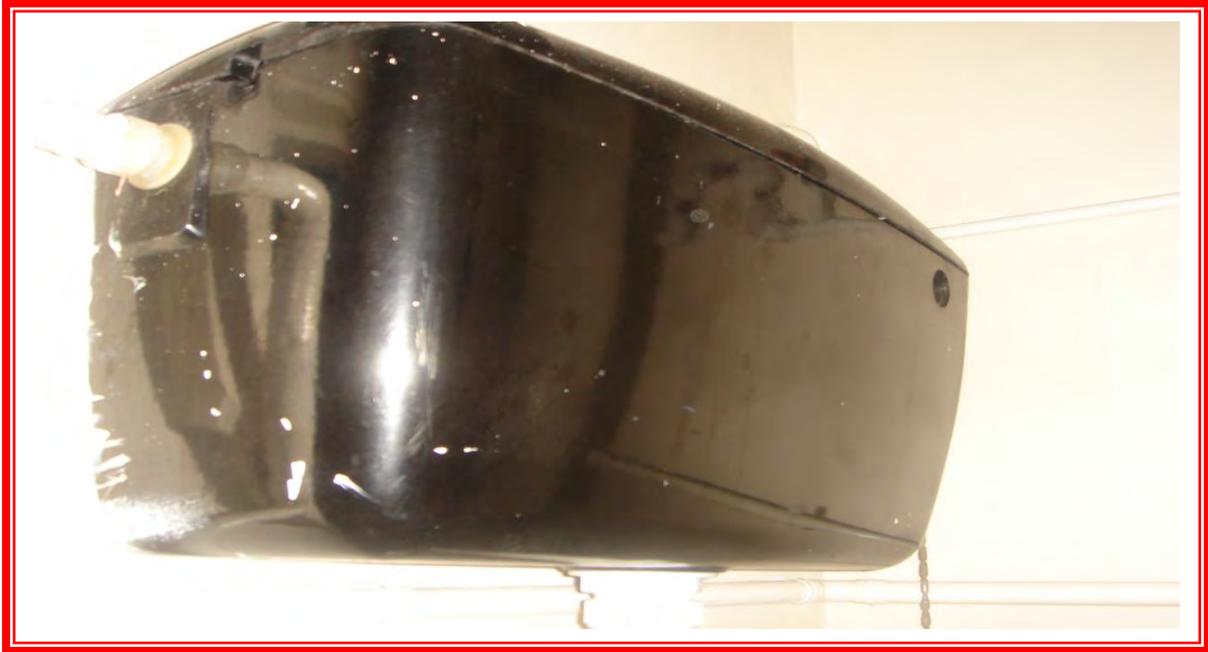
Material Description:	Toilet Cistern	
Identification:	Sampled – Asbestos Detected	
Approx. quantity:	1 X Item	
Accessibility	Low	Assessment Score
Product type:	Composite	1
Extent of Damage:	Good	0
Surface Treatment:	Non-Friable	0
Asbestos type:	Amosite	2
Material Assessment Score:		3
Priority Assessment Score:		Negligible
Action:	Manage	
Comments:	N/A

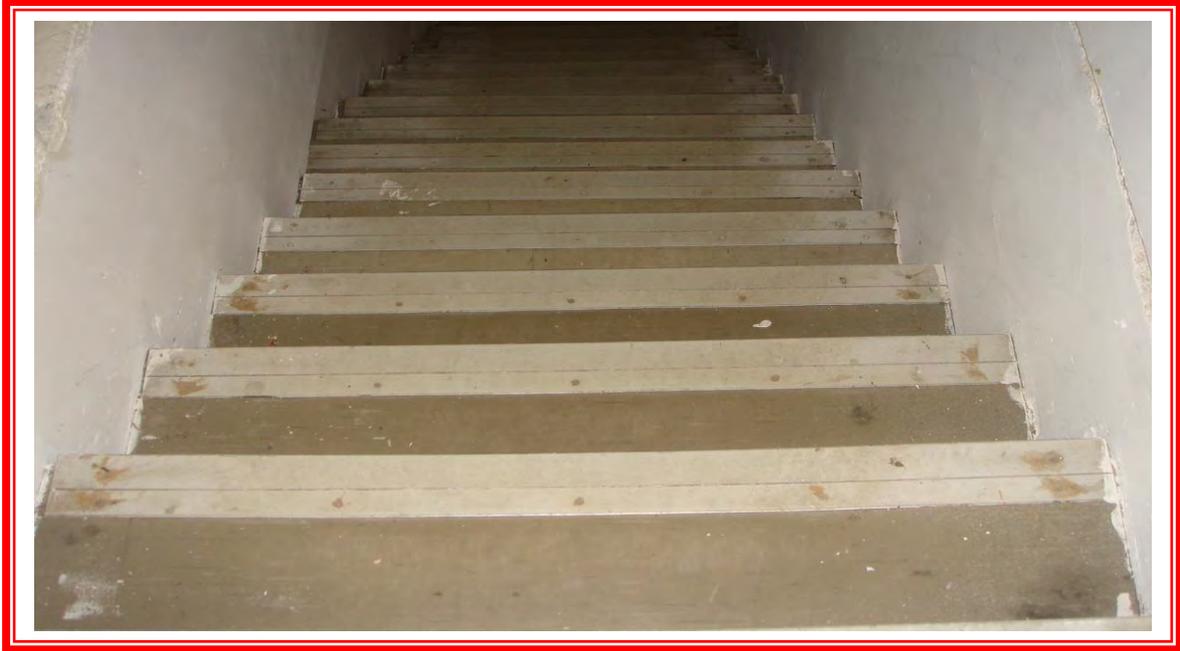
Material Description:	Vinyl Floor Tiles	
Identification:	Sampled - Asbestos Detected	
Approx. quantity:	30M2	
Accessibility	Medium	Assessment Score
Product type:	Vinyl	1
Extent of Damage:	Minor	1
Surface Treatment:	Non-Friable	0
Asbestos type:	Chrysotile	1
Material Assessment Score:		3
Priority Assessment Score:		Negligible
Action:	Manage	
Comments:	N/A

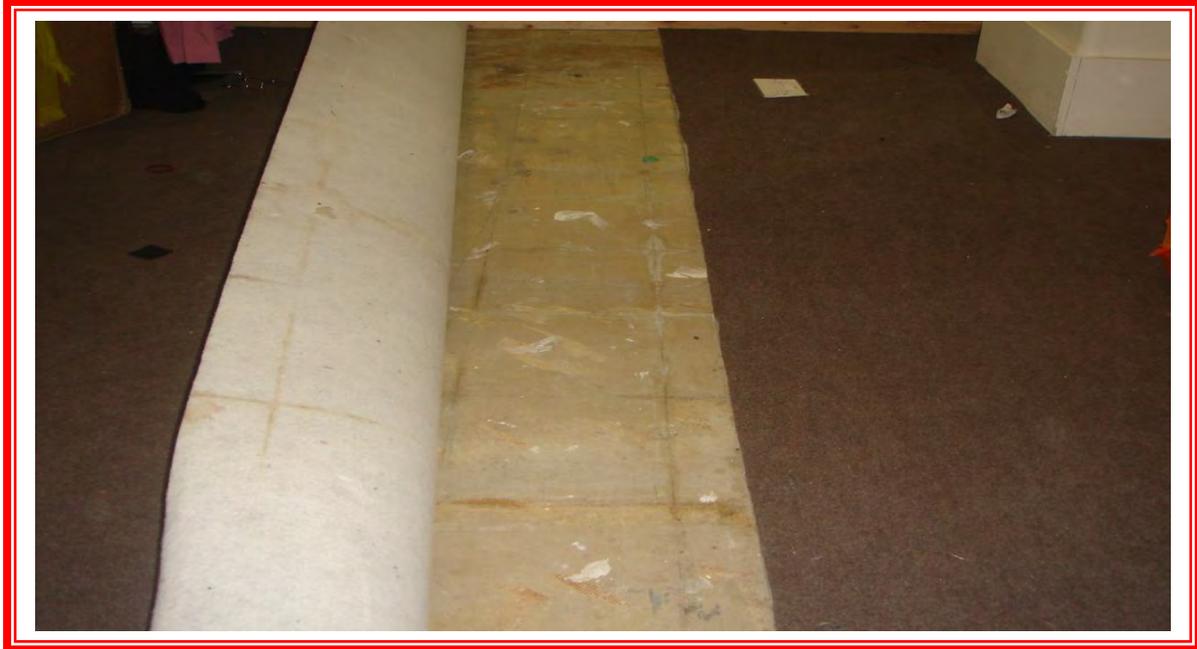
Material Description:	Vinyl Floor Tiles	
Identification:	Sampled - Asbestos Detected	
Approx. quantity:	25M2	
Accessibility	Low	Assessment Score
Product type:	Vinyl	1
Extent of Damage:	Minor	1
Surface Treatment:	Non-Friable	0
Asbestos type:	Chrysotile	1
Material Assessment Score:		3
Priority Assessment Score:		Negligible
Action:	Manage	
Comments:	N/A

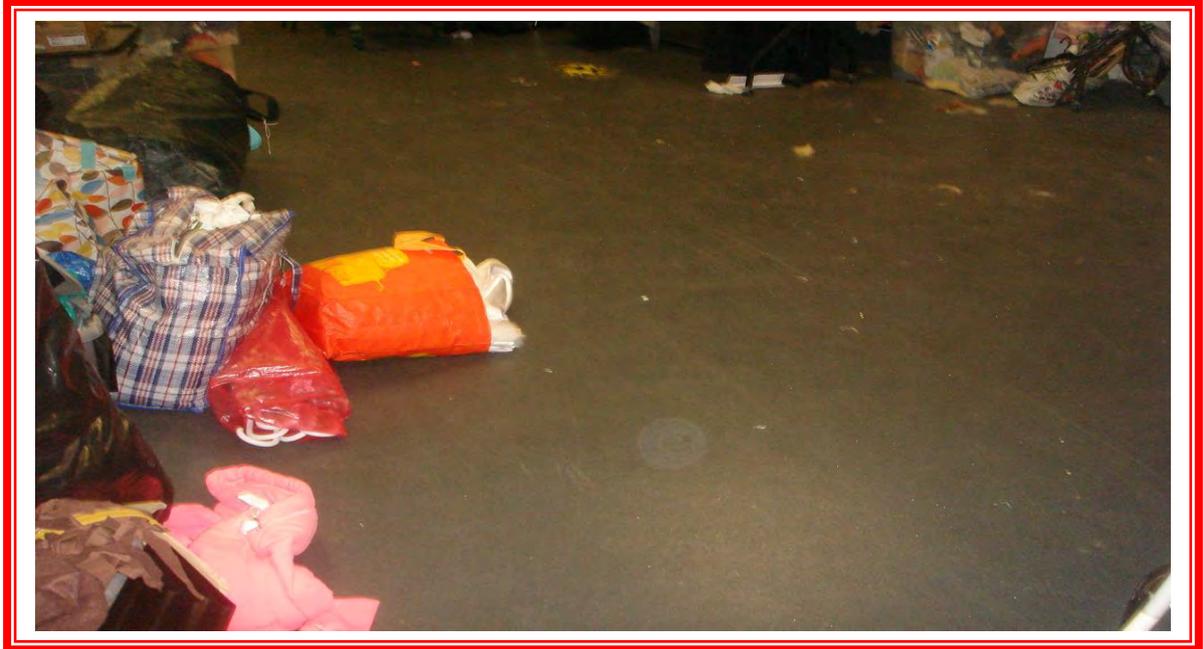
Material Description:	Vinyl Floor Tiles	
Identification:	As Per Sample NE/ - Asbestos Detected	
Approx. quantity:	75M2	
Accessibility	Low	Assessment Score
Product type:	Vinyl	1
Extent of Damage:	Minor	1
Surface Treatment:	Non-Friable	0
Asbestos type:	Chrysotile	1
Material Assessment Score:		3
Priority Assessment Score:		Negligible
Action:	Manage	
Comments:	Below Modern Vinyl

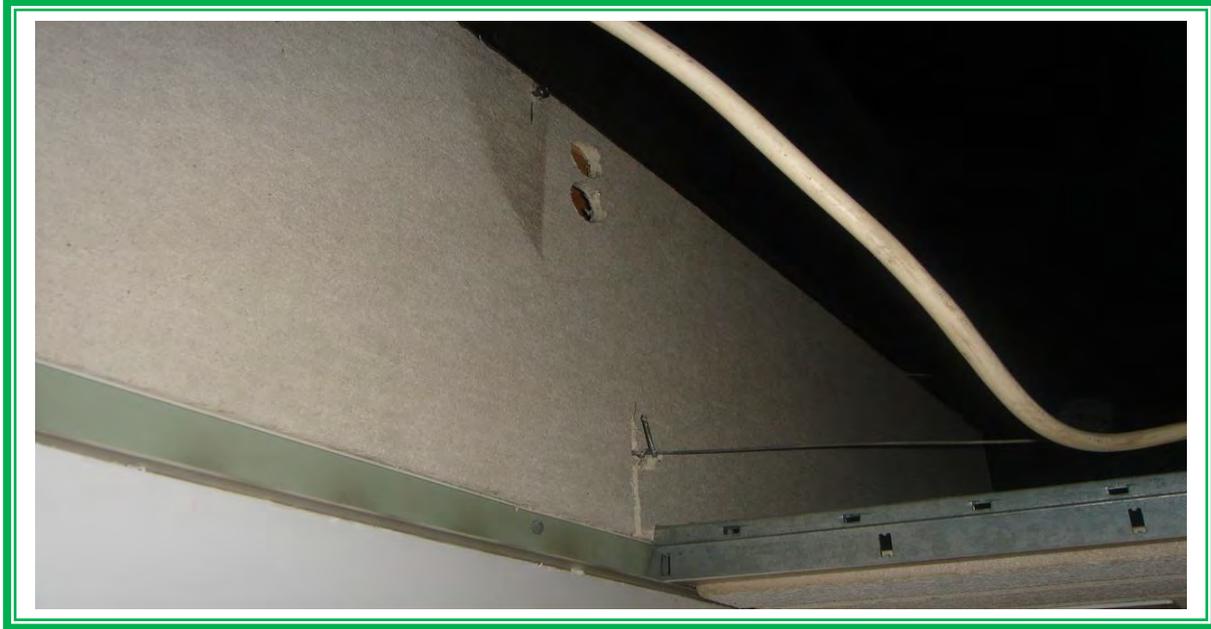
Material Description:	Insulating Board – Above Entrance	
Identification:	Sampled – No Asbestos Detected	
Approx. quantity:	5M2	
Accessibility	N/A	<i>Assessment Score</i>
Product type:	N/A	N/A
Extent of Damage:	N/A	N/A
Surface Treatment:	N/A	N/A
Asbestos type:	N/A	N/A
Material Assessment Score:		N/A
Priority Assessment Score:		N/A
Action:	N/A	
Comments:	N/A

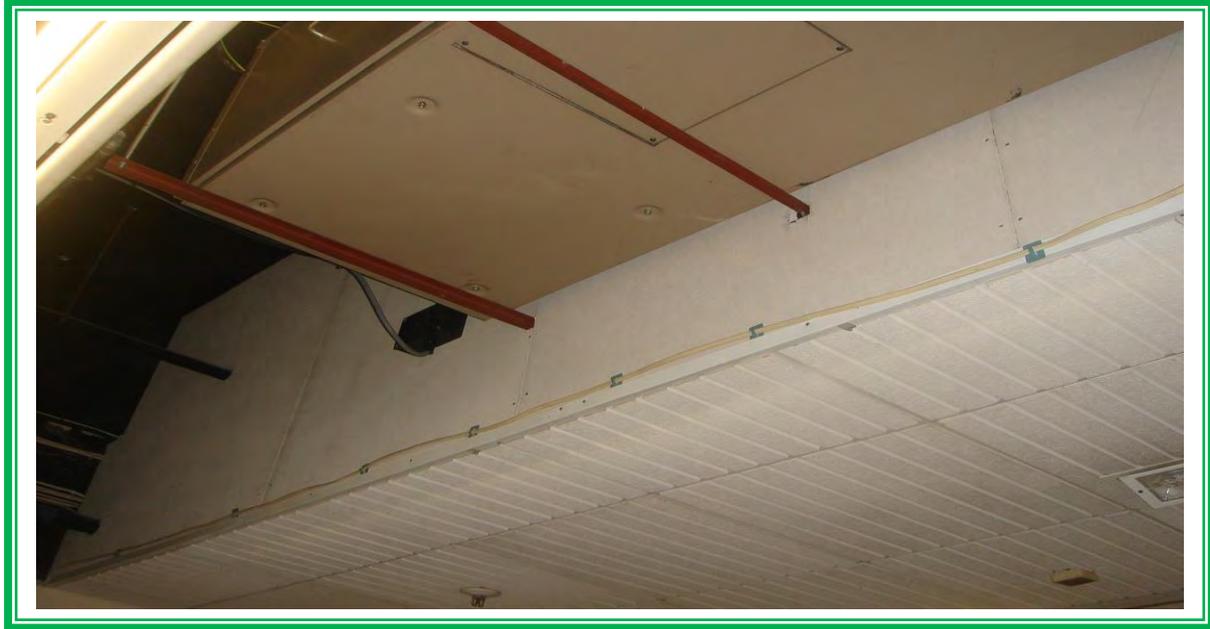
Material Description:	Insulating Board – High Level to Air Con Unit	
Identification:	As Per Sampled NE/3 – No Asbestos Detected	
Approx. quantity:	10M2	
Accessibility	N/A	Assessment Score
Product type:	N/A	N/A
Extent of Damage:	N/A	N/A
Surface Treatment:	N/A	N/A
Asbestos type:	N/A	N/A
Material Assessment Score:		N/A
Priority Assessment Score:		N/A
Action:	N/A	
Comments:	N/A

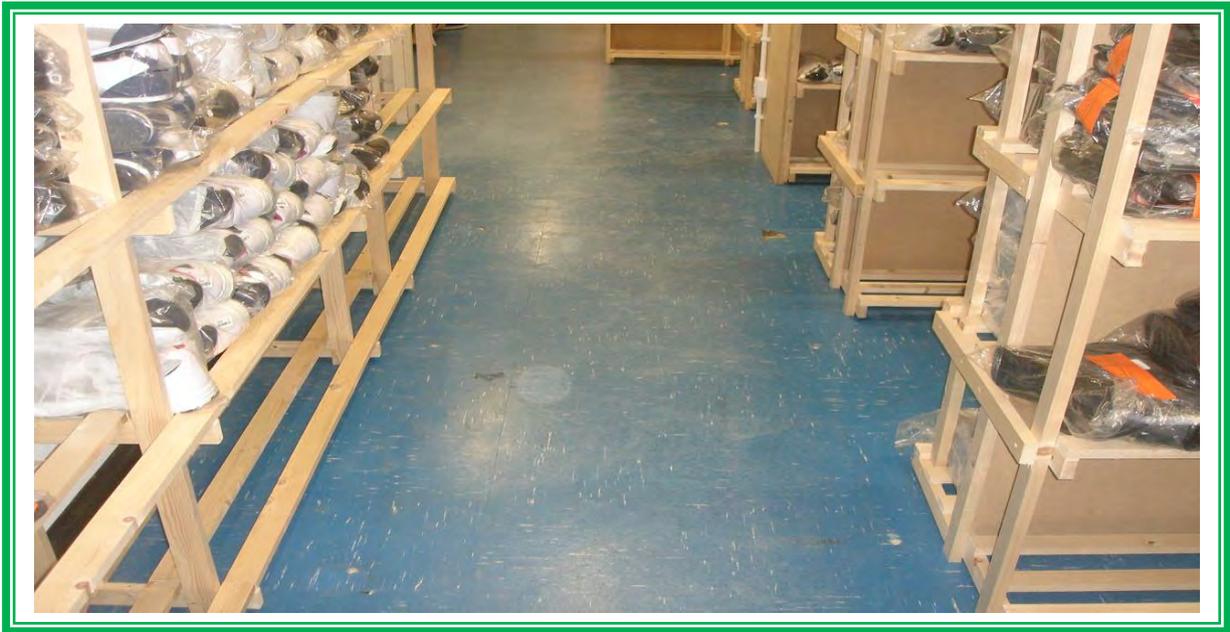
Material Description:	Vinyl Floor Tiles	
Identification:	Sampled – No Asbestos Detected	
Approx. quantity:	60M2	
Accessibility	N/A	Assessment Score
Product type:	N/A	N/A
Extent of Damage:	N/A	N/A
Surface Treatment:	N/A	N/A
Asbestos type:	N/A	N/A
Material Assessment Score:		N/A
Priority Assessment Score:		N/A
Action:	N/A	
Comments:	N/A

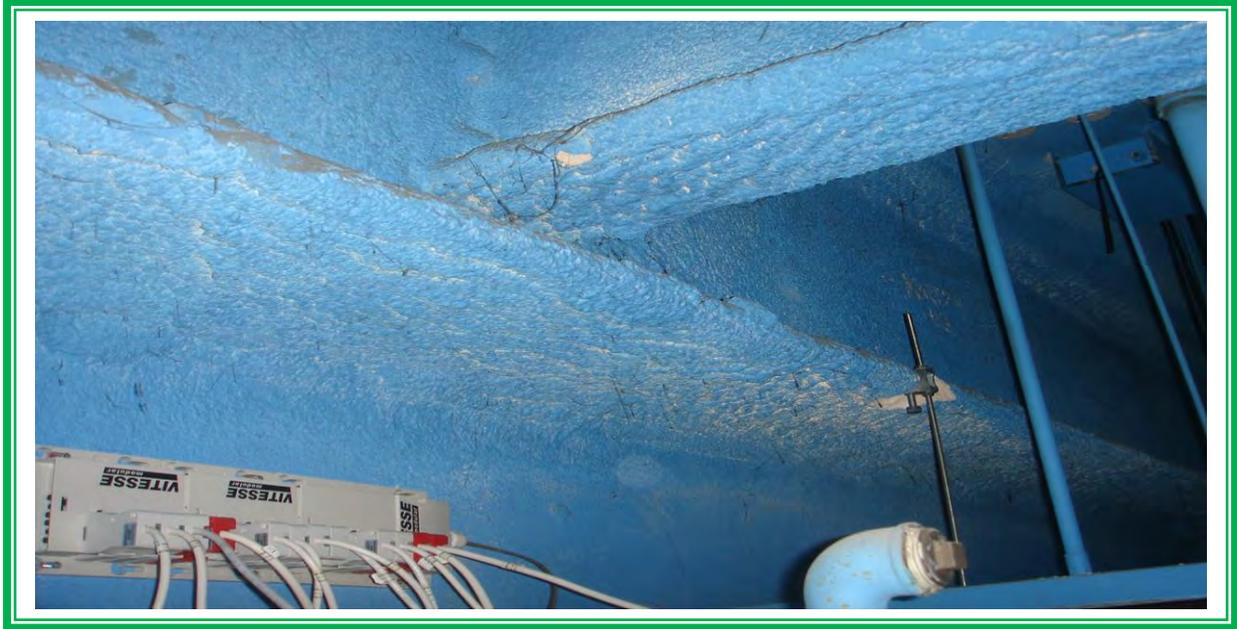
Material Description:	Sprayed Coating	
Identification:	Sampled - No Asbestos Detected	
Approx. quantity:	20M2	
Accessibility	N/A	Assessment Score
Product type:	N/A	N/A
Extent of Damage:	N/A	N/A
Surface Treatment:	N/A	N/A
Asbestos type:	N/A	N/A
Material Assessment Score:		N/A
Priority Assessment Score:		N/A
Action:	N/A	
Comments:	Coating is Encapsulated

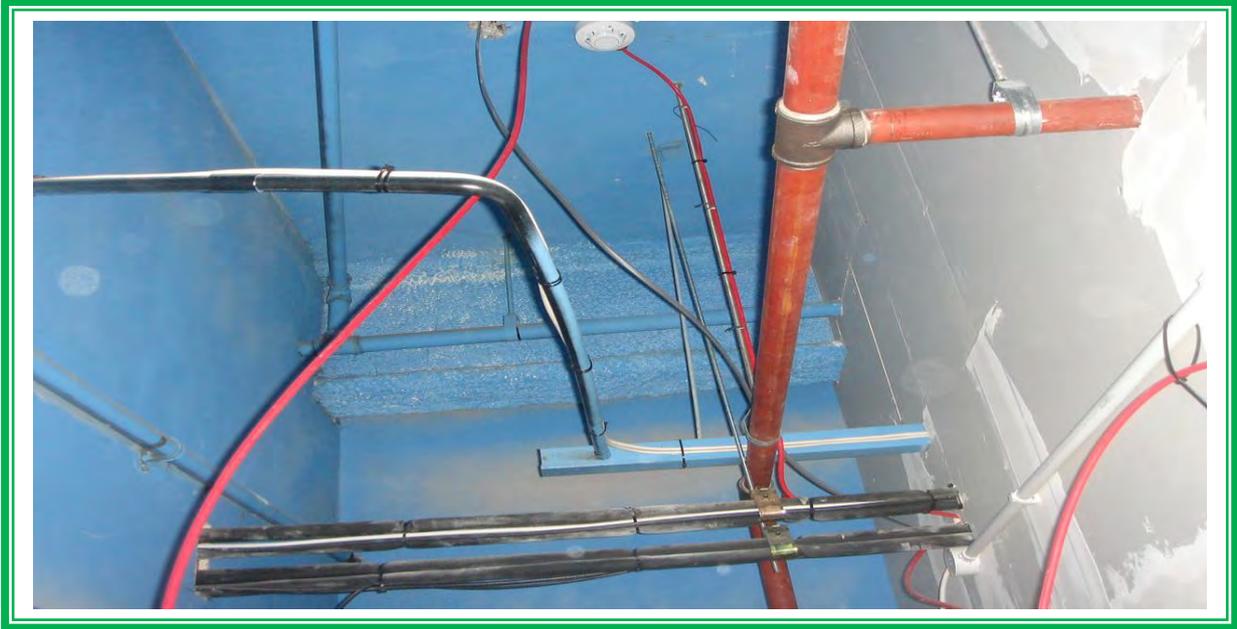
Material Description:	Sprayed Coating to Beams	
Identification:	As Per Sample NE/2 – No Asbestos Detected	
Approx. quantity:	4M2	
Accessibility	N/A	Assessment Score
Product type:	N/A	N/A
Extent of Damage:	N/A	N/A
Surface Treatment:	N/A	N/A
Asbestos type:	N/A	N/A
Material Assessment Score:		N/A
Priority Assessment Score:		N/A
Action:	N/A	
Comments:	N/A

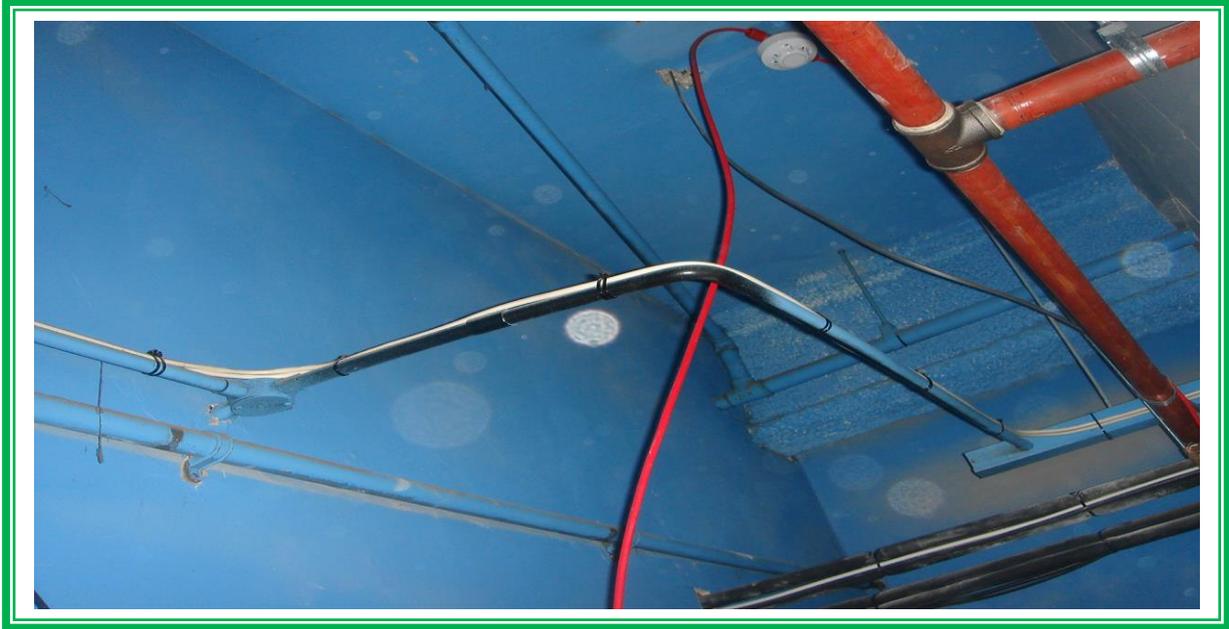
Material Description:	Sprayed Coating to Beams	
Identification:	As Per Sampled NE/2 - No Asbestos Detected	
Approx. quantity:	4M2	
Accessibility	N/A	Assessment Score
Product type:	N/A	N/A
Extent of Damage:	N/A	N/A
Surface Treatment:	N/A	N/A
Asbestos type:	N/A	N/A
Material Assessment Score:		N/A
Priority Assessment Score:		N/A
Action:	N/A	
Comments:	N/A

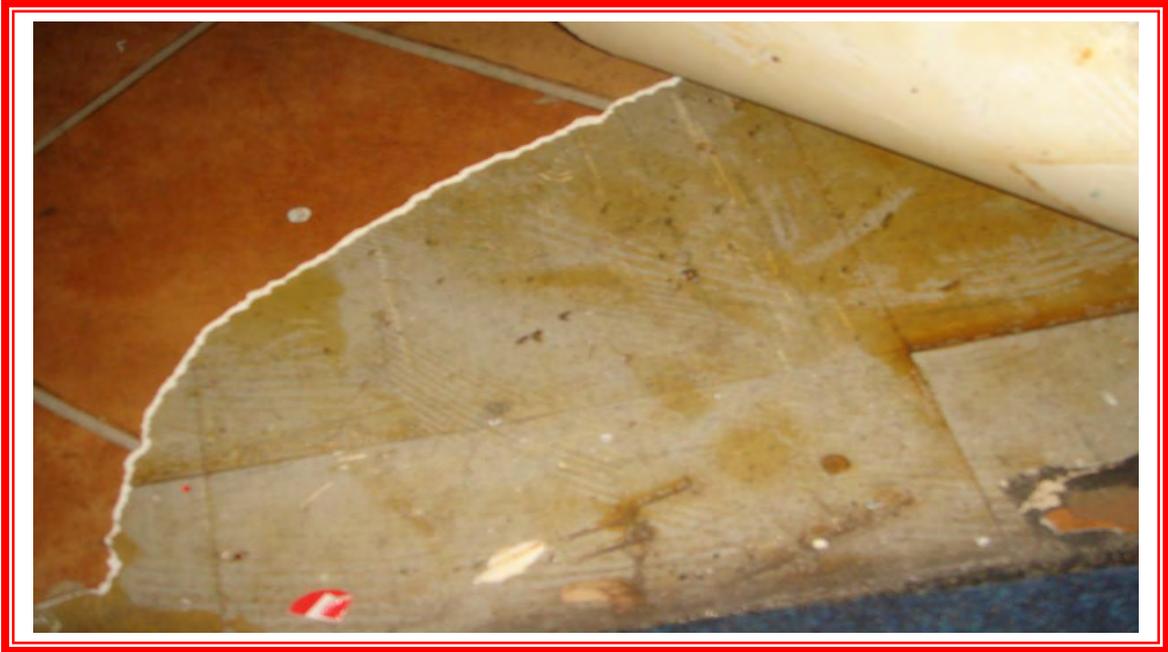
Material Description:	Vinyl Floor Tiles	
Identification:	Sampled – Asbestos Detected	
Approx. quantity:	10M2	
Accessibility	Low	Assessment Score
Product type:	Vinyl	1
Extent of Damage:	Minor	1
Surface Treatment:	Non-Friable	0
Asbestos type:	Chrysotile	1
Material Assessment Score:		3
Priority Assessment Score:		Negligible
Action:	Manage	
Comments:	N/A

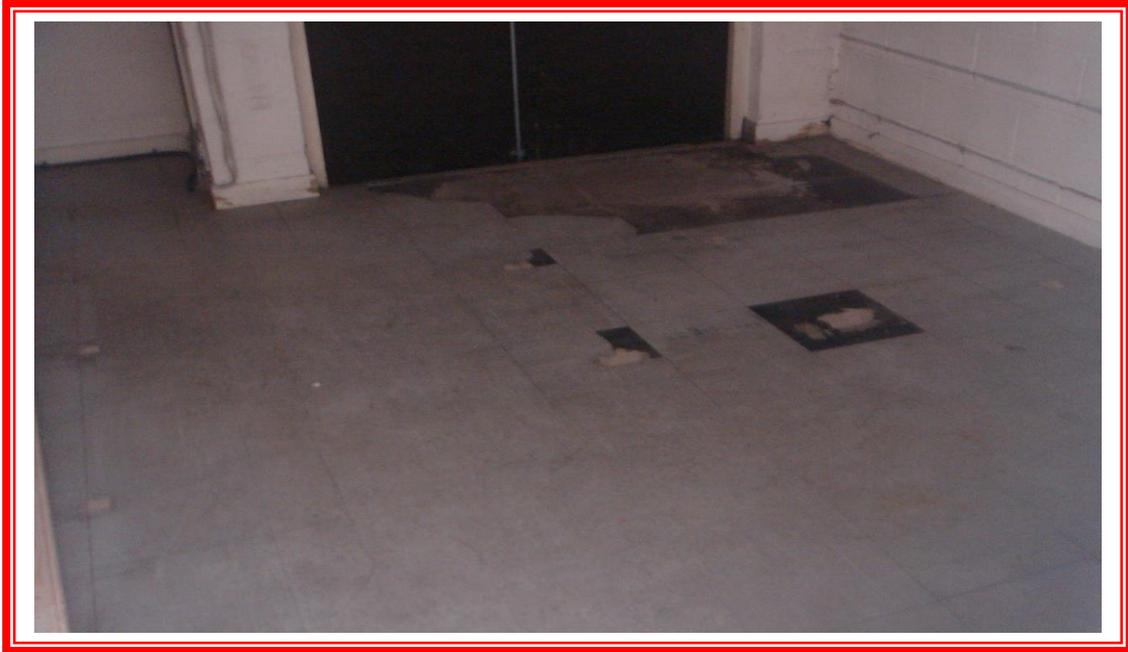
Material Description:	Vinyl Floor Tiles	
Identification:	Sampled – Asbestos Detected	
Approx. quantity:	20M2	
Accessibility	Low	Assessment Score
Product type:	Vinyl	1
Extent of Damage:	Moderate	2
Surface Treatment:	Non-Friable	0
Asbestos type:	Chrysotile	1
Material Assessment Score:		4
Priority Assessment Score:		Negligible
Action:	Manage	
Comments:	N/A

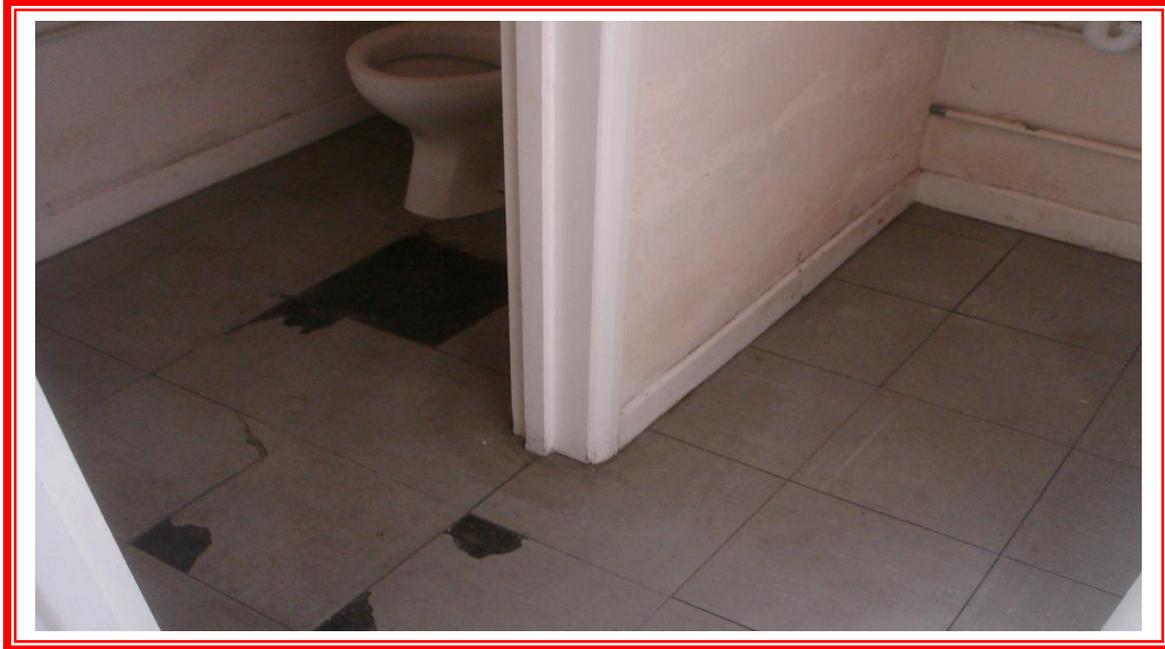
Material Description:	Vinyl Floor Tiles	
Identification:	As Per Sample NE/1 - Asbestos Detected	
Approx. quantity:	2M2	
Accessibility	Low	Assessment Score
Product type:	Vinyl	1
Extent of Damage:	Low	1
Surface Treatment:	Non-Friable	0
Asbestos type:	Chrysotile	1
Material Assessment Score:		3
Priority Assessment Score:		Negligible
Action:	Manage	
Comments:	N/A
