Proposed Redevelopment  
The Kennet Centre  
Newbury

Ground Investigation Report

**Proposed redevelopment  
The Kennet Centre  
Market Street  
Newbury  
RG14 5EN**

**GROUND INVESTIGATION REPORT**

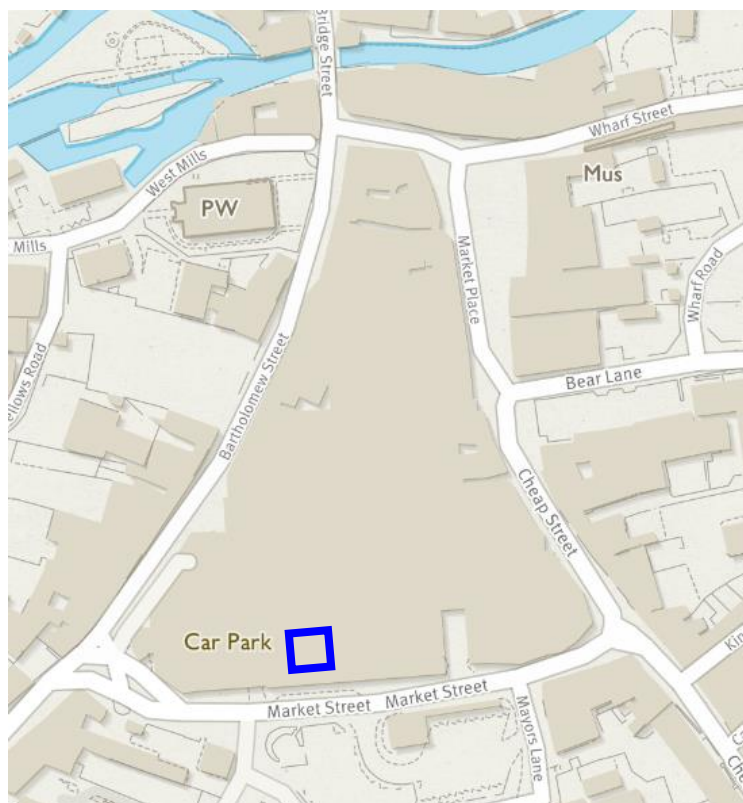
The Site was situated on the ground floor of the Kennet Centre multi-storey car park in Newbury. The surveyed pile was one of multiple piles associated with a concrete support column. A borehole was drilled in close proximity to the column to allow investigation of the underlying pile structure. From core samples observed on Site the bedrock is known to be chalk at a depth of 17m.

The borehole was located adjacent to the pile, ~1.7 m north west of the support column and extended to ~24 m bgl (below ground level).
