Project Number 3113

Management  
Asbestos Survey Report

Kennet Centre, Market Street, Newbury,  
Berkshire, RG14 5EN

1-3 The Mall

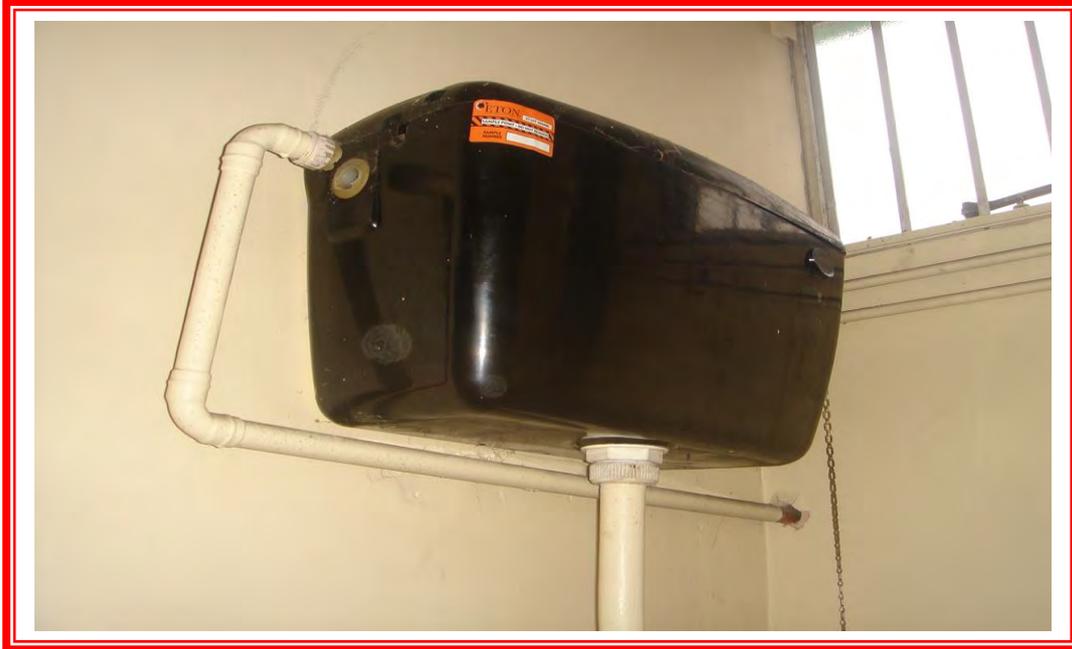
Location: 1/005 WC

Material Description:	Toilet Cistern	
Identification:	As Per Sample NE/3 - Asbestos Detected	
Approx. quantity:	1 X Item	
Accessibility	Low	Assessment Score
Product type:	Composite	1
Extent of Damage:	Good	0
Surface Treatment:	Non-Friable	0
Asbestos type:	Amosite	2
Material Assessment Score:		3
Priority Assessment Score:		Negligible
Action:	Manage	
Comments:	N/A

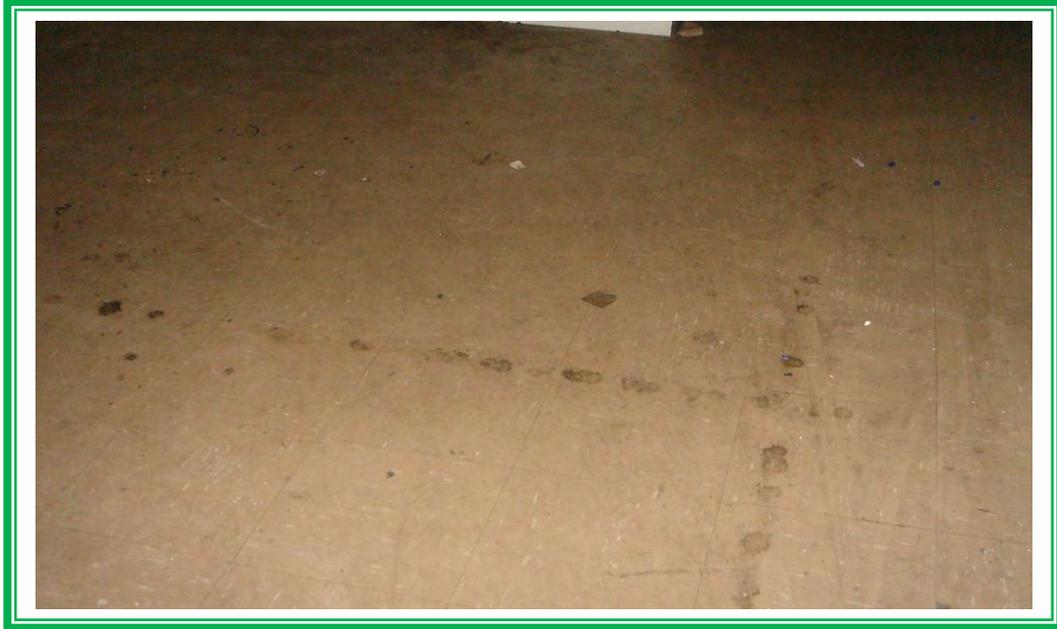
Location: 1/003 Lobby

Material Description:	Vinyl Floor Tiles	
Identification:	As Per Sample NE/2 – No Asbestos Detected	
Approx. quantity:	25M2	
Accessibility	N/A	Assessment Score
Product type:	N/A	N/A
Extent of Damage:	N/A	N/A
Surface Treatment:	N/A	N/A
Asbestos type:	N/A	N/A
Material Assessment Score:		N/A
Priority Assessment Score:		N/A
Action:	N/A	
Comments:	N/A

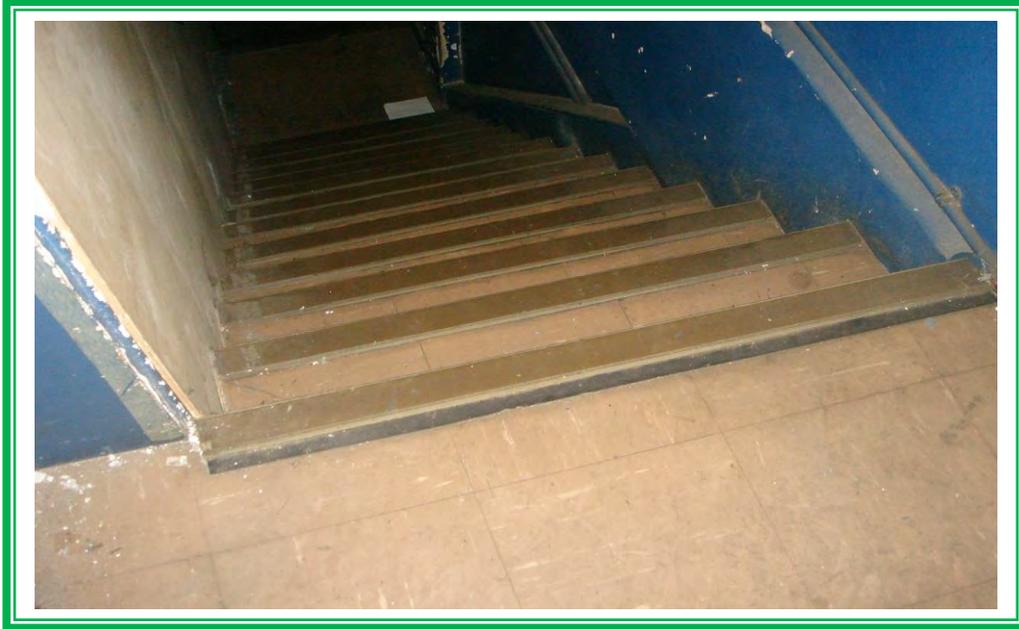
Location: 1/006 Stairs

Material Description:	Vinyl Floor Tiles	
Identification:	As Per Sample NE/2 – No Asbestos Detected	
Approx. quantity:	30M2	
Accessibility	N/A	Assessment Score
Product type:	N/A	N/A
Extent of Damage:	N/A	N/A
Surface Treatment:	N/A	N/A
Asbestos type:	N/A	N/A
Material Assessment Score:		N/A
Priority Assessment Score:		N/A
Action:	N/A	
Comments:	N/A

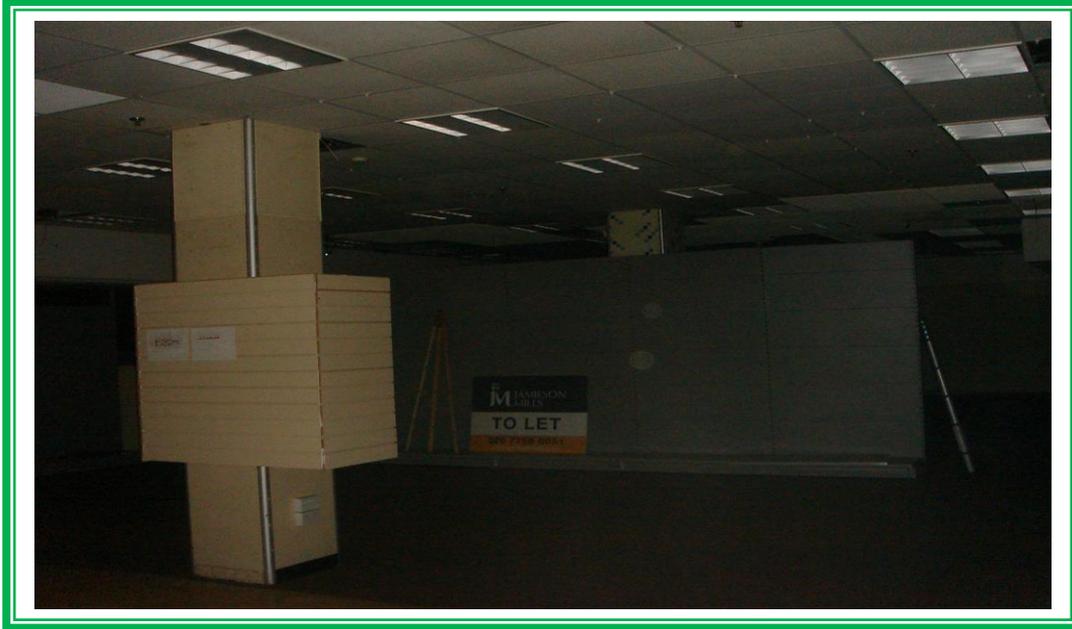
Location: 0/001 Shop Floor

Material Description:	Visual Inspection – No Suspect Materials Found	
Identification:	N/A	
Approx. quantity:	N/A	
Accessibility	N/A	Assessment Score
Product type:	N/A	N/A
Extent of Damage:	N/A	N/A
Surface Treatment:	N/A	N/A
Asbestos type:	N/A	N/A
Material Assessment Score:		N/A
Priority Assessment Score:		N/A
Action:	N/A	
Comments:	N/A

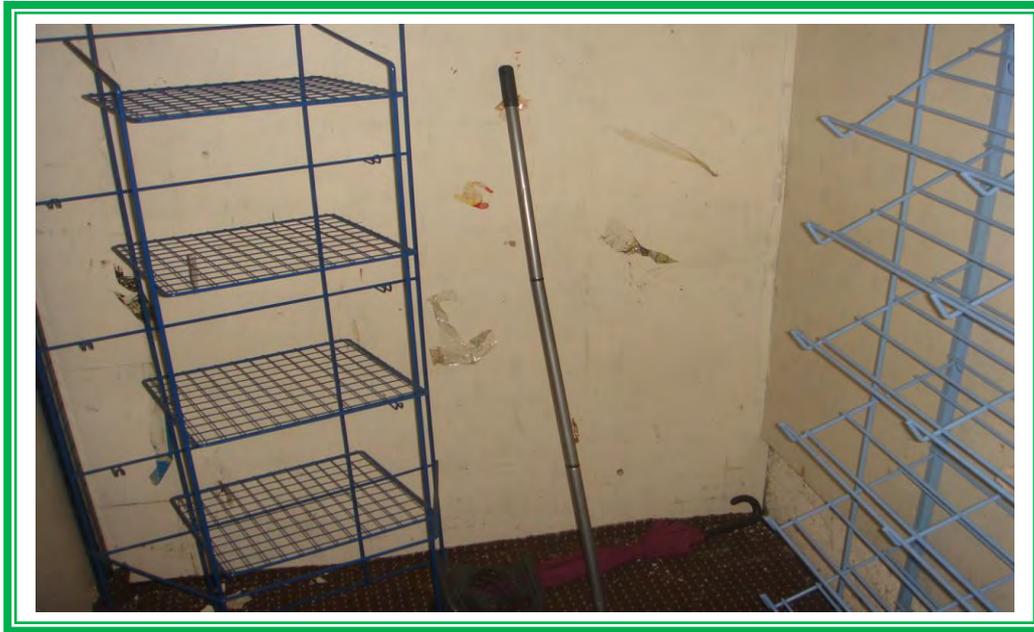
Location: 0/002 Cupboard

Material Description:	Visual Inspection – No Suspect Materials Found	
Identification:	N/A	
Approx. quantity:	N/A	
Accessibility	N/A	Assessment Score
Product type:	N/A	N/A
Extent of Damage:	N/A	N/A
Surface Treatment:	N/A	N/A
Asbestos type:	N/A	N/A
Material Assessment Score:		N/A
Priority Assessment Score:		N/A
Action:	N/A	
Comments:	N/A

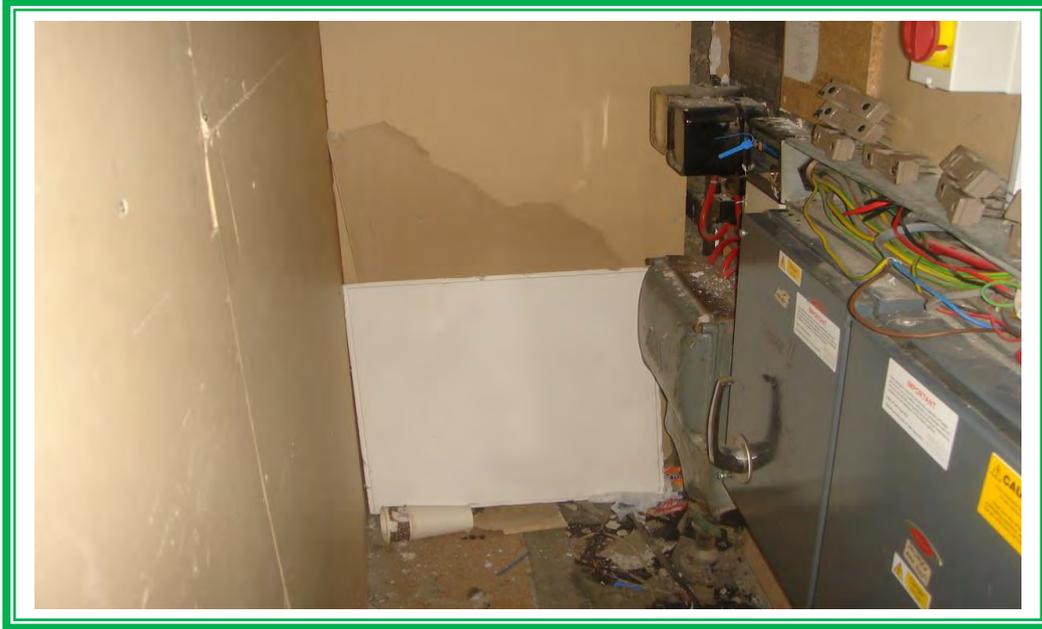
Location: 0/003 Electrics Cupboard

Material Description:	Visual Inspection – No Suspect Materials Found	
Identification:	N/A	
Approx. quantity:	N/A	
Accessibility	N/A	Assessment Score
Product type:	N/A	N/A
Extent of Damage:	N/A	N/A
Surface Treatment:	N/A	N/A
Asbestos type:	N/A	N/A
Material Assessment Score:		N/A
Priority Assessment Score:		N/A
Action:	N/A	
Comments:	N/A

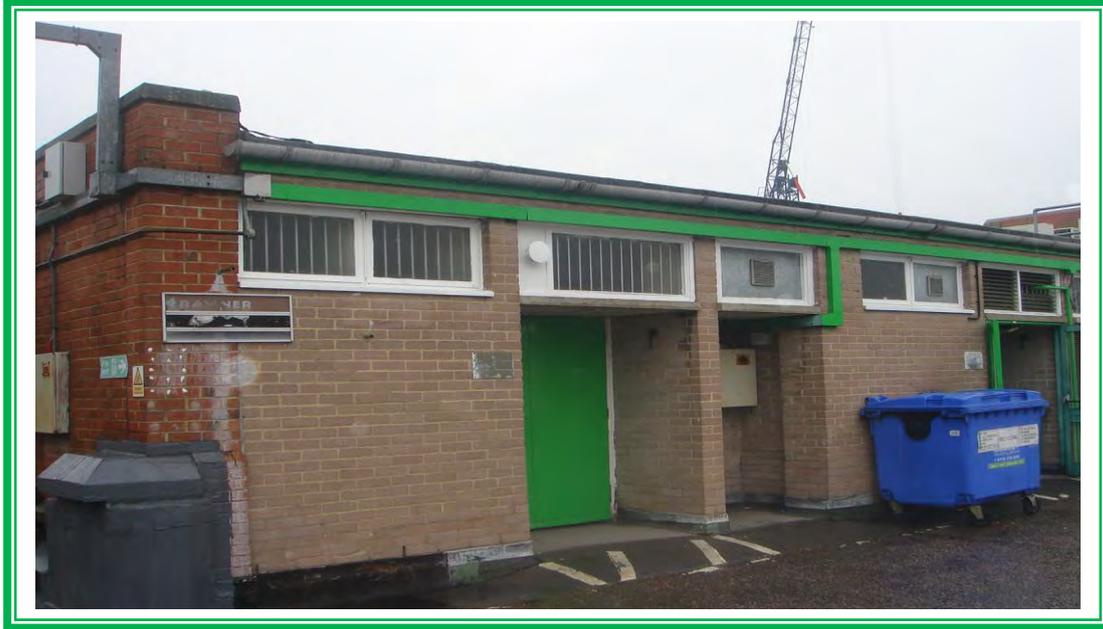
Location: 99/001 External

Material Description:	Visual Inspection – No Suspect Materials Found	
Identification:	N/A	
Approx. quantity:	N/A	
Accessibility	N/A	Assessment Score
Product type:	N/A	N/A
Extent of Damage:	N/A	N/A
Surface Treatment:	N/A	N/A
Asbestos type:	N/A	N/A
Material Assessment Score:		N/A
Priority Assessment Score:		N/A
Action:	N/A	
Comments:	N/A

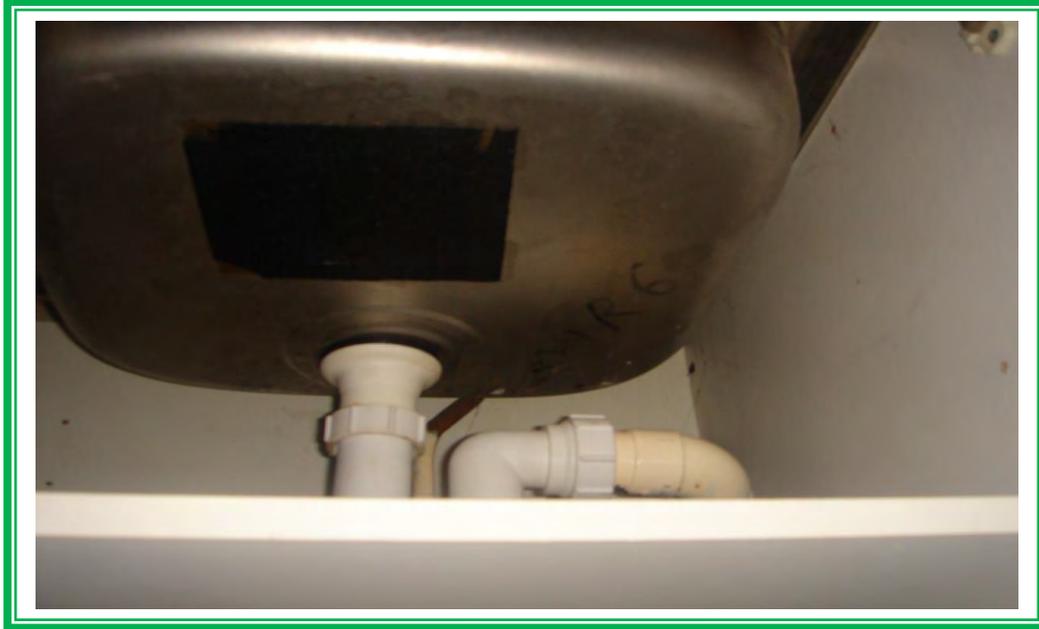
Location: 1/001 Kitchen

Material Description:	Sink Pads	
Identification:	Sampled- No Asbestos Detected	
Approx. quantity:	2 X Items	
Accessibility	N/A	Assessment Score
Product type:	N/A	N/A
Extent of Damage:	N/A	N/A
Surface Treatment:	N/A	N/A
Asbestos type:	N/A	N/A
Material Assessment Score:		N/A
Priority Assessment Score:		N/A
Action:	N/A	
Comments:	N/A

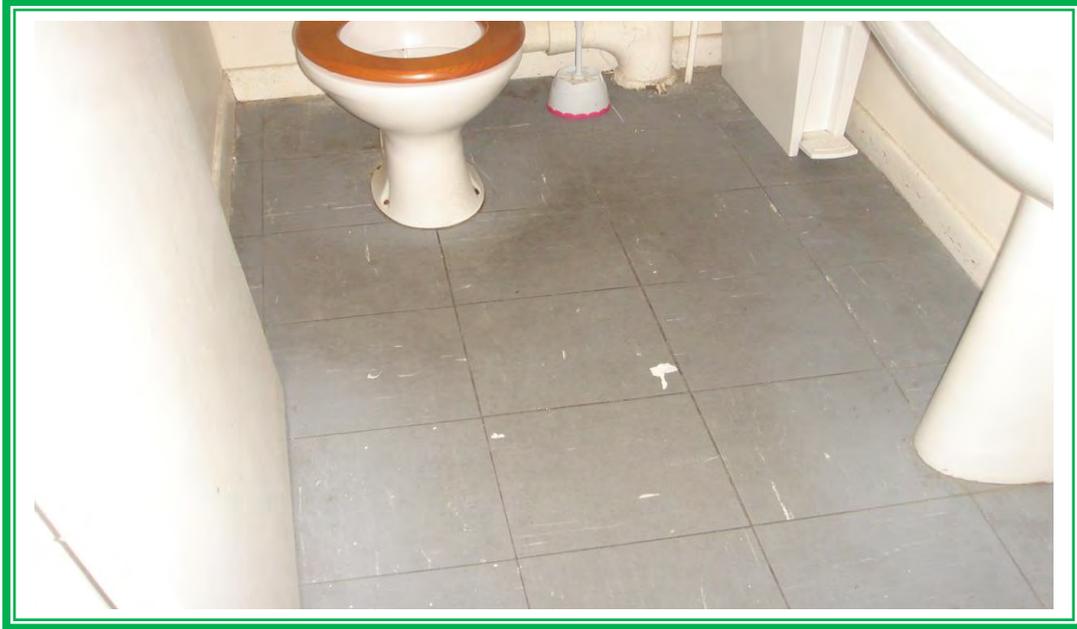
Location: 1/002 WC

Material Description:	Vinyl Floor Tiles	
Identification:	As Per Sample NE/1- No Asbestos Detected	
Approx. quantity:	4M2	
Accessibility	N/A	Assessment Score
Product type:	N/A	N/A
Extent of Damage:	N/A	N/A
Surface Treatment:	N/A	N/A
Asbestos type:	N/A	N/A
Material Assessment Score:		N/A
Priority Assessment Score:		N/A
Action:	N/A	
Comments:	N/A

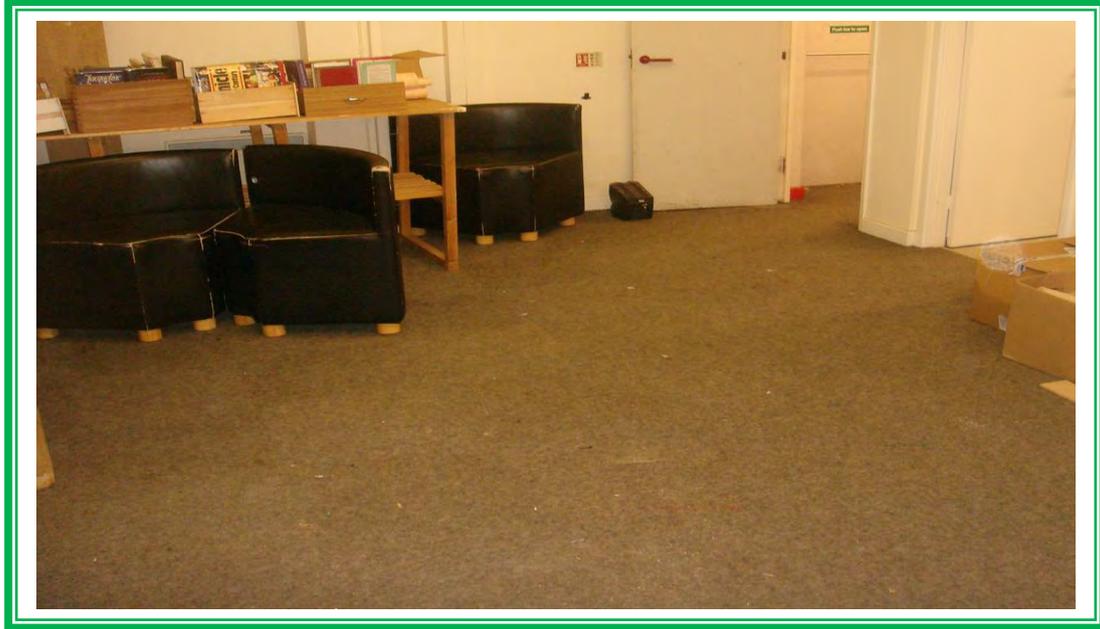
Location: 1/003 Store

Material Description:	Visual Inspection – No Suspect Materials Found	
Identification:	N/A	
Approx. quantity:	N/A	
Accessibility	N/A	Assessment Score
Product type:	N/A	N/A
Extent of Damage:	N/A	N/A
Surface Treatment:	N/A	N/A
Asbestos type:	N/A	N/A
Material Assessment Score:		N/A
Priority Assessment Score:		N/A
Action:	N/A	
Comments:	N/A

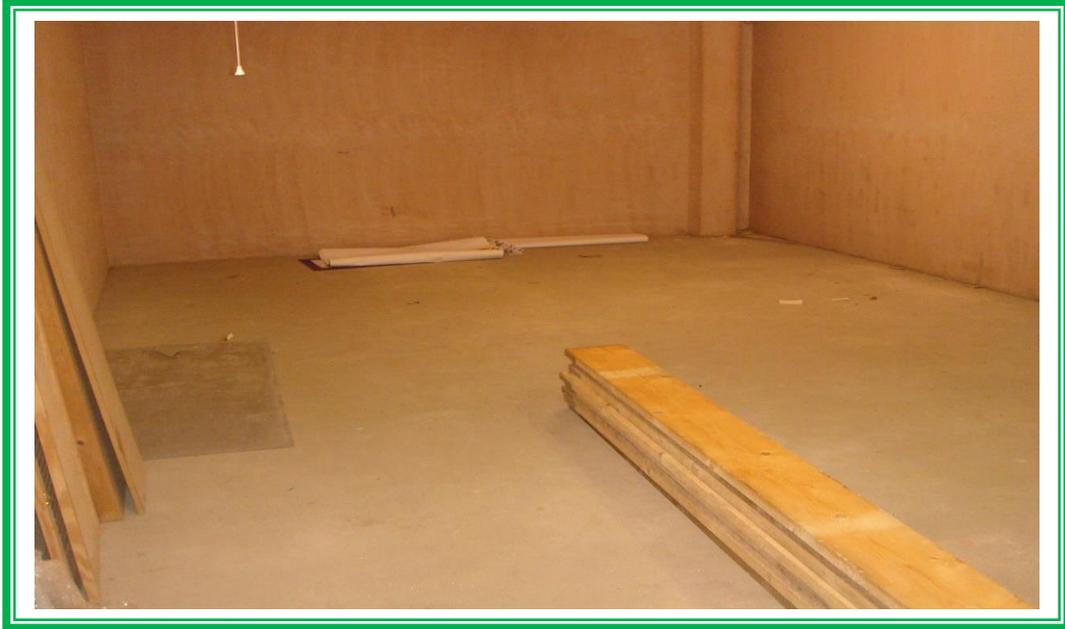
Location: 1/004 Store

Material Description:	Visual Inspection – No Suspect Materials Found	
Identification:	N/A	
Approx. quantity:	N/A	
Accessibility	N/A	Assessment Score
Product type:	N/A	N/A
Extent of Damage:	N/A	N/A
Surface Treatment:	N/A	N/A
Asbestos type:	N/A	N/A
Material Assessment Score:		N/A
Priority Assessment Score:		N/A
Action:	N/A	
Comments:	N/A

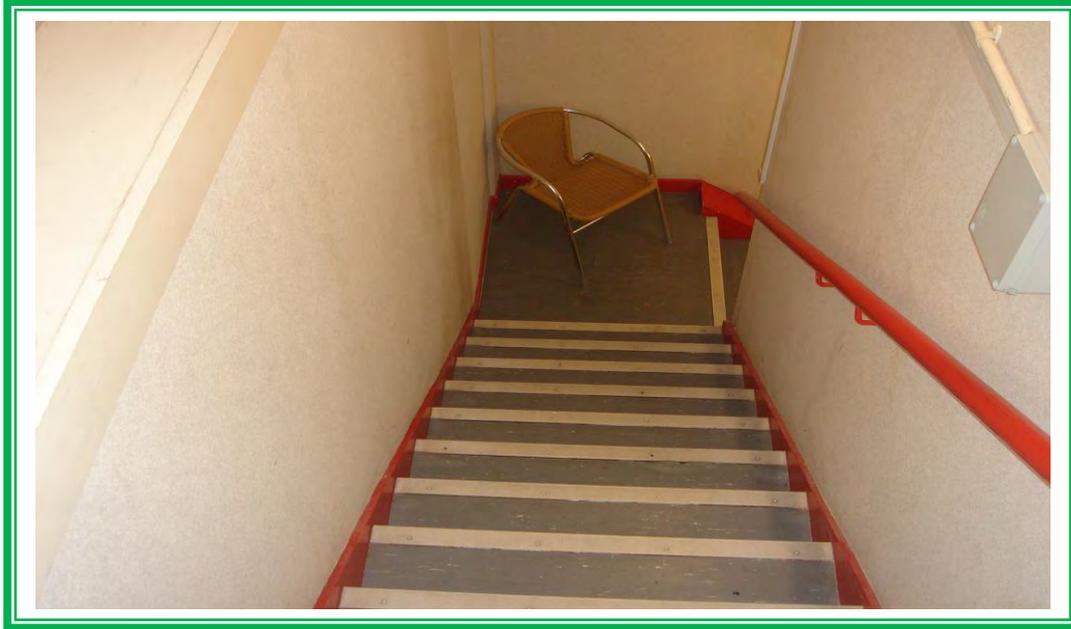
Location: 1/005 Stairs

Material Description:	Vinyl Floor Tiles	
Identification:	As Per Sample NE/1- No Asbestos Detected	
Approx. quantity:	15M2	
Accessibility	N/A	Assessment Score
Product type:	N/A	N/A
Extent of Damage:	N/A	N/A
Surface Treatment:	N/A	N/A
Asbestos type:	N/A	N/A
Material Assessment Score:		N/A
Priority Assessment Score:		N/A
Action:	N/A	
Comments:	N/A

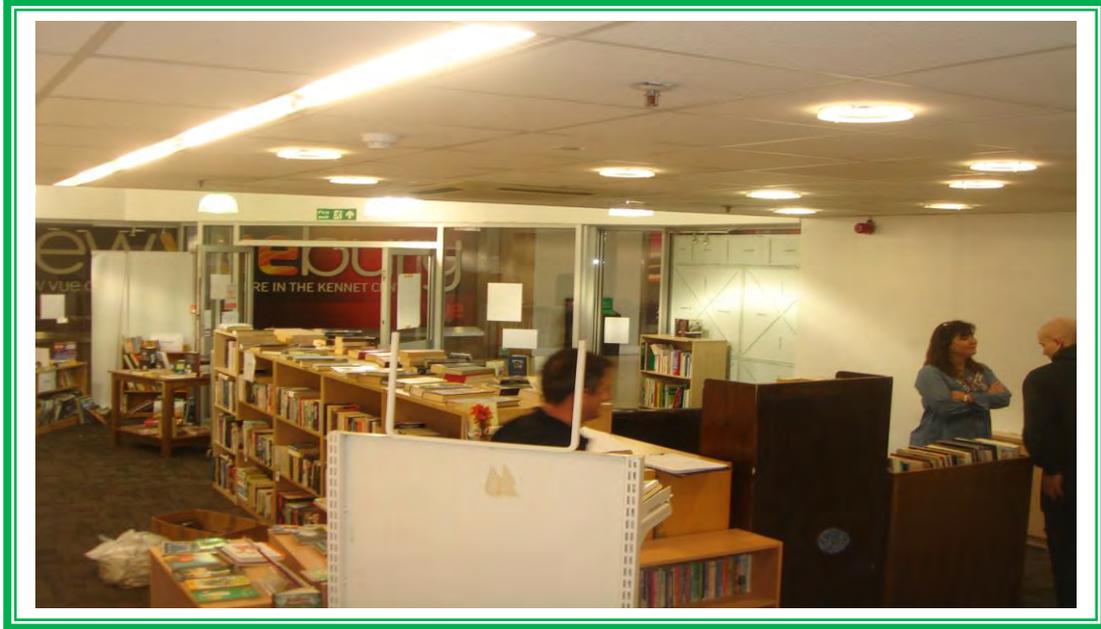
Location: 0/001 Shop Floor

Material Description:	Visual Inspection – No Suspect Materials Found	
Identification:	N/A	
Approx. quantity:	N/A	
Accessibility	N/A	Assessment Score
Product type:	N/A	N/A
Extent of Damage:	N/A	N/A
Surface Treatment:	N/A	N/A
Asbestos type:	N/A	N/A
Material Assessment Score:		N/A
Priority Assessment Score:		N/A
Action:	N/A	
Comments:	N/A

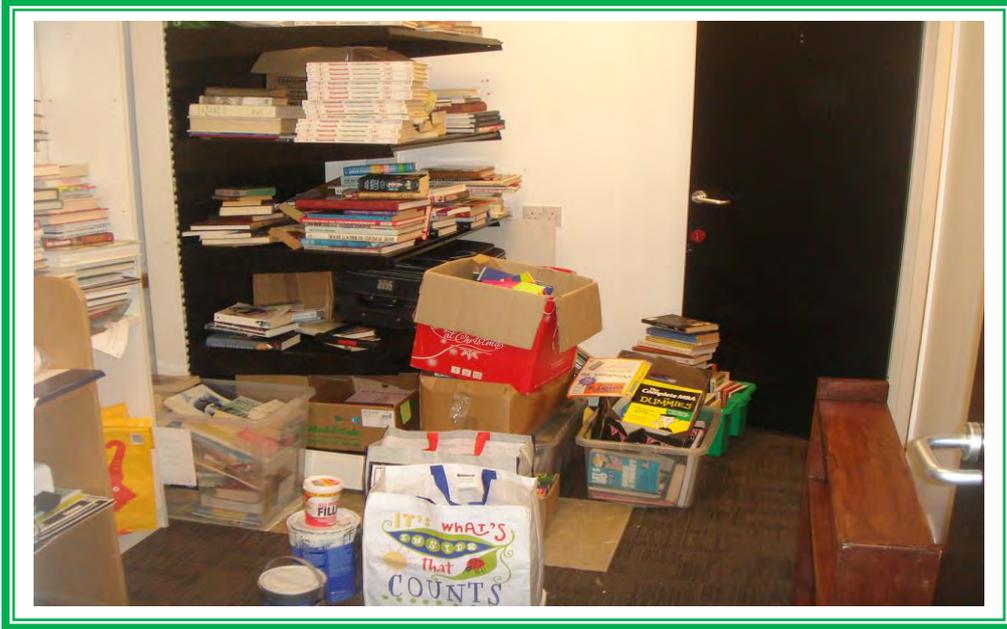
Location: 0/003 Store

Material Description:	Visual Inspection – No Suspect Materials Found	
Identification:	N/A	
Approx. quantity:	N/A	
Accessibility	N/A	Assessment Score
Product type:	N/A	N/A
Extent of Damage:	N/A	N/A
Surface Treatment:	N/A	N/A
Asbestos type:	N/A	N/A
Material Assessment Score:		N/A
Priority Assessment Score:		N/A
Action:	N/A	
Comments:	N/A

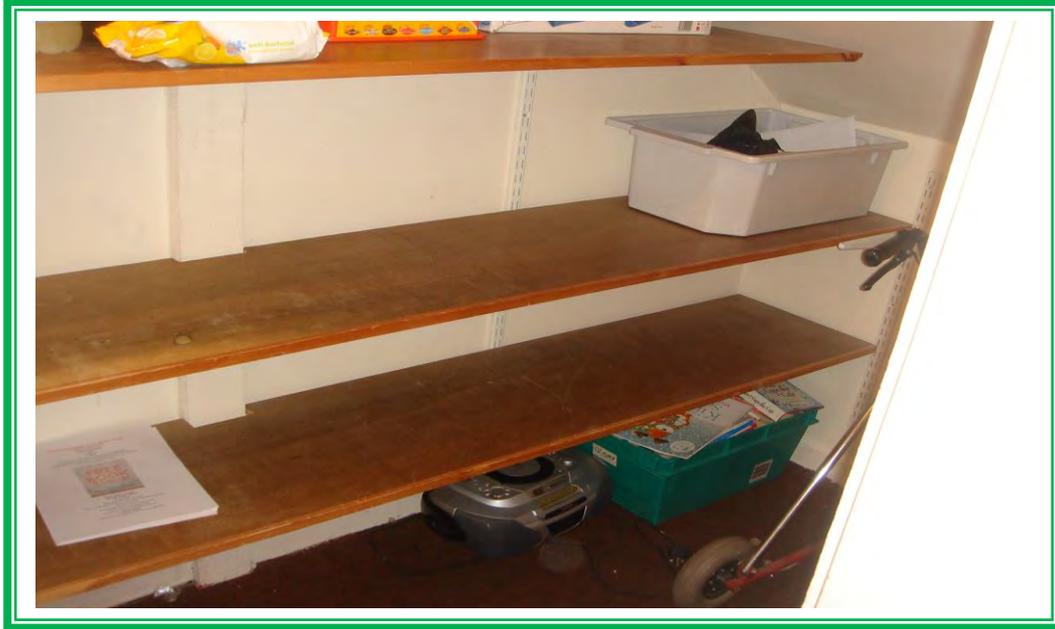
Location: 0/004

Material Description:	Visual Inspection – No Suspect Materials Found	
Identification:	N/A	
Approx. quantity:	N/A	
Accessibility	N/A	Assessment Score
Product type:	N/A	N/A
Extent of Damage:	N/A	N/A
Surface Treatment:	N/A	N/A
Asbestos type:	N/A	N/A
Material Assessment Score:		N/A
Priority Assessment Score:		N/A
Action:	N/A	
Comments:	N/A

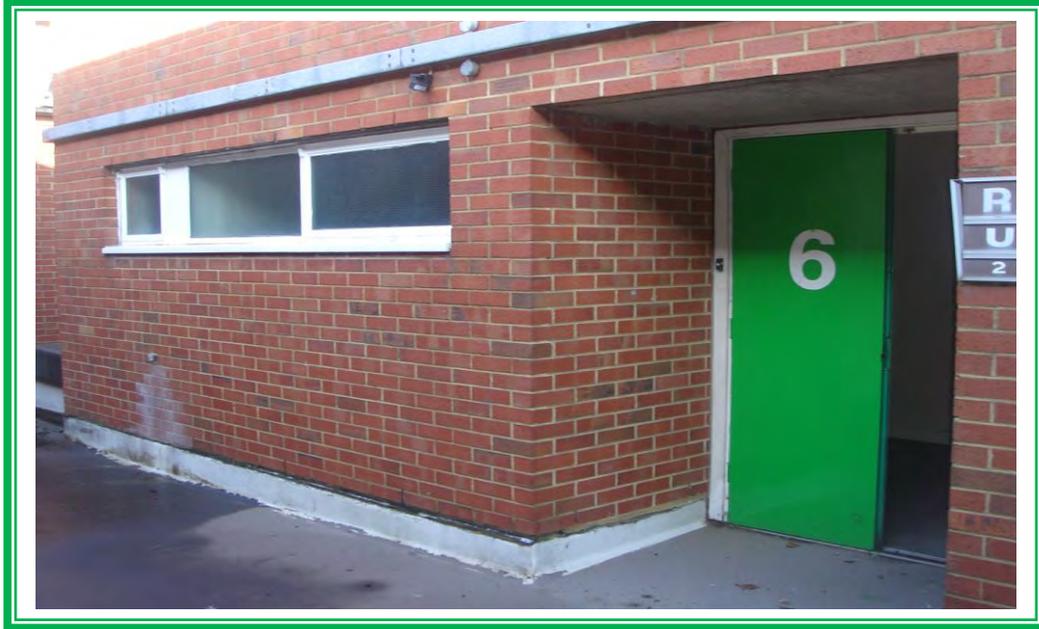
Location: 99/001 External

Material Description:	Visual Inspection – No Suspect Materials Found	
Identification:	N/A	
Approx. quantity:	N/A	
Accessibility	N/A	Assessment Score
Product type:	N/A	N/A
Extent of Damage:	N/A	N/A
Surface Treatment:	N/A	N/A
Asbestos type:	N/A	N/A
Material Assessment Score:		N/A
Priority Assessment Score:		N/A
Action:	N/A	
Comments:	N/A

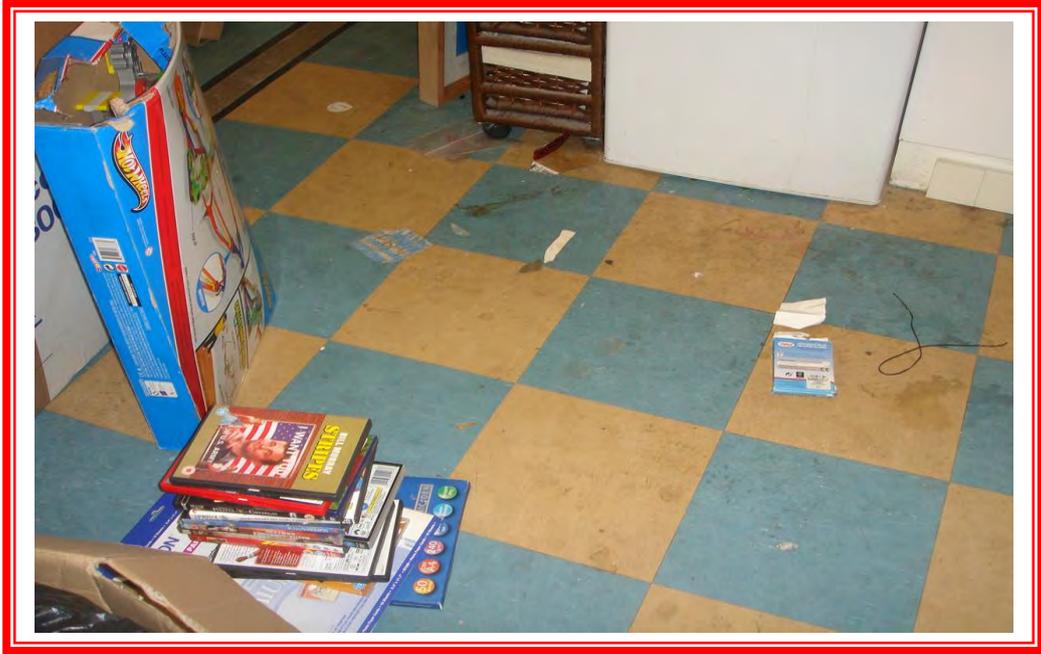
Item No: 1	Sample No: NE/1
Location: 1/001 Store

Material Description:	Vinyl Floor Tiles	
Identification:	Sampled – Asbestos Detected	
Approx. quantity:	20M2	
Accessibility	Low	Assessment Score
Product type:	Vinyl	1
Extent of Damage:	Moderate	2
Surface Treatment:	Non-Friable	0
Asbestos type:	Chrysotile	1
Material Assessment Score:		4
Priority Assessment Score:		Negligible
Action:	Repair/Seal	
Comments:	N/A

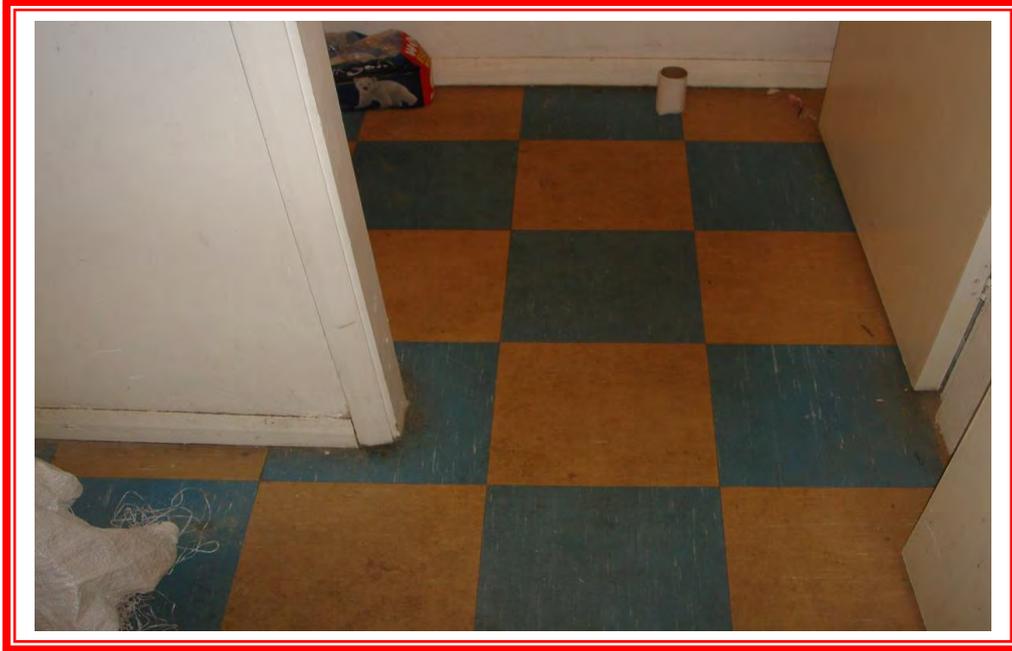
Location: 1/002 WC

Material Description:	Vinyl Floor Tiles	
Identification:	As Per Sample NE/1 - Asbestos Detected	
Approx. quantity:	4M2	
Accessibility	Low	Assessment Score
Product type:	Vinyl	1
Extent of Damage:	Minor	1
Surface Treatment:	Non-Friable	0
Asbestos type:	Chrysotile	1
Material Assessment Score:		3
Priority Assessment Score:		Negligible
Action:	Manage	
Comments:	N/A

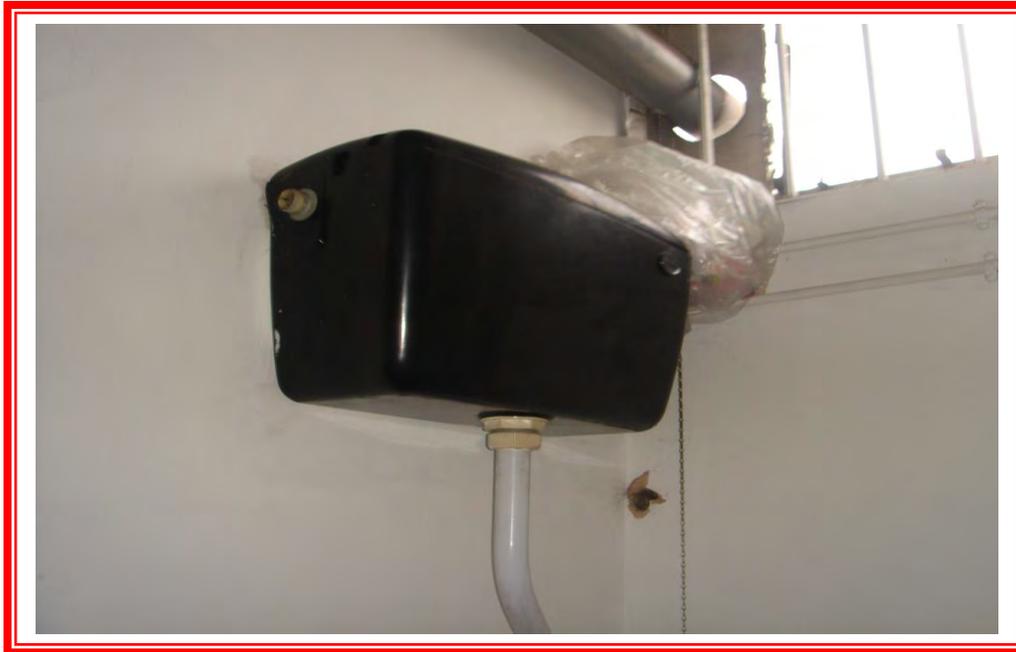
Location: 1/003 WC

Material Description:	Toilet Cistern	
Identification:	Sampled - Asbestos Detected	
Approx. quantity:	X1	
Accessibility	Low	Assessment Score
Product type:	Bakelite	1
Extent of Damage:	Good	0
Surface Treatment:	Non-Friable	0
Asbestos type:	Amosite	2
Material Assessment Score:		3
Priority Assessment Score:		Negligible
Action:	Manage	
Comments:	N/A

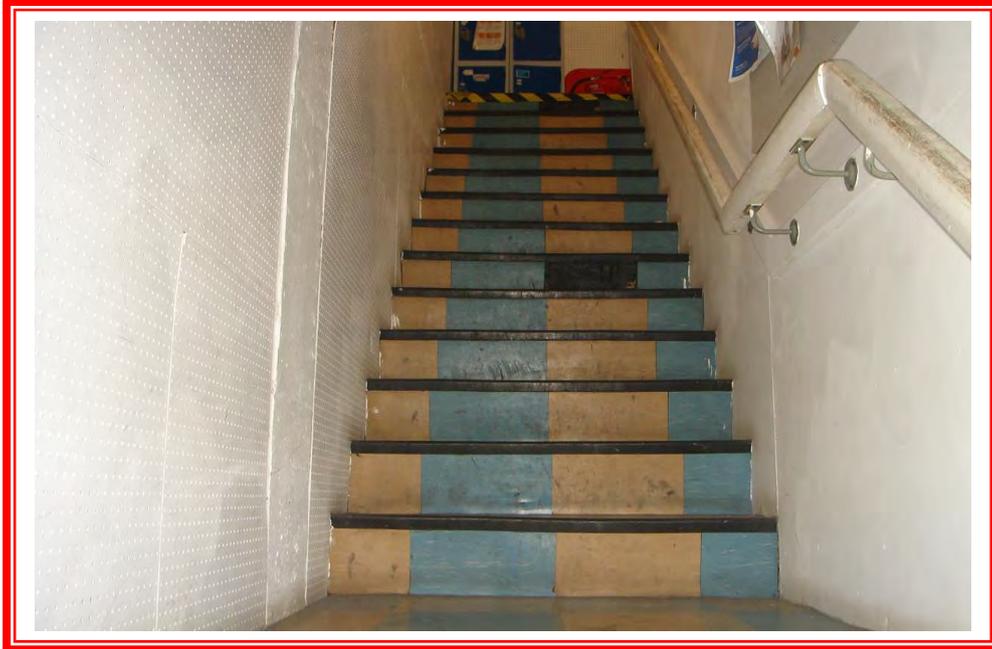
Location: 1/004 Stairs

Material Description:	Vinyl Floor Tiles	
Identification:	As Per Sample NE/1 - Asbestos Detected	
Approx. quantity:	15M2	
Accessibility	Low	Assessment Score
Product type:	Vinyl	1
Extent of Damage:	Moderate	2
Surface Treatment:	Non-Friable	0
Asbestos type:	Chrysotile	1
Material Assessment Score:		4
Priority Assessment Score:		Negligible
Action:	Manage/Repair/Seal	
Comments:	N/A

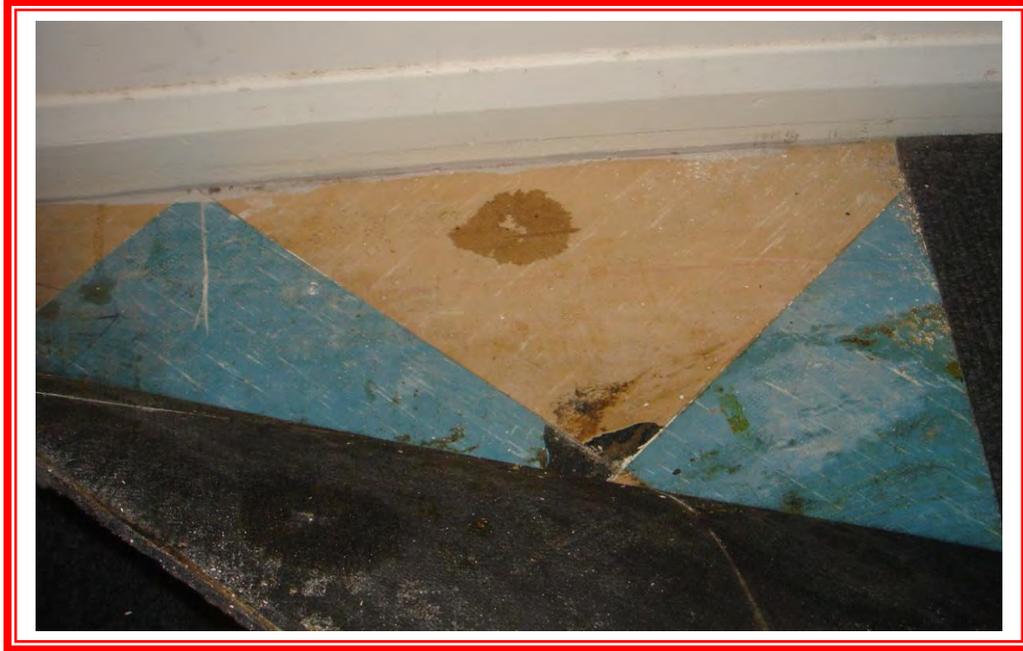
Location: 0/001 Shop Floor

Material Description:	Vinyl Floor Tiles	
Identification:	Sampled - Asbestos Detected	
Approx. quantity:	60M2	
Accessibility	Low	Assessment Score
Product type:	Vinyl	1
Extent of Damage:	Good	0
Surface Treatment:	Non-Friable	0
Asbestos type:	Chrysotile	1
Material Assessment Score:		2
Priority Assessment Score:		Negligible
Action:	Manage	
Comments:	N/A

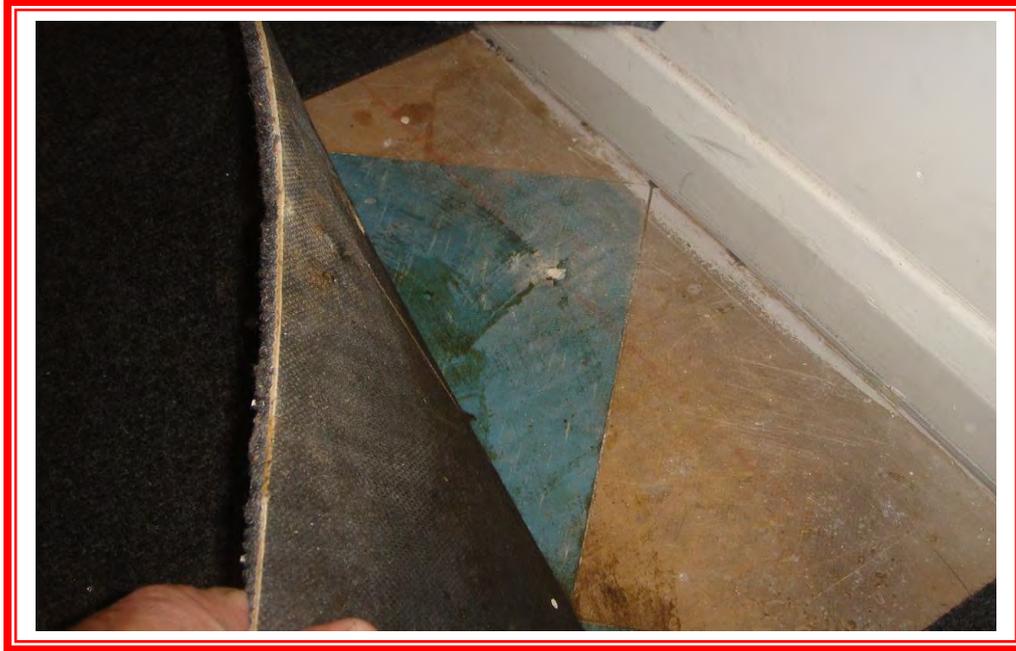
Location: 0/002 Changing Room

Material Description:	Vinyl Floor Tiles	
Identification:	As Per Sample NE/3 - Asbestos Detected	
Approx. quantity:	1M2	
Accessibility	Low	Assessment Score
Product type:	Vinyl	1
Extent of Damage:	Good	0
Surface Treatment:	Non-Friable	0
Asbestos type:	Chrysotile	1
Material Assessment Score:		2
Priority Assessment Score:		Negligible
Action:	Manage	
Comments:	N/A

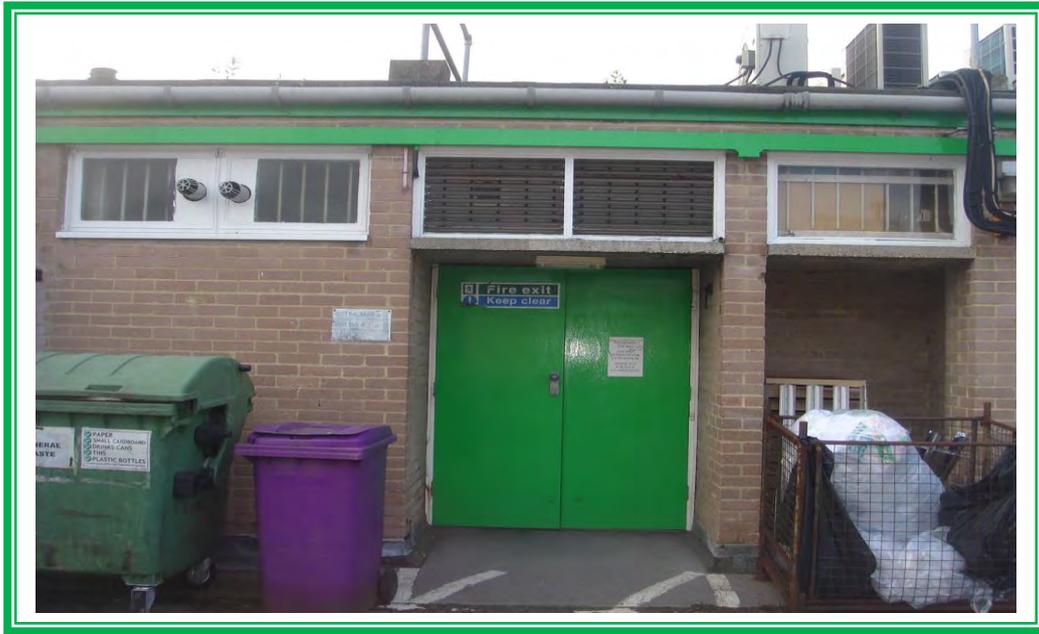
Item No: 7	Sample No: N/A
Location: 99/001 External

Material Description:	Visual Inspection – No Suspect Materials Found	
Identification:	N/A	
Approx. quantity:	N/A	
Accessibility	N/A	Assessment Score
Product type:	N/A	N/A
Extent of Damage:	N/A	N/A
Surface Treatment:	N/A	N/A
Asbestos type:	N/A	N/A
Material Assessment Score:		N/A
Priority Assessment Score:		N/A
Action:	N/A	
Comments:	N/A

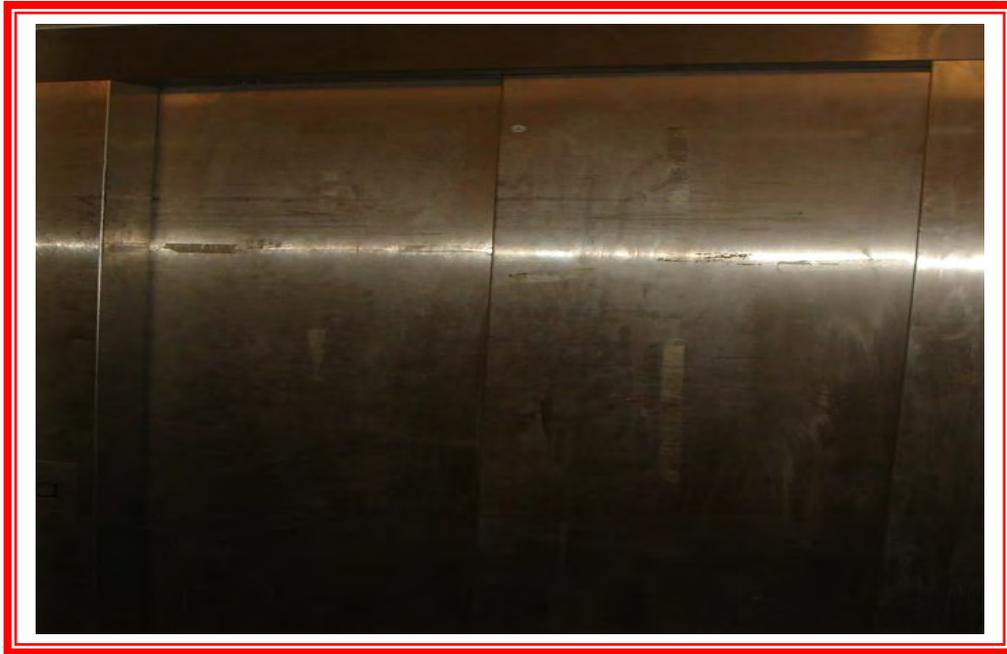
Location: Lift and Lift Shaft

Material Description:	No Access	
Identification:	Presumed to Contain Asbestos	
Approx. quantity:	Unknown	
Accessibility	Low	Assessment Score
Product type:	No Access	3
Extent of Damage:	No Access	3
Surface Treatment:	No Access	3
Asbestos type:	No Access	3
Material Assessment Score:		12
Priority Assessment Score:		High
Action:	Further Inspection Required	
Comments:	No access as no lift engineer onsite

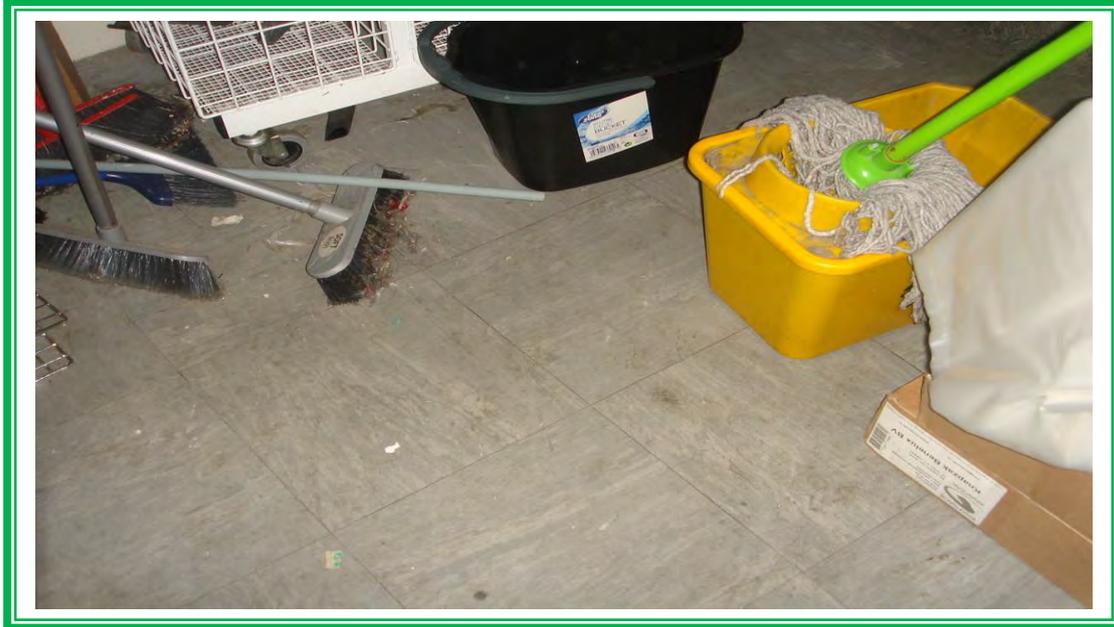
Location: 1/003 Cleaners Cupboard

Material Description:	Vinyl Floor Tiles	
Identification:	As Per Sample NE/1 – No Asbestos Detected	
Approx. quantity:	3M2	
Accessibility	N/A	Assessment Score
Product type:	N/A	N/A
Extent of Damage:	N/A	N/A
Surface Treatment:	N/A	N/A
Asbestos type:	N/A	N/A
Material Assessment Score:		N/A
Priority Assessment Score:		N/A
Action:	N/A	
Comments:	N/A

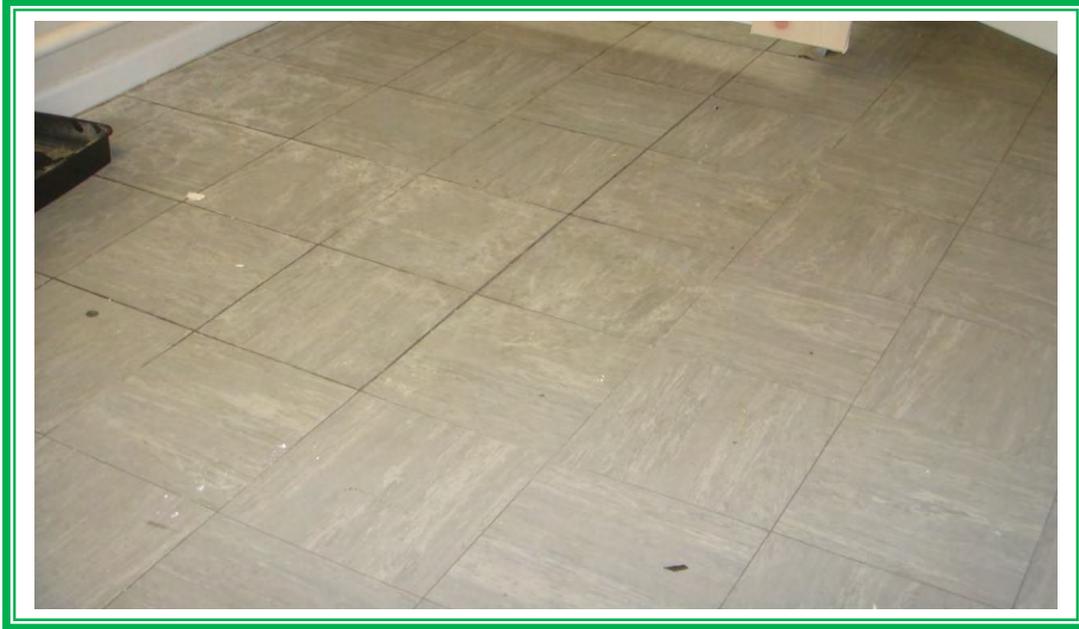
Location: 1/004 WC

Material Description:	Vinyl Floor Tiles	
Identification:	As Per Sample NE/1 – No Asbestos Detected	
Approx. quantity:	8M2	
Accessibility	N/A	Assessment Score
Product type:	N/A	N/A
Extent of Damage:	N/A	N/A
Surface Treatment:	N/A	N/A
Asbestos type:	N/A	N/A
Material Assessment Score:		N/A
Priority Assessment Score:		N/A
Action:	N/A	
Comments:	N/A

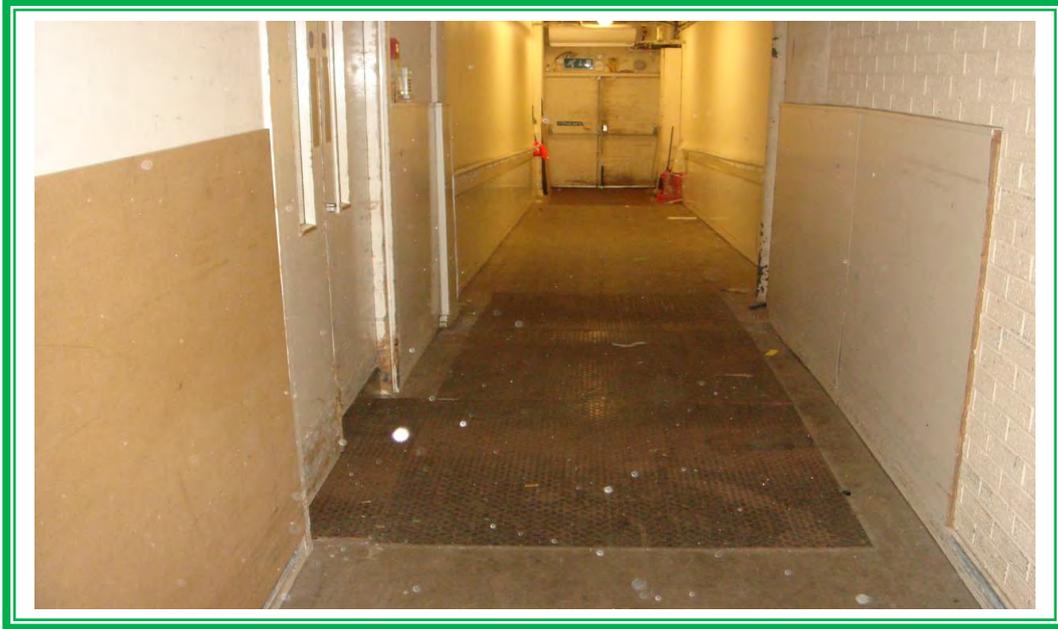
Location: 1/006 Corridor

Material Description:	Vinyl Floor Tiles	
Identification:	Sampled – No Asbestos Detected	
Approx. quantity:	16M2	
Accessibility	N/A	Assessment Score
Product type:	N/A	N/A
Extent of Damage:	N/A	N/A
Surface Treatment:	N/A	N/A
Asbestos type:	N/A	N/A
Material Assessment Score:		N/A
Priority Assessment Score:		N/A
Action:	N/A	
Comments:	N/A

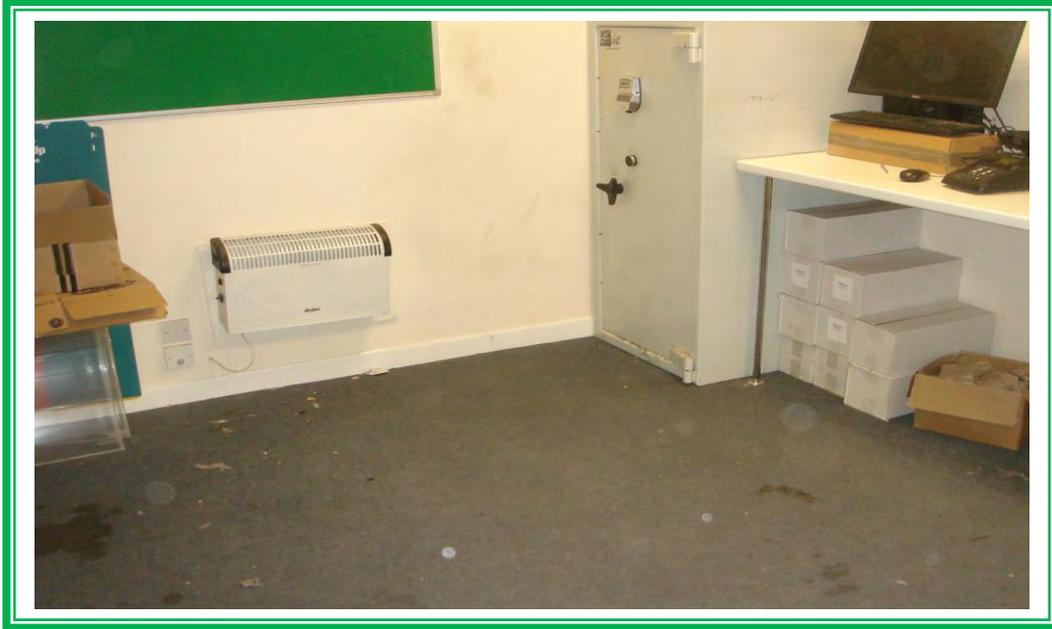
Location: 1/009 Cash Office

Material Description:	Visual Inspection – No Suspect Materials Found	
Identification:	N/A	
Approx. quantity:	N/A	
Accessibility	N/A	Assessment Score
Product type:	N/A	N/A
Extent of Damage:	N/A	N/A
Surface Treatment:	N/A	N/A
Asbestos type:	N/A	N/A
Material Assessment Score:		N/A
Priority Assessment Score:		N/A
Action:	N/A	
Comments:	N/A

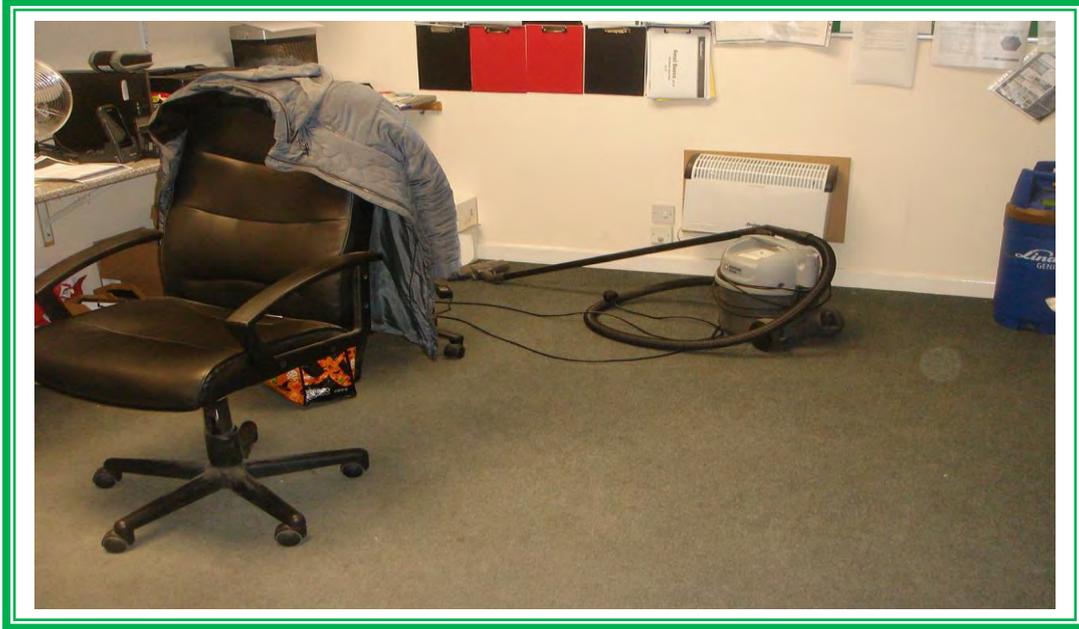
Location: 1/010 Office

Material Description:	Visual Inspection – No Suspect Materials Found	
Identification:	N/A	
Approx. quantity:	N/A	
Accessibility	N/A	Assessment Score
Product type:	N/A	N/A
Extent of Damage:	N/A	N/A
Surface Treatment:	N/A	N/A
Asbestos type:	N/A	N/A
Material Assessment Score:		N/A
Priority Assessment Score:		N/A
Action:	N/A	
Comments:	N/A
