Project Number 3113

Management  
Asbestos Survey Report

Kennet Centre, Market Street, Newbury,  
Berkshire, RG14 5EN

1-3 The Mall

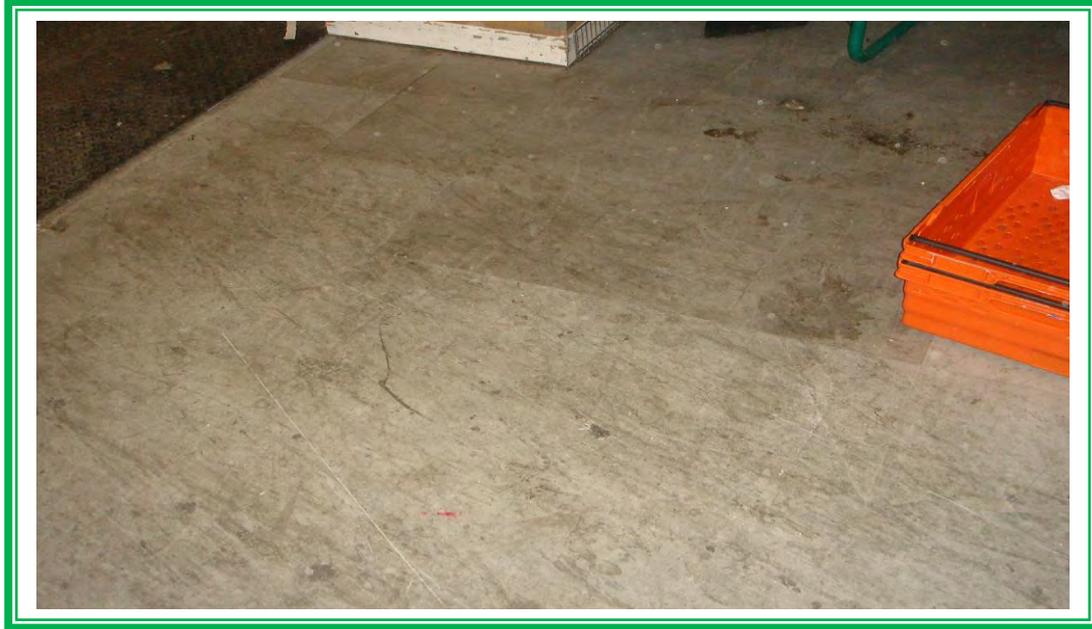
Location: 1/011 Lobby and Stairs

Material Description:	Vinyl Floor Tiles	
Identification:	As Per Sample NE/2 – No Asbestos Detected	
Approx. quantity:	30M2	
Accessibility	N/A	Assessment Score
Product type:	N/A	N/A
Extent of Damage:	N/A	N/A
Surface Treatment:	N/A	N/A
Asbestos type:	N/A	N/A
Material Assessment Score:		N/A
Priority Assessment Score:		N/A
Action:	N/A	
Comments:	N/A

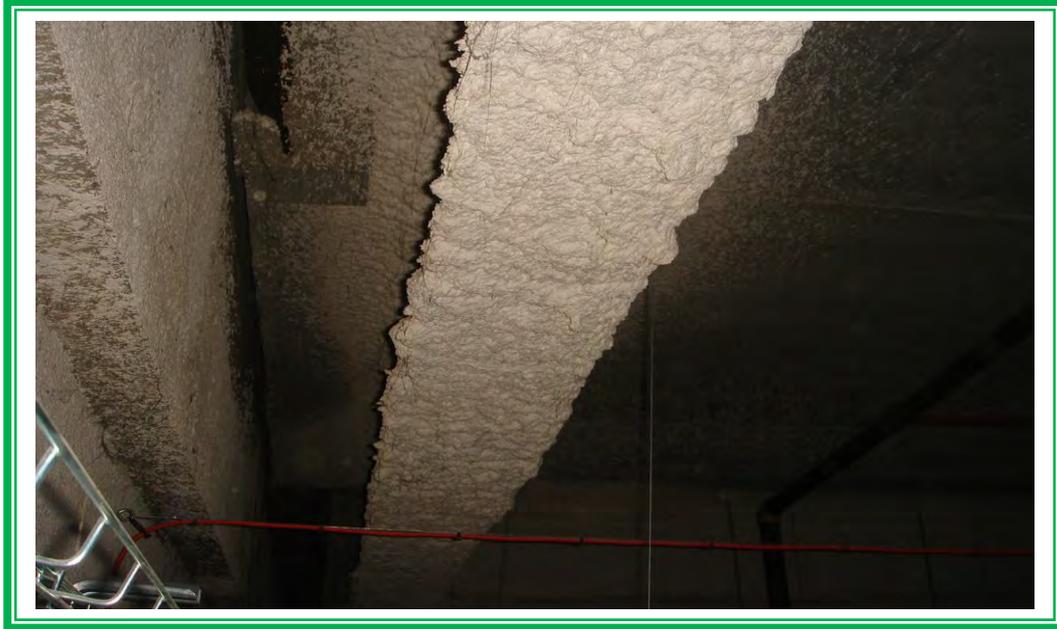
Location: 0/001 Shop Floor

Material Description:	Sprayed Coating to Beams	
Identification:	Sampled - No Asbestos Detected	
Approx. quantity:	100M	
Accessibility	N/A	Assessment Score
Product type:	N/A	N/A
Extent of Damage:	N/A	N/A
Surface Treatment:	N/A	N/A
Asbestos type:	N/A	N/A
Material Assessment Score:		N/A
Priority Assessment Score:		N/A
Action:	N/A	
Comments:	N/A

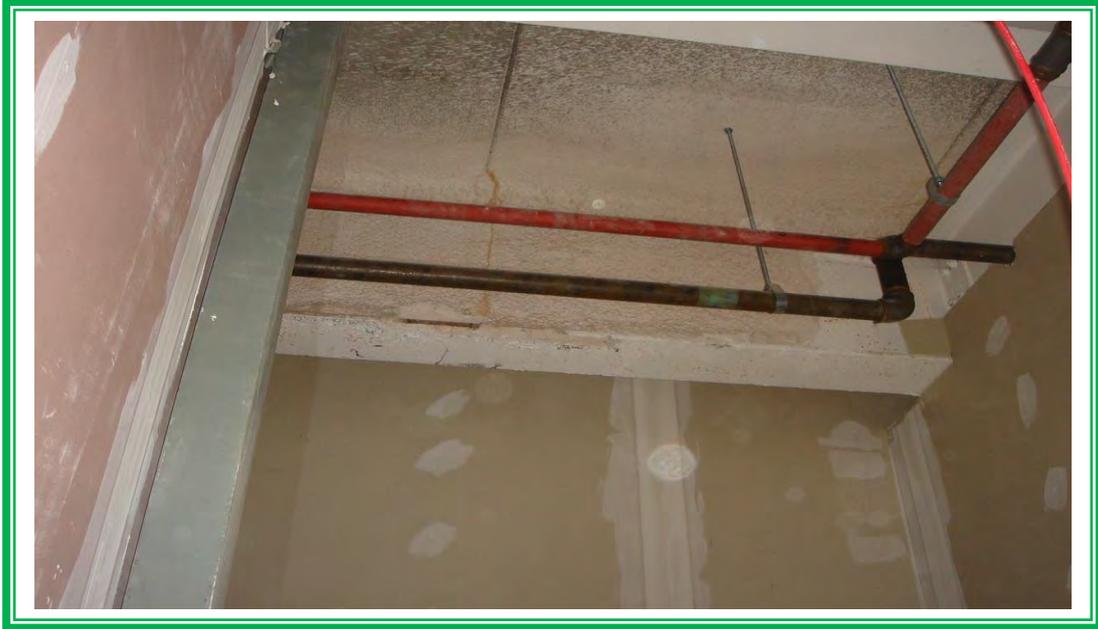
Location: 0/002 Lobby

Material Description:	Sprayed Coating to Beams	
Identification:	As Per Sample NE/3 – No Asbestos Detected	
Approx. quantity:	20M	
Accessibility	N/A	Assessment Score
Product type:	N/A	N/A
Extent of Damage:	N/A	N/A
Surface Treatment:	N/A	N/A
Asbestos type:	N/A	N/A
Material Assessment Score:		N/A
Priority Assessment Score:		N/A
Action:	N/A	
Comments:	N/A

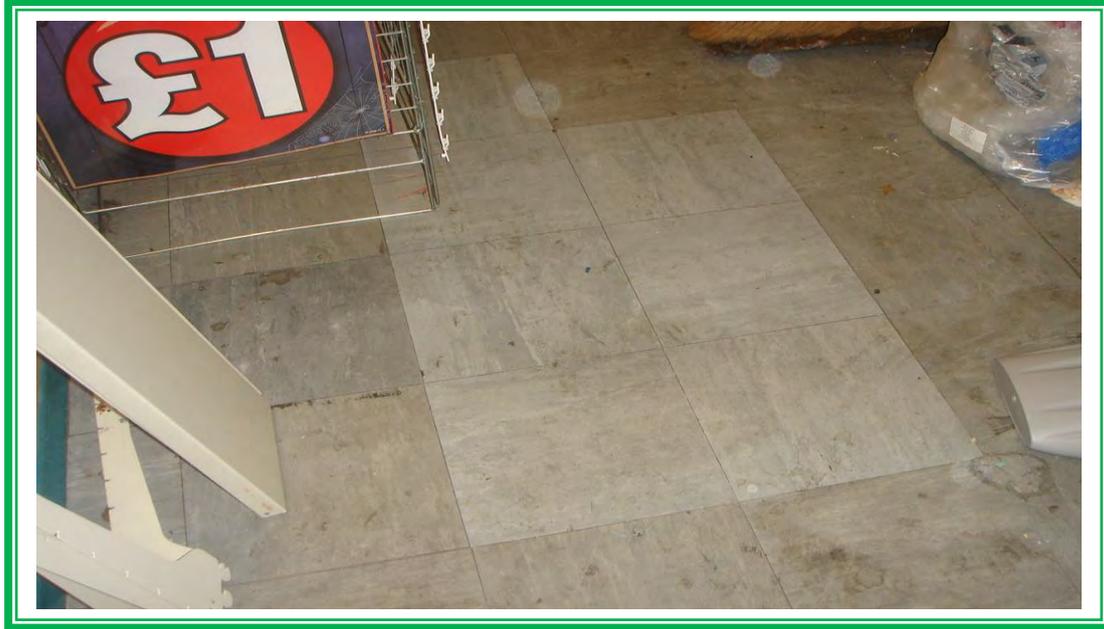
Location: 0/002 Lobby

Material Description:	Vinyl Floor Tiles	
Identification:	Sampled - No Asbestos Detected	
Approx. quantity:	16M2	
Accessibility	N/A	Assessment Score
Product type:	N/A	N/A
Extent of Damage:	N/A	N/A
Surface Treatment:	N/A	N/A
Asbestos type:	N/A	N/A
Material Assessment Score:		N/A
Priority Assessment Score:		N/A
Action:	N/A	
Comments:	N/A

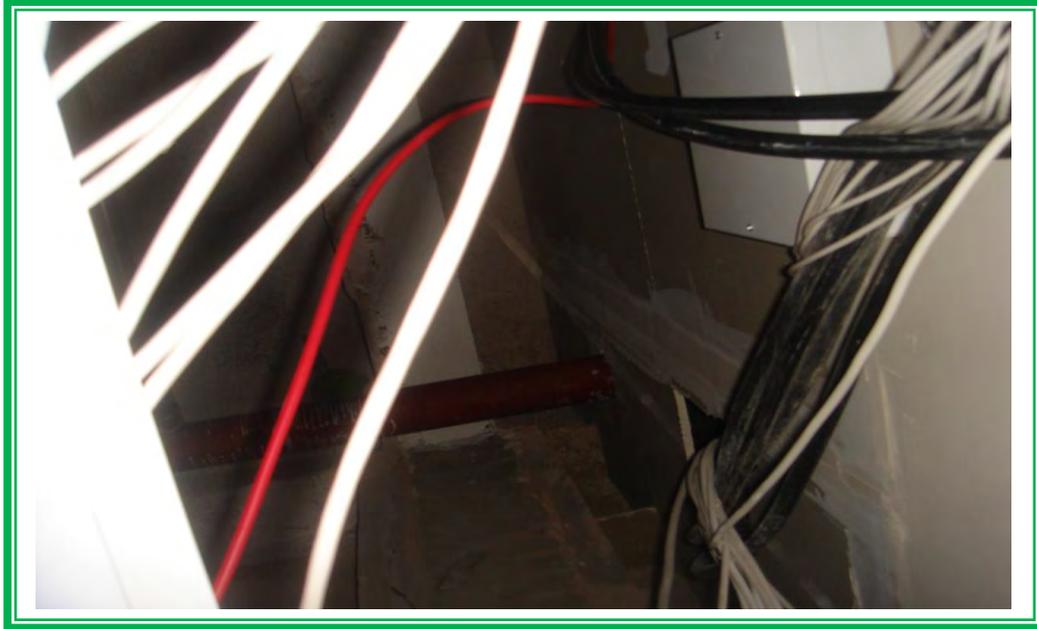
Location: 0/003 Lift Motor Room

Material Description:	Sprayed Coating to Beams	
Identification:	As Per Sample NE/3 – No Asbestos Detected	
Approx. quantity:	10M	
Accessibility	N/A	Assessment Score
Product type:	N/A	N/A
Extent of Damage:	N/A	N/A
Surface Treatment:	N/A	N/A
Asbestos type:	N/A	N/A
Material Assessment Score:		N/A
Priority Assessment Score:		N/A
Action:	N/A	
Comments:	N/A

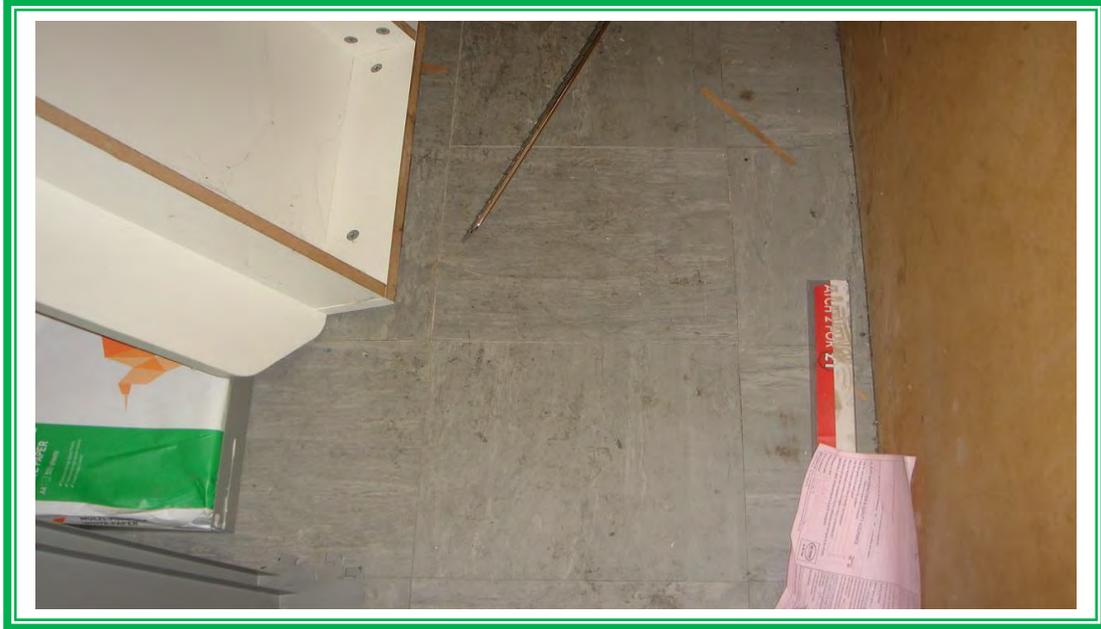
Location: 0/003 Lift Motor Room

Material Description:	Vinyl Floor Tiles	
Identification:	As Per Sample NE/4 – No Asbestos Detected	
Approx. quantity:	2M2	
Accessibility	N/A	Assessment Score
Product type:	N/A	N/A
Extent of Damage:	N/A	N/A
Surface Treatment:	N/A	N/A
Asbestos type:	N/A	N/A
Material Assessment Score:		N/A
Priority Assessment Score:		N/A
Action:	N/A	
Comments:	N/A

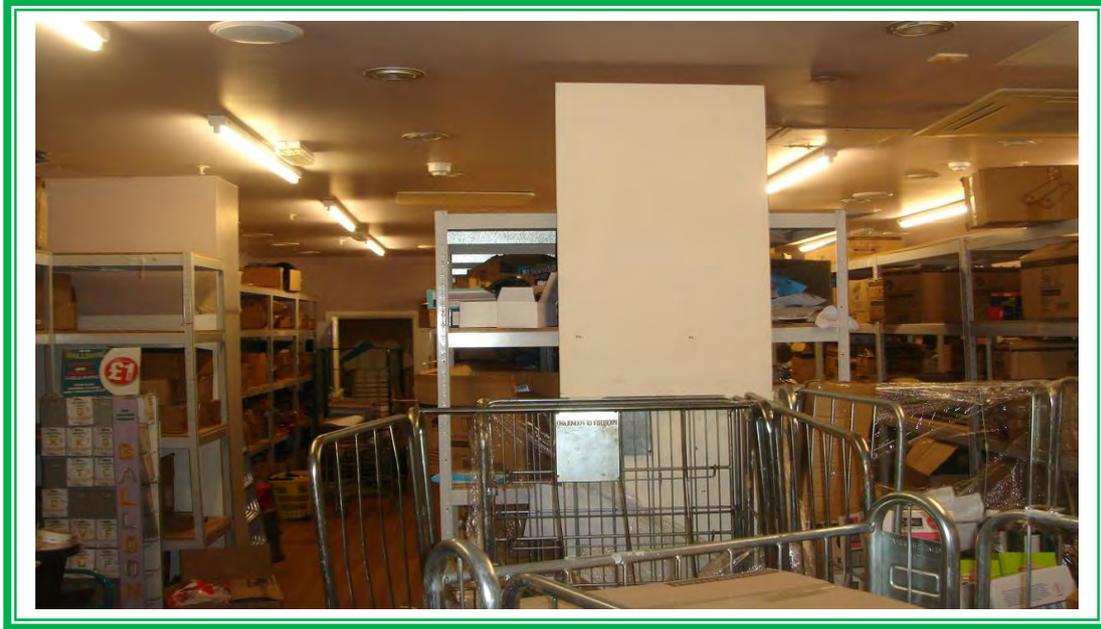
Location: 0/004 Store

Material Description:	Visual Inspection – No Suspect Materials Found	
Identification:	N/A	
Approx. quantity:	N/A	
Accessibility	N/A	Assessment Score
Product type:	N/A	N/A
Extent of Damage:	N/A	N/A
Surface Treatment:	N/A	N/A
Asbestos type:	N/A	N/A
Material Assessment Score:		N/A
Priority Assessment Score:		N/A
Action:	N/A	
Comments:	N/A

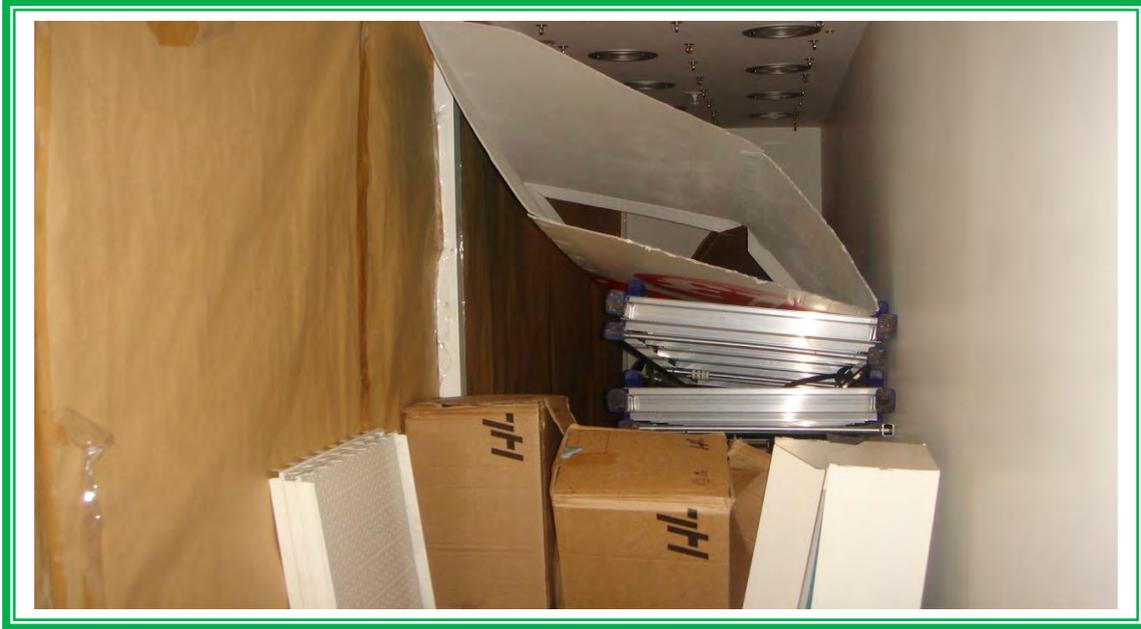
Location: 0/005 Display/Store

Material Description:	Visual Inspection – No Suspect Materials Found	
Identification:	N/A	
Approx. quantity:	N/A	
Accessibility	N/A	Assessment Score
Product type:	N/A	N/A
Extent of Damage:	N/A	N/A
Surface Treatment:	N/A	N/A
Asbestos type:	N/A	N/A
Material Assessment Score:		N/A
Priority Assessment Score:		N/A
Action:	N/A	
Comments:	N/A

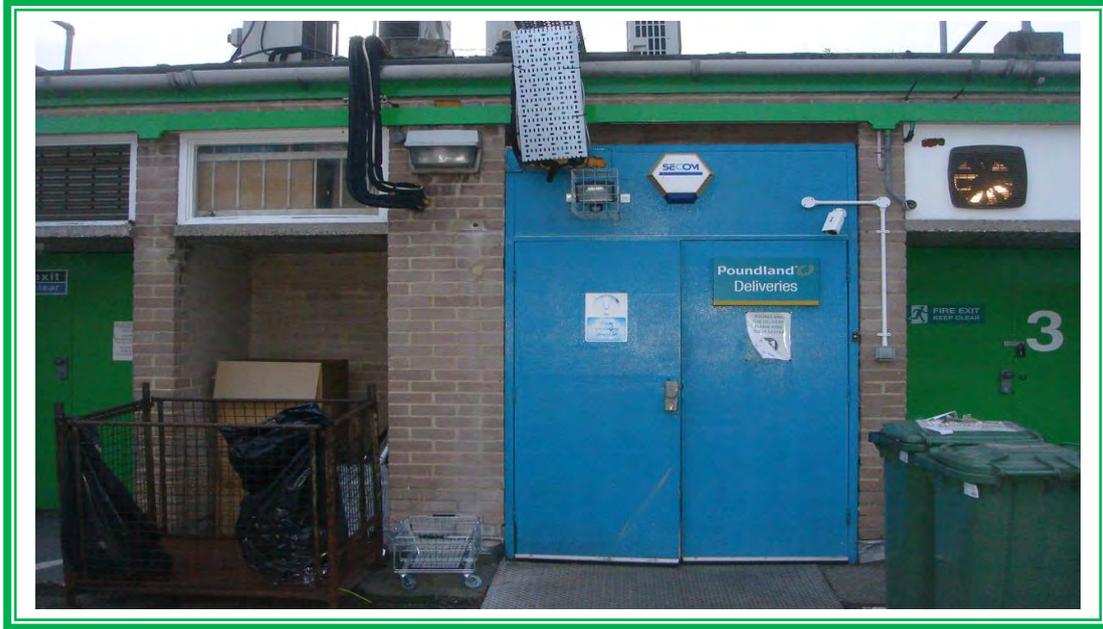
Location: 99/001 External

Material Description:	Visual Inspection – No Suspect Materials Found	
Identification:	N/A	
Approx. quantity:	N/A	
Accessibility	N/A	Assessment Score
Product type:	N/A	N/A
Extent of Damage:	N/A	N/A
Surface Treatment:	N/A	N/A
Asbestos type:	N/A	N/A
Material Assessment Score:		N/A
Priority Assessment Score:		N/A
Action:	N/A	
Comments:	N/A

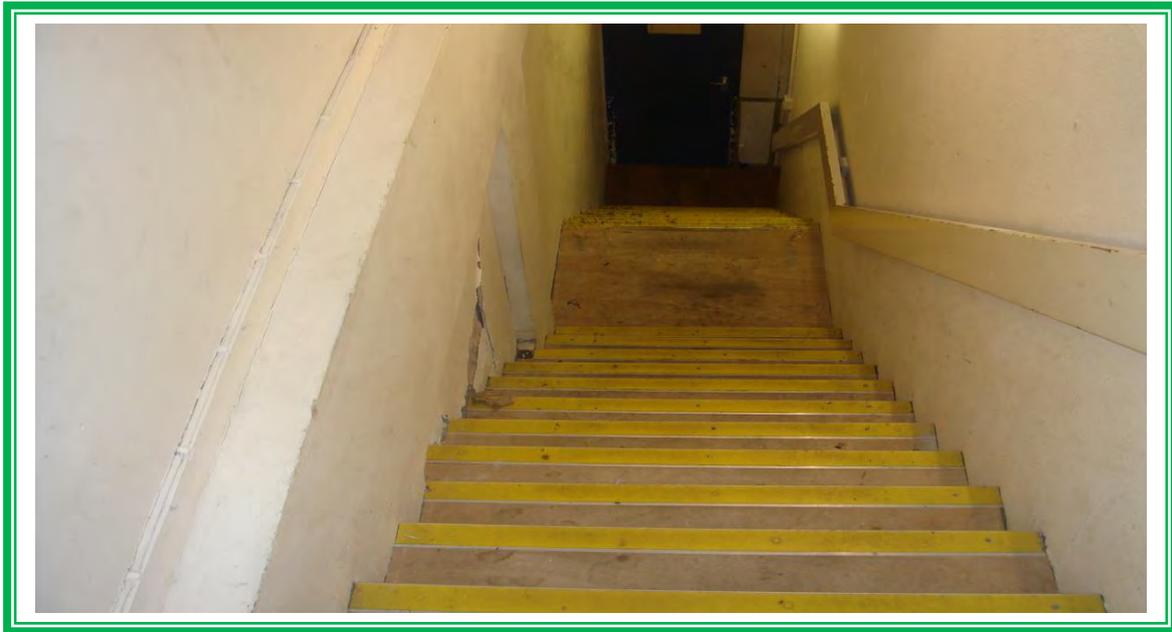
Item No: 5	Sample No: N/A
Location: 1/005

Material Description:	Visual Inspection – No Suspect Materials Found	
Identification:	N/A	
Approx. quantity:	N/A	
Accessibility	N/A	Assessment Score
Product type:	N/A	N/A
Extent of Damage:	N/A	N/A
Surface Treatment:	N/A	N/A
Asbestos type:	N/A	N/A
Material Assessment Score:		N/A
Priority Assessment Score:		N/A
Action:	N/A	
Comments:	N/A

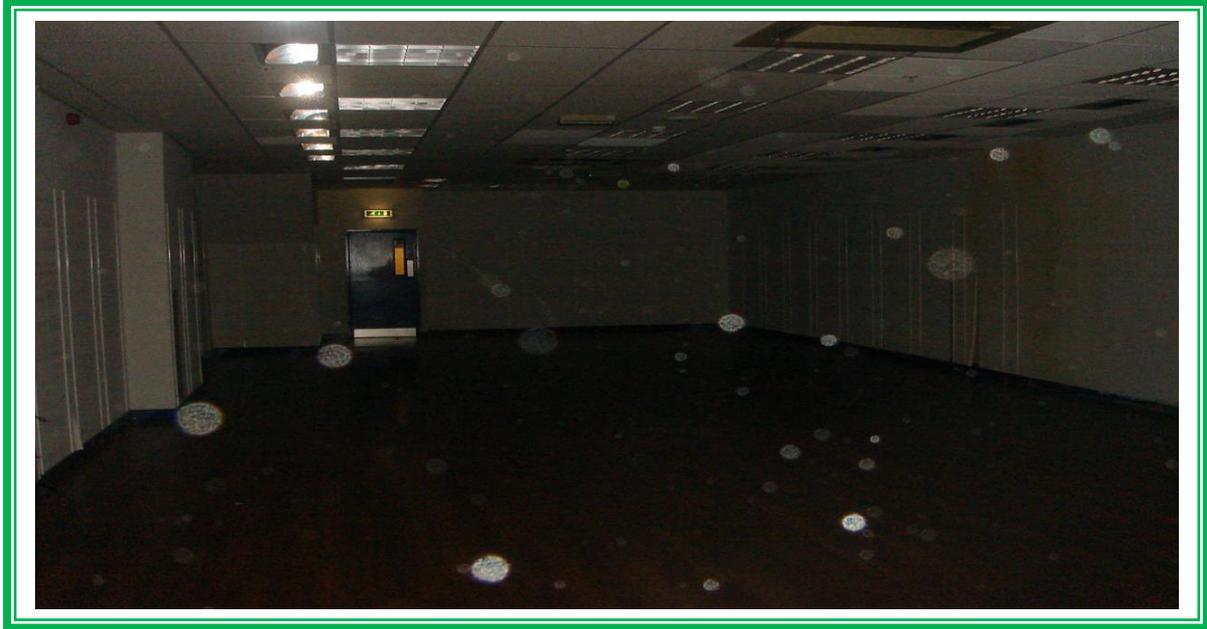
Location: 0/001 Shop Floor

Material Description:	Visual Inspection – No Suspect Materials Found	
Identification:	N/A	
Approx. quantity:	N/A	
Accessibility	N/A	Assessment Score
Product type:	N/A	N/A
Extent of Damage:	N/A	N/A
Surface Treatment:	N/A	N/A
Asbestos type:	N/A	N/A
Material Assessment Score:		N/A
Priority Assessment Score:		N/A
Action:	N/A	
Comments:	N/A

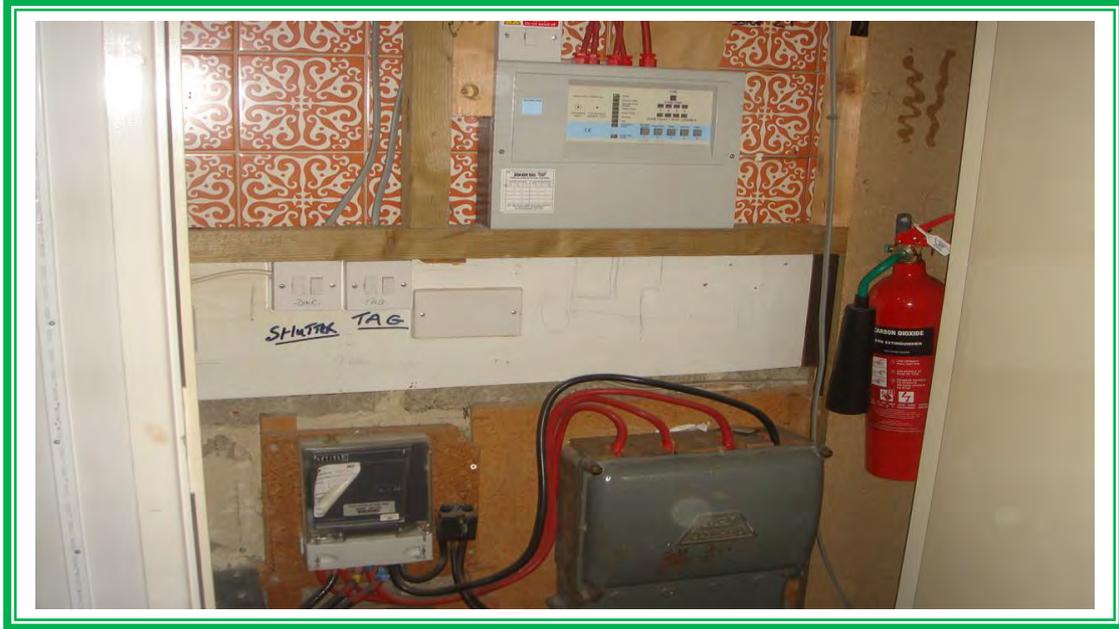
Location: 0/002 – Electric Cupboard

Material Description:	Visual Inspection – No Suspect Materials Found	
Identification:	N/A	
Approx. quantity:	N/A	
Accessibility	N/A	Assessment Score
Product type:	N/A	N/A
Extent of Damage:	N/A	N/A
Surface Treatment:	N/A	N/A
Asbestos type:	N/A	N/A
Material Assessment Score:		N/A
Priority Assessment Score:		N/A
Action:	N/A	
Comments:	N/A

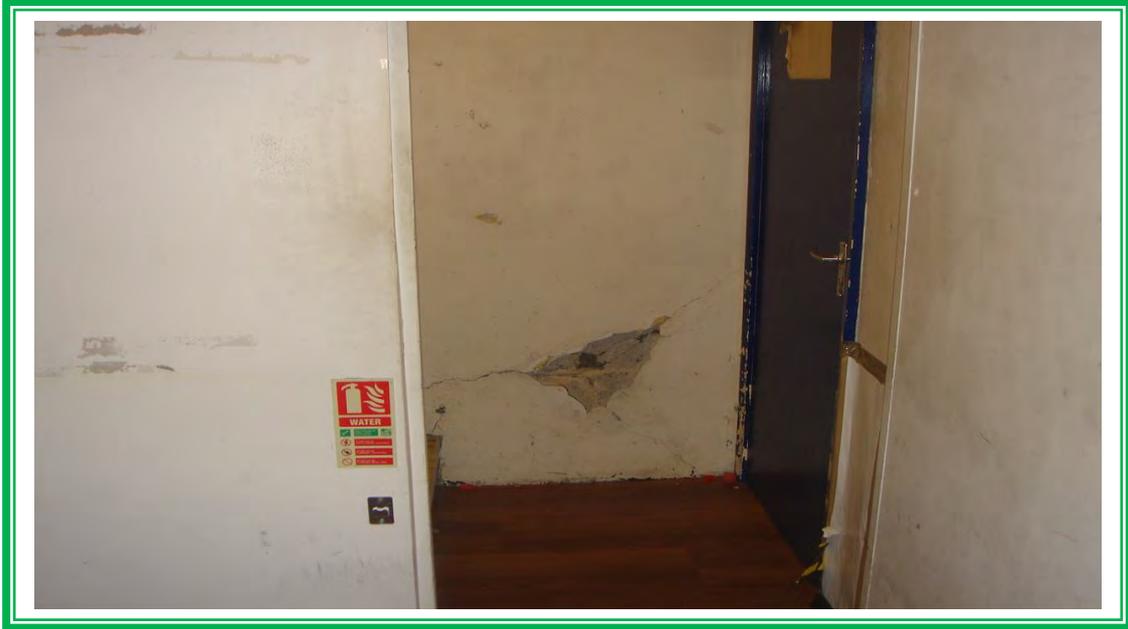
Location: 0/003 Lobby

Material Description:	Visual Inspection – No Suspect Materials Found	
Identification:	N/A	
Approx. quantity:	N/A	
Accessibility	N/A	Assessment Score
Product type:	N/A	N/A
Extent of Damage:	N/A	N/A
Surface Treatment:	N/A	N/A
Asbestos type:	N/A	N/A
Material Assessment Score:		N/A
Priority Assessment Score:		N/A
Action:	N/A	
Comments:	N/A

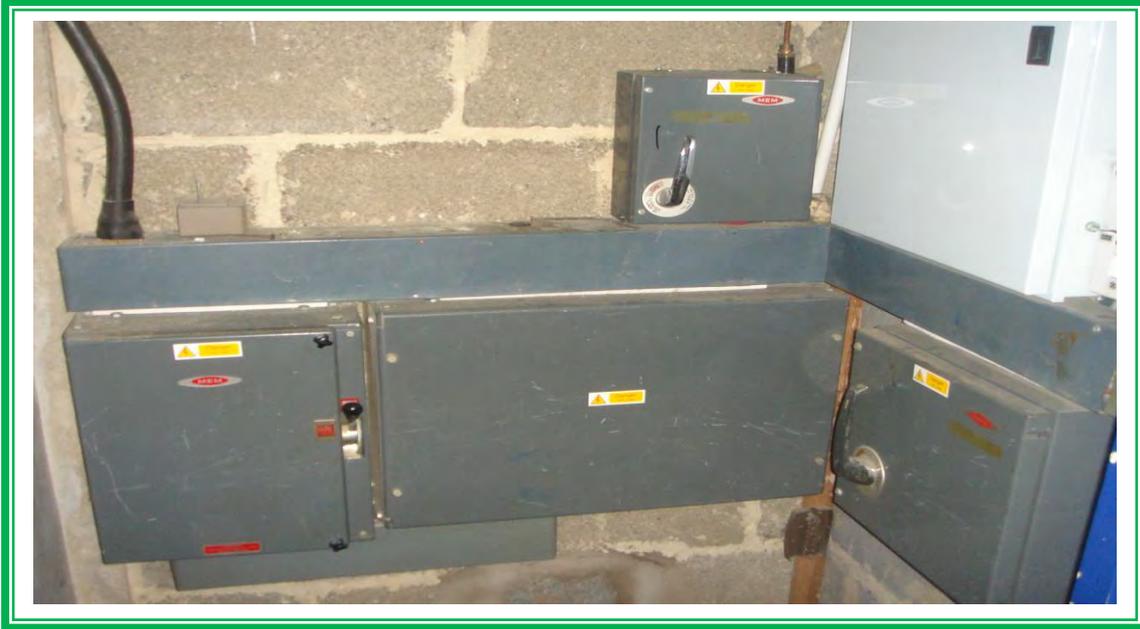
Location: 0/005 Electrics Cupboard 2

Material Description:	Visual Inspection – No Suspect Materials Found	
Identification:	N/A	
Approx. quantity:	N/A	
Accessibility	N/A	Assessment Score
Product type:	N/A	N/A
Extent of Damage:	N/A	N/A
Surface Treatment:	N/A	N/A
Asbestos type:	N/A	N/A
Material Assessment Score:		N/A
Priority Assessment Score:		N/A
Action:	N/A	
Comments:	N/A

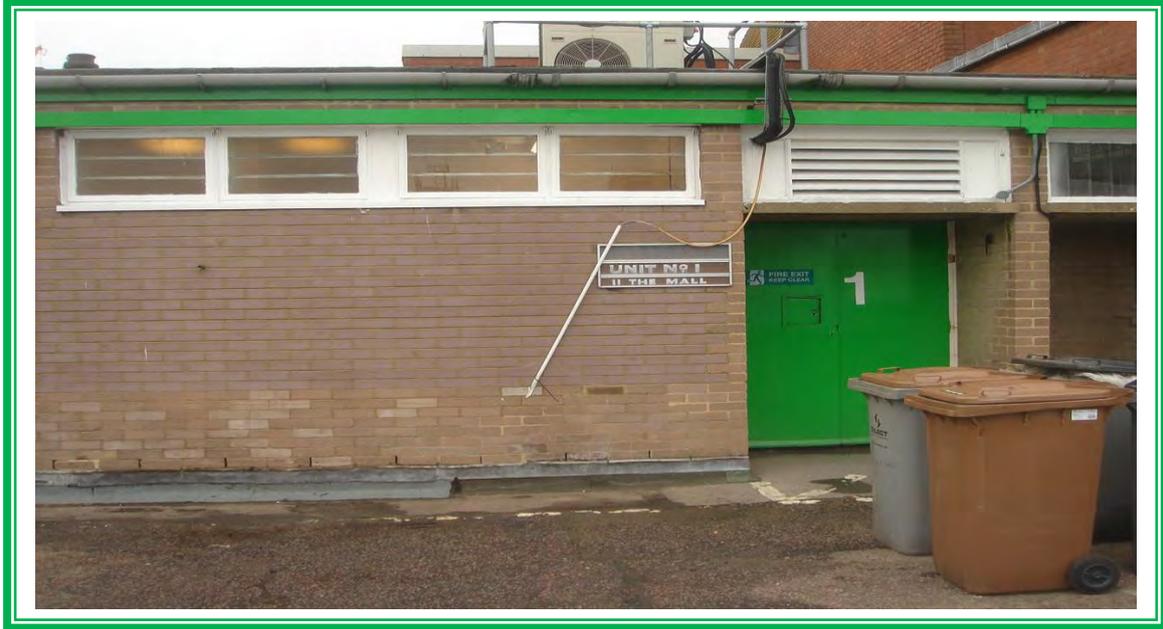
Location: 99/001 External

Material Description:	Visual Inspection – No Suspect Materials Found	
Identification:	N/A	
Approx. quantity:	N/A	
Accessibility	N/A	Assessment Score
Product type:	N/A	N/A
Extent of Damage:	N/A	N/A
Surface Treatment:	N/A	N/A
Asbestos type:	N/A	N/A
Material Assessment Score:		N/A
Priority Assessment Score:		N/A
Action:	N/A	
Comments:	N/A

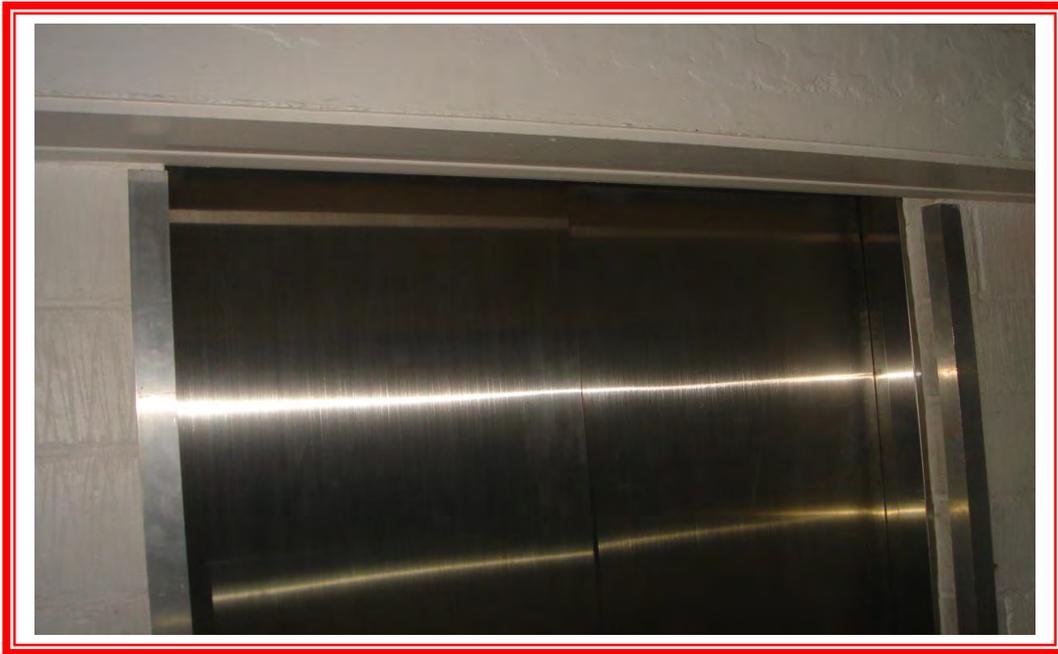
Item No: 19	Sample No: N/A
Location: Lift/Lift Shaft

Material Description:	No Access	
Identification:	Presumed to Contain Asbestos	
Approx. quantity:	Entire Lift and Lift Shaft	
Accessibility	Low	<i>Assessment Score</i>
Product type:	No Access	3
Extent of Damage:	No Access	3
Surface Treatment:	No Access	3
Asbestos type:	No Access	3
Material Assessment Score:		12
Priority Assessment Score:		High
Action:	Manage	
Comments:	No access as no lift engineer was onsite

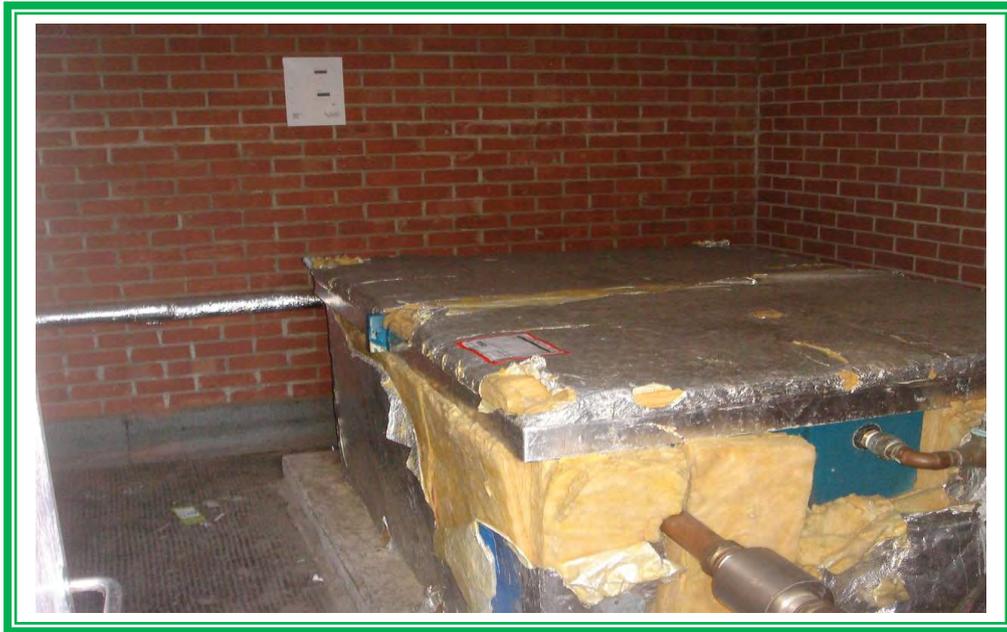
Location: 2/001 Water Tank Room

Material Description:	Visual Inspection – No Suspect Materials Found	
Identification:	N/A	
Approx. quantity:	N/A	
Accessibility	N/A	Assessment Score
Product type:	N/A	N/A
Extent of Damage:	N/A	N/A
Surface Treatment:	N/A	N/A
Asbestos type:	N/A	N/A
Material Assessment Score:		N/A
Priority Assessment Score:		N/A
Action:	N/A	
Comments:	N/A

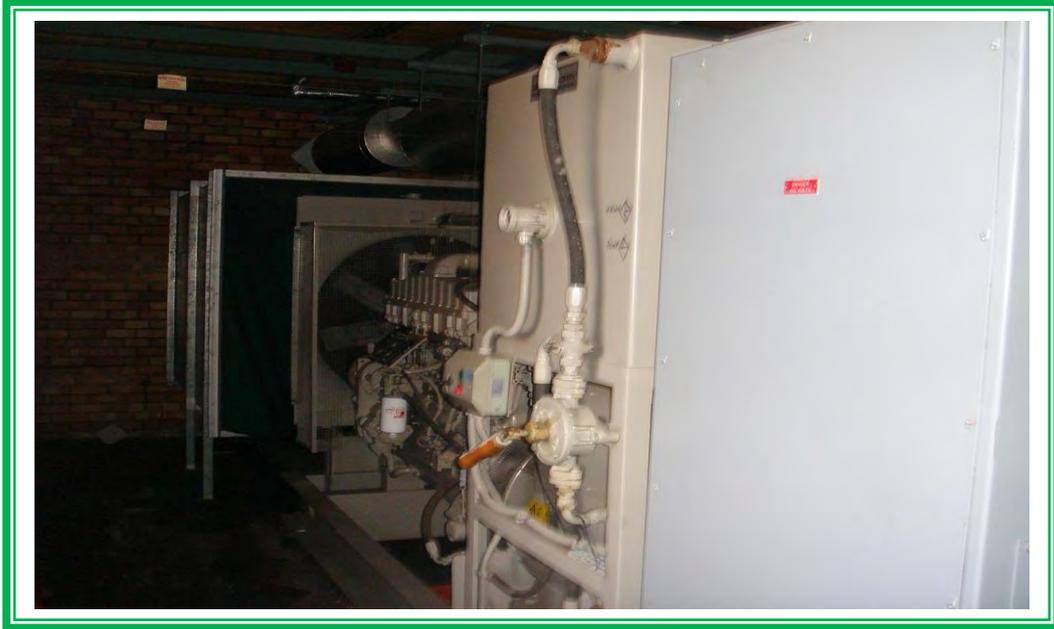
Location: 2/002 Air Con Room

Material Description:	Visual Inspection – No Suspect Materials Found	
Identification:	N/A	
Approx. quantity:	N/A	
Accessibility	N/A	Assessment Score
Product type:	N/A	N/A
Extent of Damage:	N/A	N/A
Surface Treatment:	N/A	N/A
Asbestos type:	N/A	N/A
Material Assessment Score:		N/A
Priority Assessment Score:		N/A
Action:	N/A	
Comments:	N/A

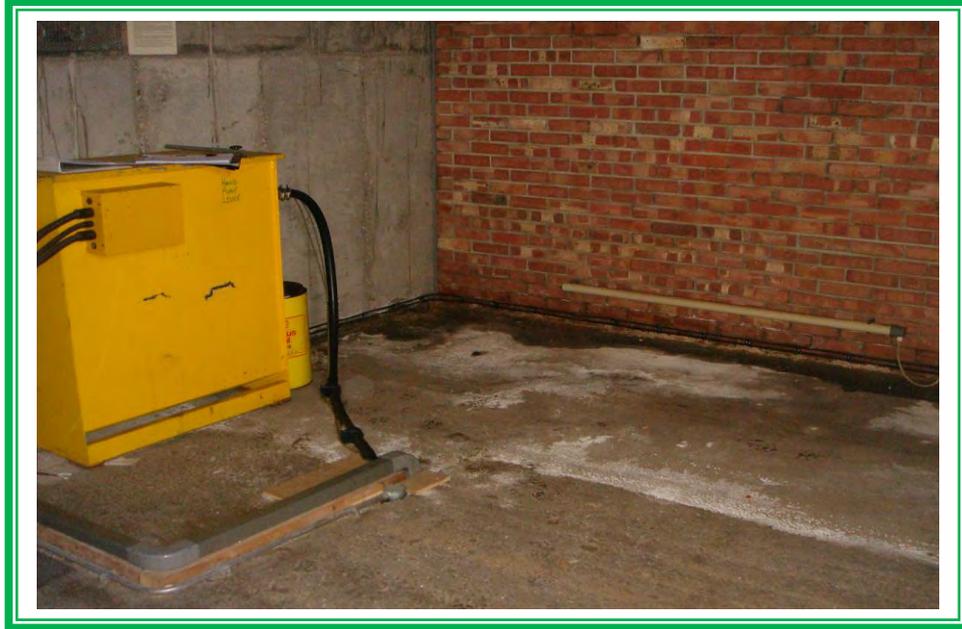
Location: 2/003 Lift Motor Room

Material Description:	Visual Inspection – No Suspect Materials Found	
Identification:	N/A	
Approx. quantity:	N/A	
Accessibility	N/A	Assessment Score
Product type:	N/A	N/A
Extent of Damage:	N/A	N/A
Surface Treatment:	N/A	N/A
Asbestos type:	N/A	N/A
Material Assessment Score:		N/A
Priority Assessment Score:		N/A
Action:	N/A	
Comments:	N/A

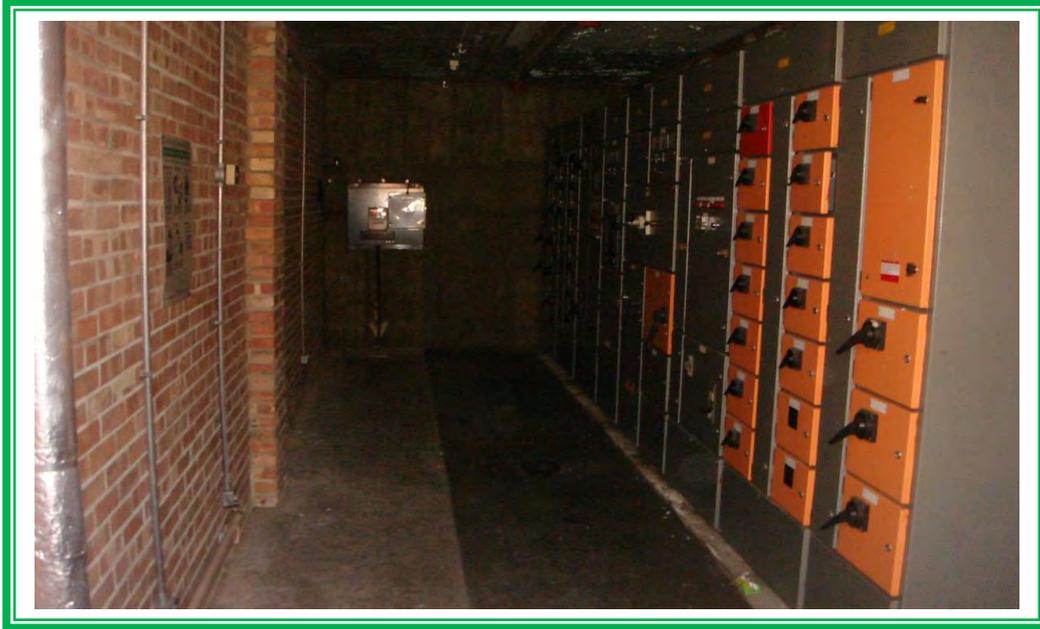
Location: 2/004 Electrics

Material Description:	Visual Inspection – No Suspect Materials Found	
Identification:	N/A	
Approx. quantity:	N/A	
Accessibility	N/A	Assessment Score
Product type:	N/A	N/A
Extent of Damage:	N/A	N/A
Surface Treatment:	N/A	N/A
Asbestos type:	N/A	N/A
Material Assessment Score:		N/A
Priority Assessment Score:		N/A
Action:	N/A	
Comments:	N/A

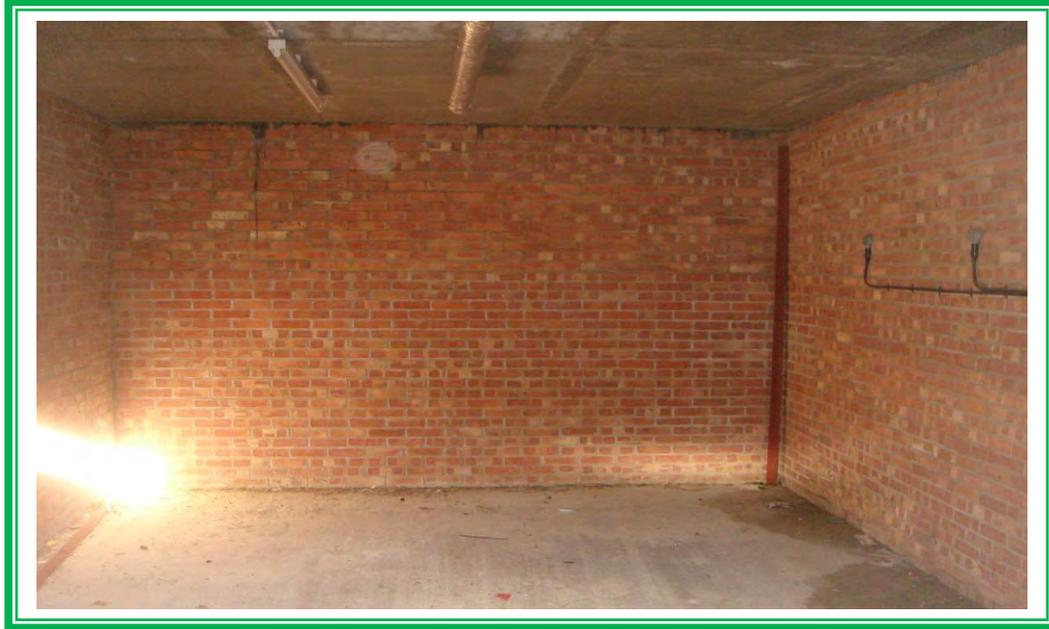
Location: 2/005

Material Description:	Visual Inspection – No Suspect Materials Found	
Identification:	N/A	
Approx. quantity:	N/A	
Accessibility	N/A	Assessment Score
Product type:	N/A	N/A
Extent of Damage:	N/A	N/A
Surface Treatment:	N/A	N/A
Asbestos type:	N/A	N/A
Material Assessment Score:		N/A
Priority Assessment Score:		N/A
Action:	N/A	
Comments:	N/A

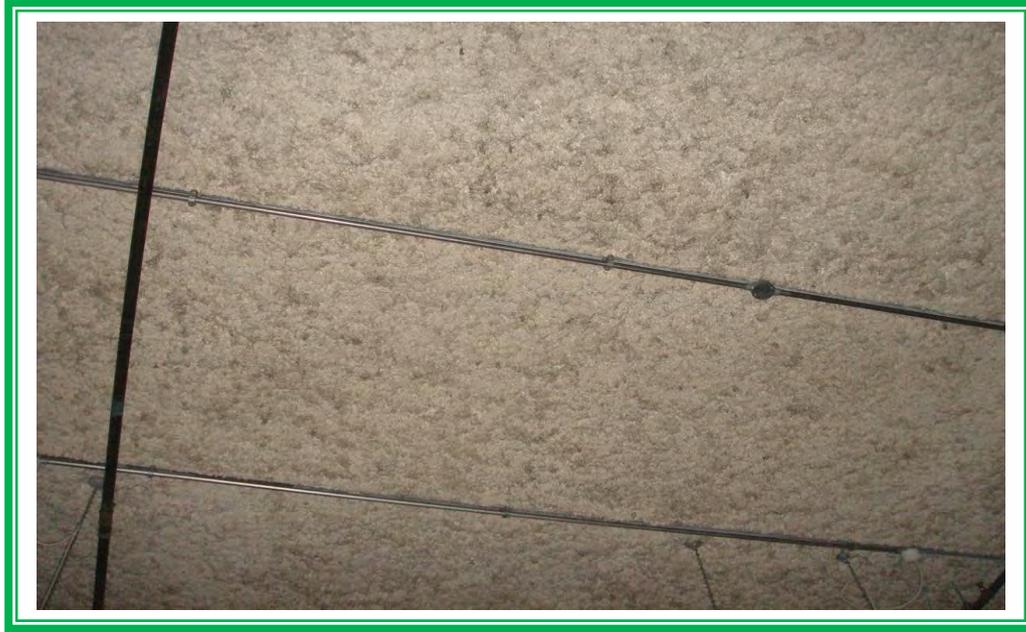
Location: 1/001, 1/002 and 1/003, Loading Bay and Stores x 2

Material Description:	Spray Coating to Ceiling/Beams	
Identification:	Sampled - No Asbestos Detected	
Approx. quantity:	Throughout Floor	
Accessibility	N/A	Assessment Score
Product type:	N/A	N/A
Extent of Damage:	N/A	N/A
Surface Treatment:	N/A	N/A
Asbestos type:	N/A	N/A
Material Assessment Score:		N/A
Priority Assessment Score:		N/A
Action:	N/A	
Comments:	N/A

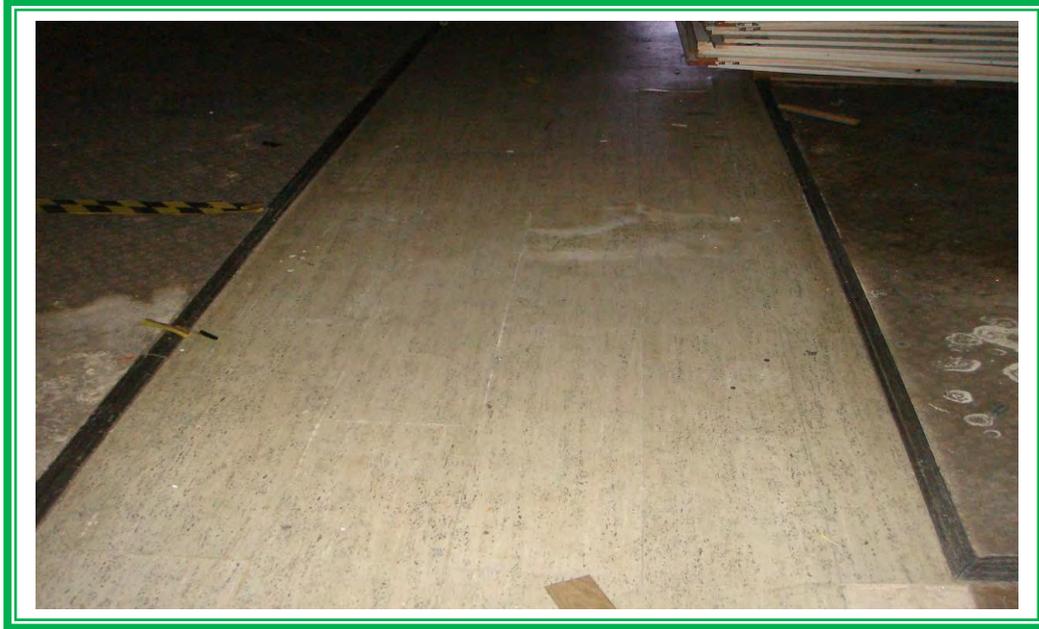
Location: 1/004 Main Shop Floor and Changing Rooms

Material Description:	Floor Tiles	
Identification:	Sampled – No Asbestos Detected	
Approx. quantity:	40M2	
Accessibility	N/A	Assessment Score
Product type:	N/A	N/A
Extent of Damage:	N/A	N/A
Surface Treatment:	N/A	N/A
Asbestos type:	N/A	N/A
Material Assessment Score:		N/A
Priority Assessment Score:		N/A
Action:	N/A	
Comments:	N/A

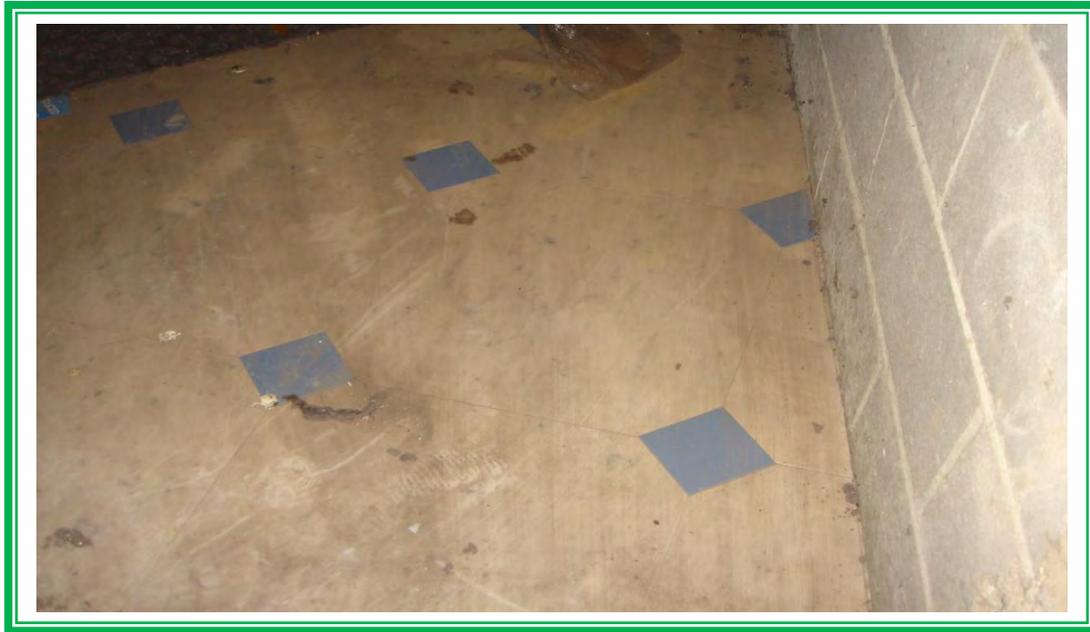
Location: 1/004 Main Shop Floor and Changing Rooms

Material Description:	Floor Tiles	
Identification:	Sampled – No Asbestos Detected	
Approx. quantity:	10M2 Visible – May be more under the carpet throughout	
Accessibility	N/A	Assessment Score
Product type:	N/A	N/A
Extent of Damage:	N/A	N/A
Surface Treatment:	N/A	N/A
Asbestos type:	N/A	N/A
Material Assessment Score:		N/A
Priority Assessment Score:		N/A
Action:	N/A	
Comments:	N/A

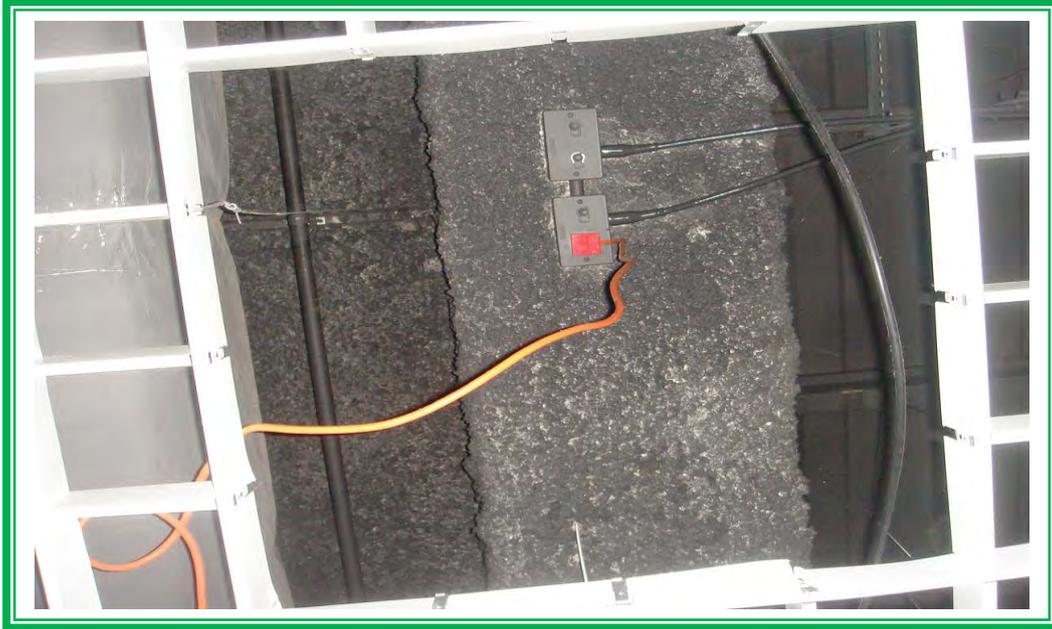
Location: 1/004 Main Shop Floor and Changing Rooms

Material Description:	Spray Coating to Ceilings/Beams	
Identification:	Sampled – No Asbestos Detected	
Approx. quantity:	Non-Quantifiable Throughout Floor	
Accessibility	N/A	Assessment Score
Product type:	N/A	N/A
Extent of Damage:	N/A	N/A
Surface Treatment:	N/A	N/A
Asbestos type:	N/A	N/A
Material Assessment Score:		N/A
Priority Assessment Score:		N/A
Action:	N/A	
Comments:	N/A

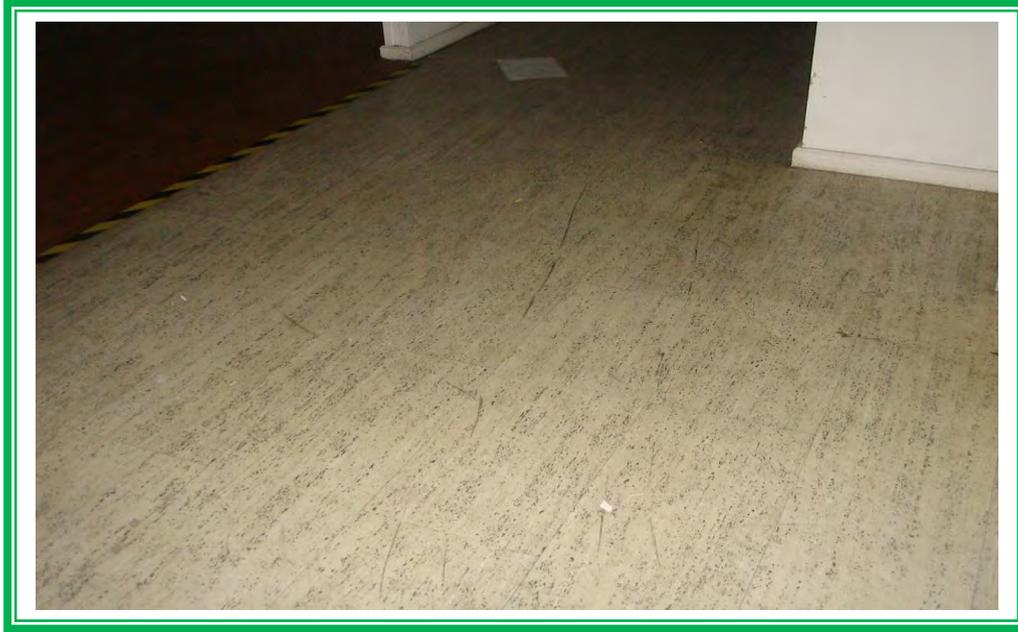
Location: 1/005 Corridor, Landing, 1006 Office and Stairwell

Material Description:	Floor Tiles	
Identification:	As Per Sample NE/2 – No Asbestos Detected	
Approx. quantity:	80M2	
Accessibility	N/A	Assessment Score
Product type:	N/A	N/A
Extent of Damage:	N/A	N/A
Surface Treatment:	N/A	N/A
Asbestos type:	N/A	N/A
Material Assessment Score:		N/A
Priority Assessment Score:		N/A
Action:	N/A	
Comments:	Non-Asbestos vermiculite panels in ceiling void

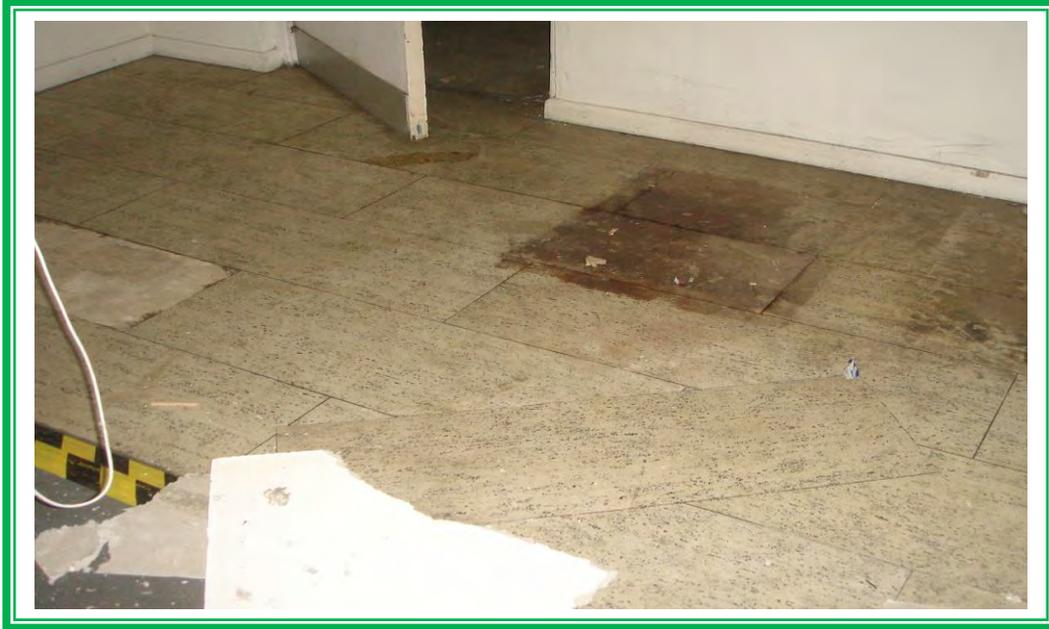
Location: 1/007 Office, 1/008 Kitchen and 1/009 Store

Material Description:	Floor Tiles	
Identification:	As Per Sample NE/2 – No Asbestos Detected	
Approx. quantity:	8M2	
Accessibility	N/A	Assessment Score
Product type:	N/A	N/A
Extent of Damage:	N/A	N/A
Surface Treatment:	N/A	N/A
Asbestos type:	N/A	N/A
Material Assessment Score:		N/A
Priority Assessment Score:		N/A
Action:	N/A	
Comments:	Modern water heater in store

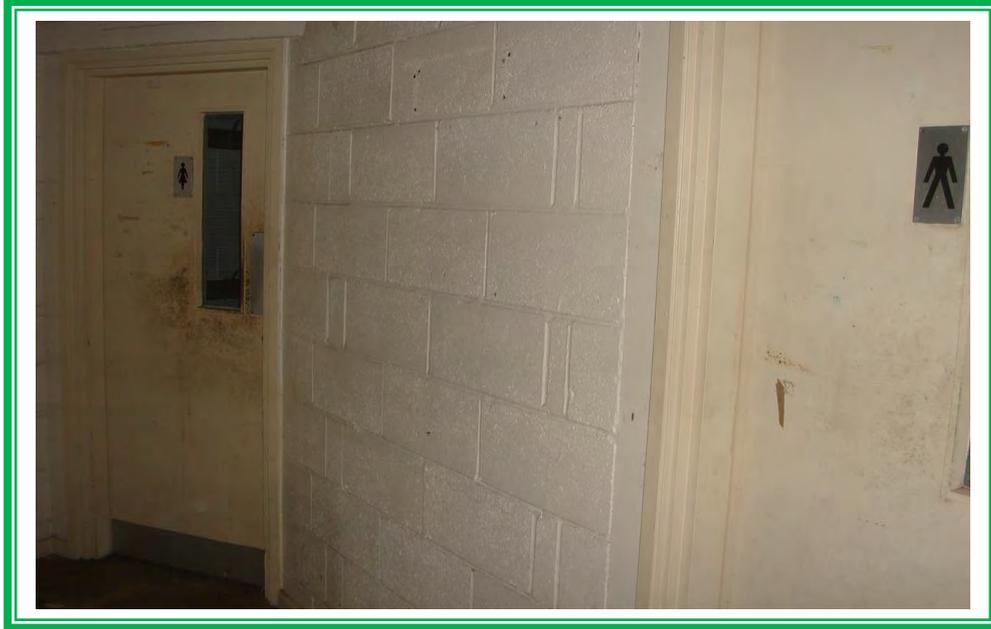
Location: 1/010 WC and 1/011 WC

Material Description:	Visual Inspection – No Suspect Materials Found	
Identification:	N/A	
Approx. quantity:	N/A	
Accessibility	N/A	Assessment Score
Product type:	N/A	N/A
Extent of Damage:	N/A	N/A
Surface Treatment:	N/A	N/A
Asbestos type:	N/A	N/A
Material Assessment Score:		N/A
Priority Assessment Score:		N/A
Action:	N/A	
Comments:	N/A

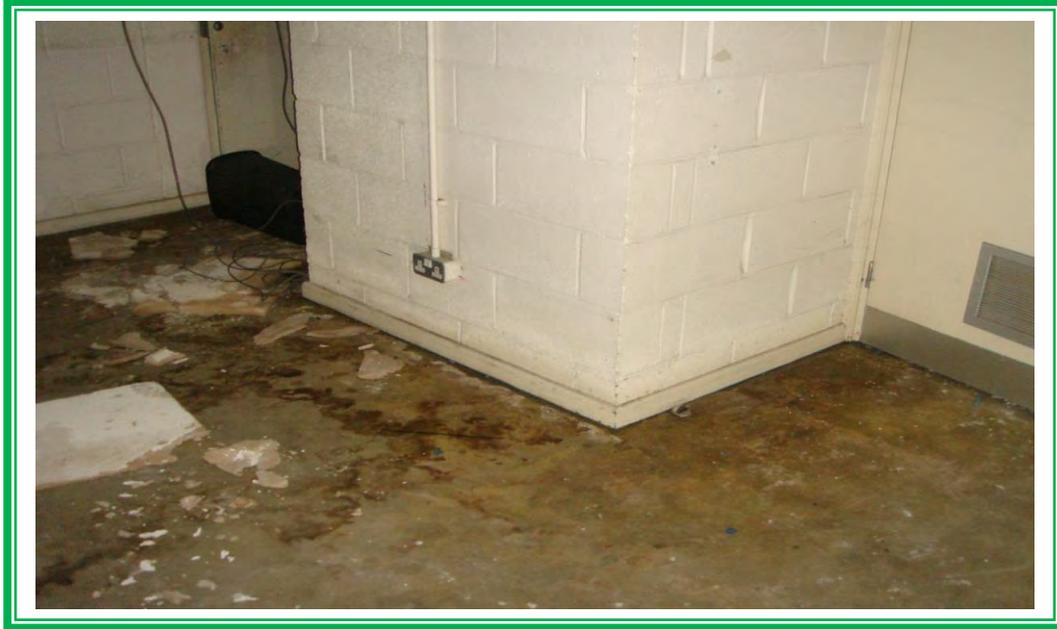
Location: 1/012 Lobby, 1/013 WC and 1/014 Office

Material Description:	Visual Inspection – No Suspect Materials Found	
Identification:	N/A	
Approx. quantity:	N/A	
Accessibility	N/A	Assessment Score
Product type:	N/A	N/A
Extent of Damage:	N/A	N/A
Surface Treatment:	N/A	N/A
Asbestos type:	N/A	N/A
Material Assessment Score:		N/A
Priority Assessment Score:		N/A
Action:	N/A	
Comments:	N/A
