Project Number 3113

Management  
Asbestos Survey Report

Kennet Centre, Market Street, Newbury,  
Berkshire, RG14 5EN

1-3 The Mall

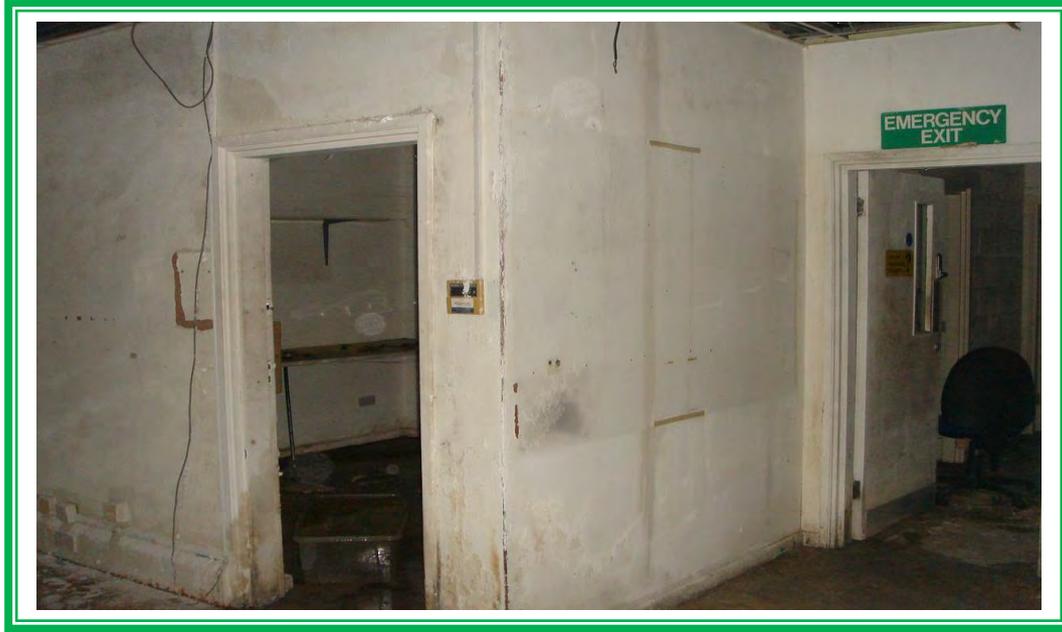
Location: 1/015 Cupboard, 1/016 Office and 1/017  
Circulation

Material Description:	Visual Inspection – No Suspect Materials Found	
Identification:	N/A	
Approx. quantity:	N/A	
Accessibility	N/A	Assessment Score
Product type:	N/A	N/A
Extent of Damage:	N/A	N/A
Surface Treatment:	N/A	N/A
Asbestos type:	N/A	N/A
Material Assessment Score:		N/A
Priority Assessment Score:		N/A
Action:	N/A	
Comments:	N/A

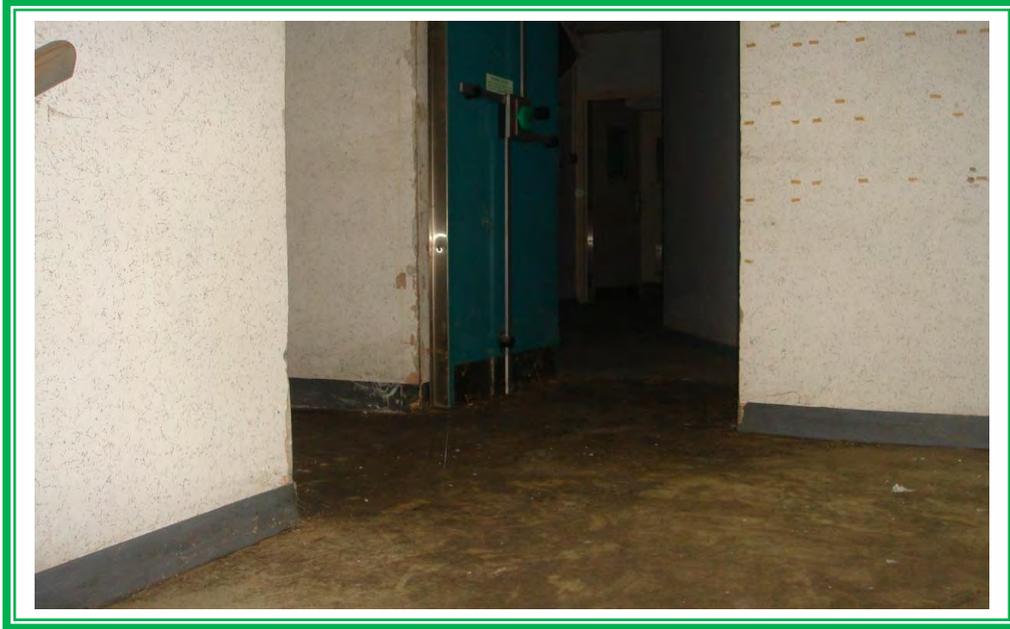
Location: 1/018 Office, 1/019 Landing and Stairwell

Material Description:	Visual Inspection – No Suspect Materials Found	
Identification:	N/A	
Approx. quantity:	N/A	
Accessibility	N/A	Assessment Score
Product type:	N/A	N/A
Extent of Damage:	N/A	N/A
Surface Treatment:	N/A	N/A
Asbestos type:	N/A	N/A
Material Assessment Score:		N/A
Priority Assessment Score:		N/A
Action:	N/A	
Comments:	Rubber Stair Nosing

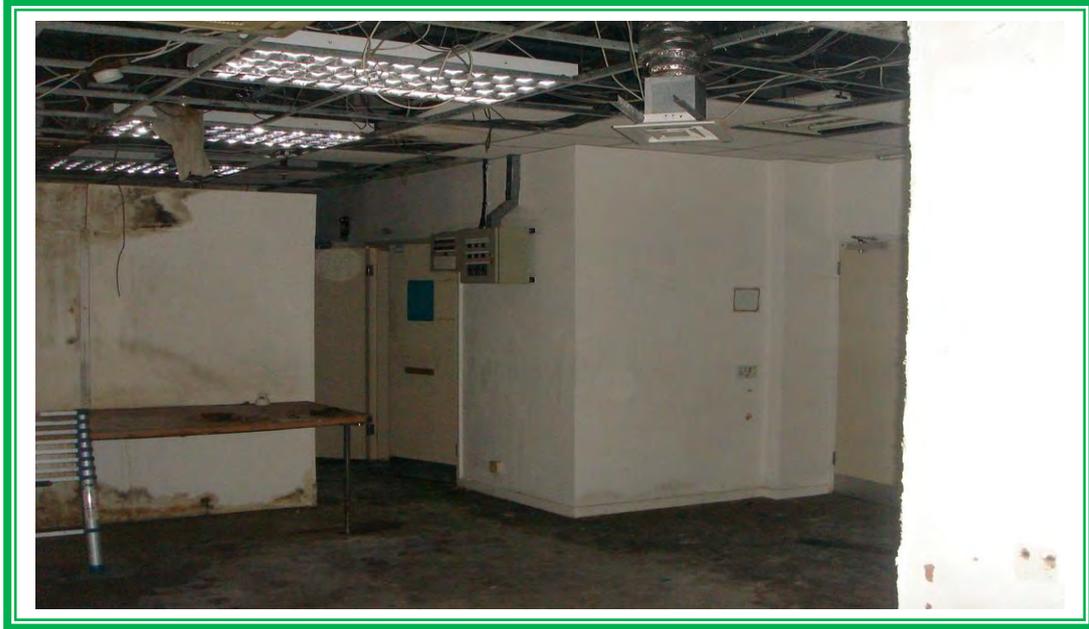
Location: 1/020 Lobby and 1/021 Office

Material Description:	Visual Inspection – No Suspect Materials Found	
Identification:	N/A	
Approx. quantity:	N/A	
Accessibility	N/A	Assessment Score
Product type:	N/A	N/A
Extent of Damage:	N/A	N/A
Surface Treatment:	N/A	N/A
Asbestos type:	N/A	N/A
Material Assessment Score:		N/A
Priority Assessment Score:		N/A
Action:	N/A	
Comments:	Non-Asbestos Electrical Panels

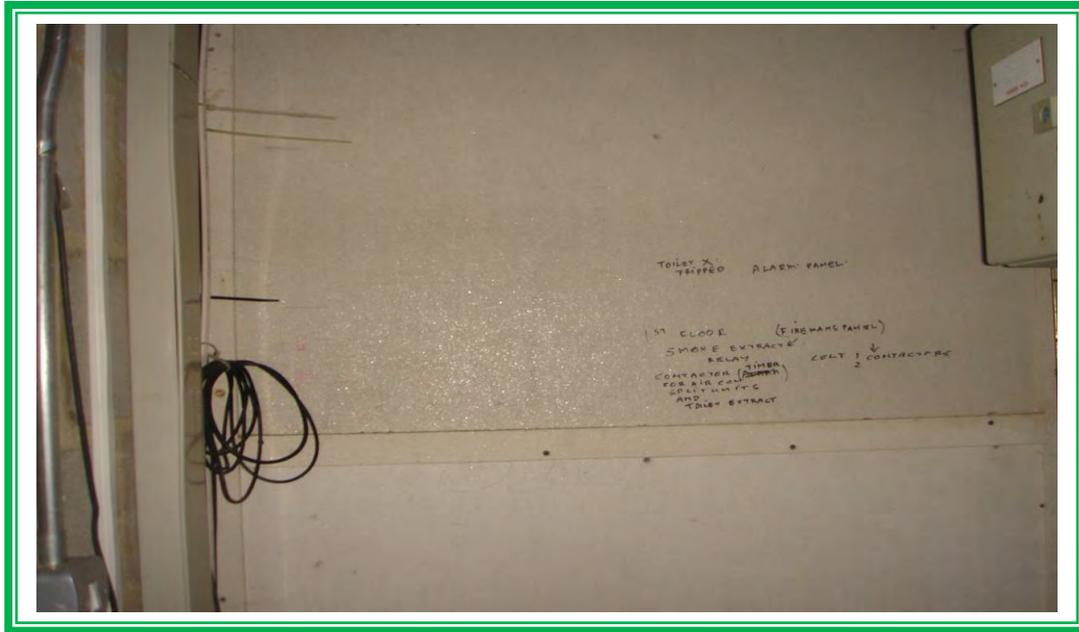
Location: 1/022 Switch Room

Material Description:	Insulation Board Wall Panels	
Identification:	Sampled - No Asbestos Detected	
Approx. quantity:	5M2	
Accessibility	N/A	Assessment Score
Product type:	N/A	N/A
Extent of Damage:	N/A	N/A
Surface Treatment:	N/A	N/A
Asbestos type:	N/A	N/A
Material Assessment Score:		N/A
Priority Assessment Score:		N/A
Action:	N/A	
Comments:	Non-Asbestos Electrics

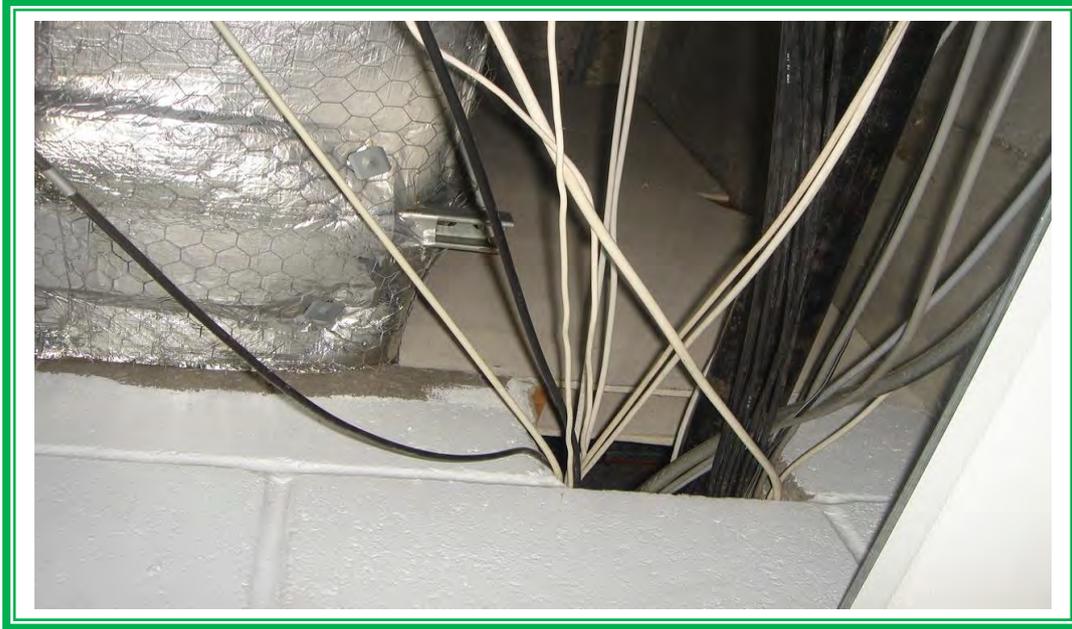
Location: 1/023 Corridor

Material Description:	Insulation Board Wall Panels	
Identification:	As Per Sample NE/5 – No Asbestos Detected	
Approx. quantity:	6M2	
Accessibility	N/A	Assessment Score
Product type:	N/A	N/A
Extent of Damage:	N/A	N/A
Surface Treatment:	N/A	N/A
Asbestos type:	N/A	N/A
Material Assessment Score:		N/A
Priority Assessment Score:		N/A
Action:	N/A	
Comments:	N/A

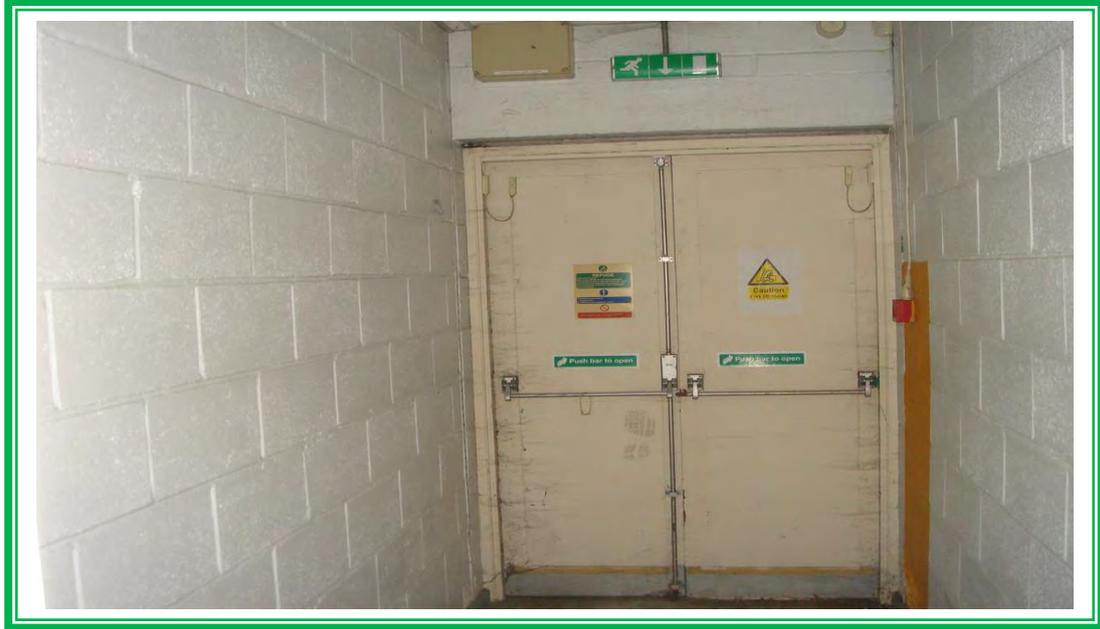
Location: 1/024 Lobby

Material Description:	Visual Inspection – No Suspect Materials Found	
Identification:	N/A	
Approx. quantity:	N/A	
Accessibility	N/A	Assessment Score
Product type:	N/A	N/A
Extent of Damage:	N/A	N/A
Surface Treatment:	N/A	N/A
Asbestos type:	N/A	N/A
Material Assessment Score:		N/A
Priority Assessment Score:		N/A
Action:	N/A	
Comments:	N/A

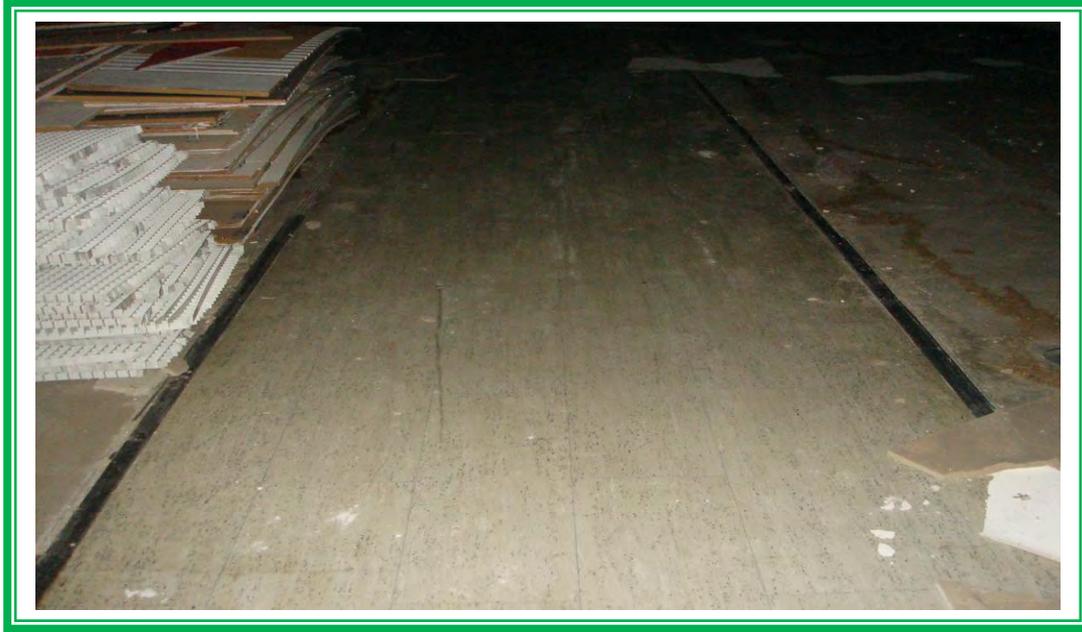
Location: 0/001 Main Shop Floor, Including stores, Fitting Rooms and Shop Windows

Material Description:	Floor Tiles	
Identification:	Sampled – No Asbestos Detected	
Approx. quantity:	100M2 +	
Accessibility	N/A	Assessment Score
Product type:	N/A	N/A
Extent of Damage:	N/A	N/A
Surface Treatment:	N/A	N/A
Asbestos type:	N/A	N/A
Material Assessment Score:		N/A
Priority Assessment Score:		N/A
Action:	N/A	
Comments:	N/A

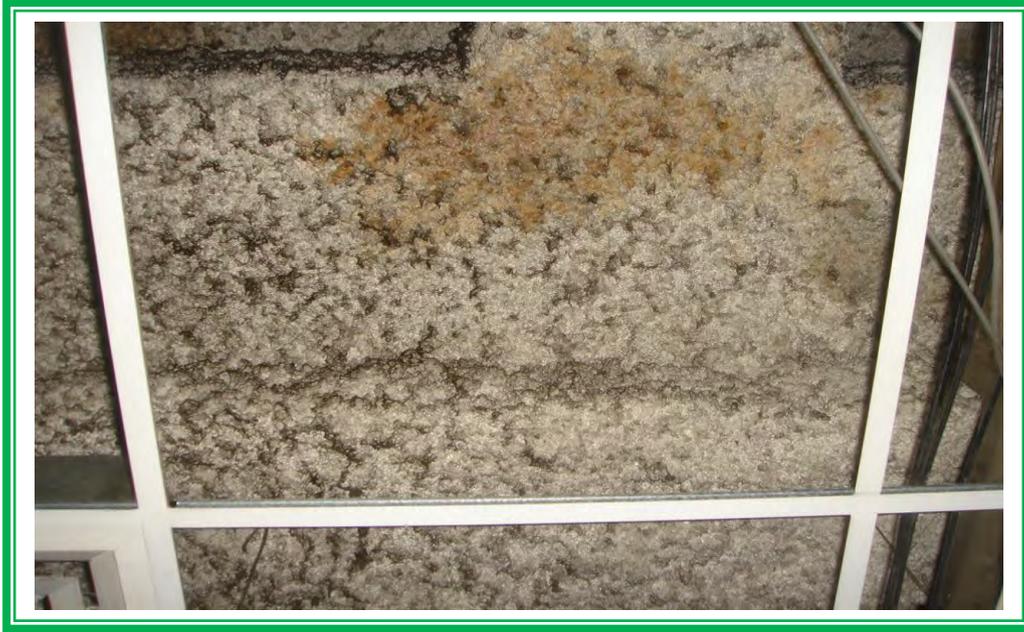
Location: 0/001 Main Shop Floor Including Stores, Fitting Rooms and Shop Windows

Material Description:	Spray Coating to Ceiling/Beams	
Identification:	Sampled – No Asbestos Detected	
Approx. quantity:	Non-Quantifiable Throughout Ground Floor	
Accessibility	N/A	Assessment Score
Product type:	N/A	N/A
Extent of Damage:	N/A	N/A
Surface Treatment:	N/A	N/A
Asbestos type:	N/A	N/A
Material Assessment Score:		N/A
Priority Assessment Score:		N/A
Action:	N/A	
Comments:	N/A

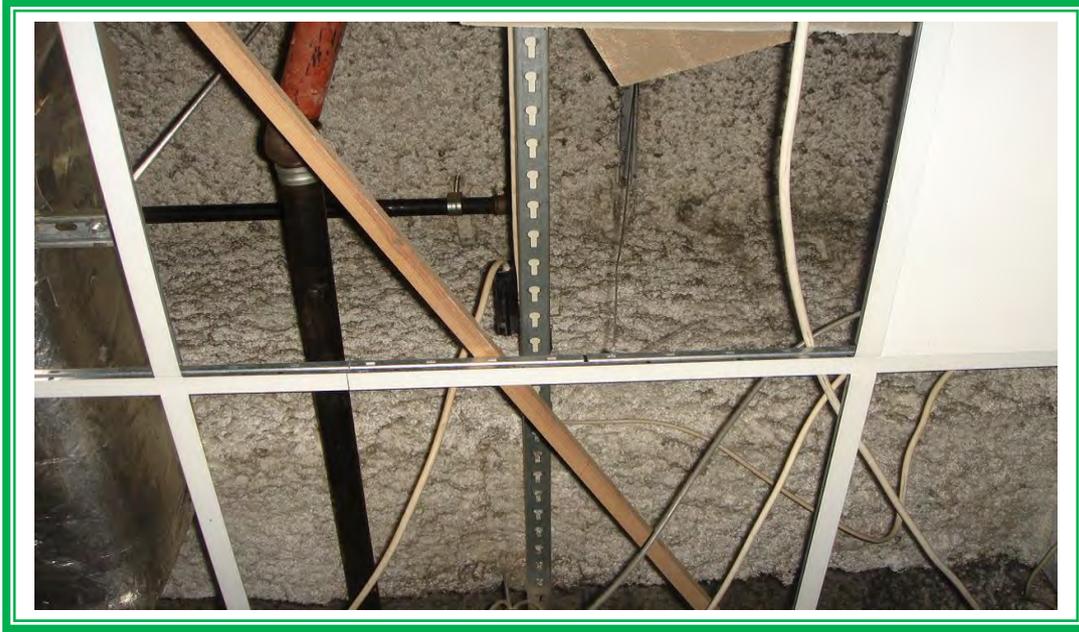
Location: 0/001 Main Shop Floor Including Stores,  
Fitting Rooms and Shop Windows

Material Description:	Spray Coating to Ceiling/Beams	
Identification:	Sampled – No Asbestos Detected	
Approx. quantity:	Non-Quantifiable Throughout Ground Floor	
Accessibility	N/A	Assessment Score
Product type:	N/A	N/A
Extent of Damage:	N/A	N/A
Surface Treatment:	N/A	N/A
Asbestos type:	N/A	N/A
Material Assessment Score:		N/A
Priority Assessment Score:		N/A
Action:	N/A	
Comments:	N/A

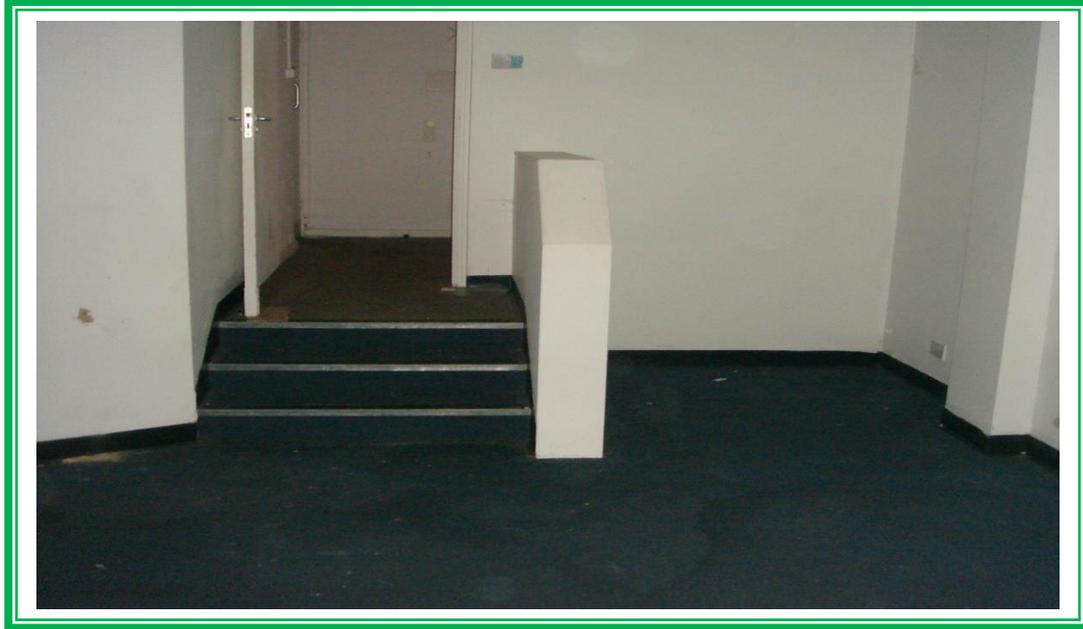
Location: 0/002 Store

Material Description:	Visual Inspection – No Suspect Materials Found	
Identification:	N/A	
Approx. quantity:	N/A	
Accessibility	N/A	Assessment Score
Product type:	N/A	N/A
Extent of Damage:	N/A	N/A
Surface Treatment:	N/A	N/A
Asbestos type:	N/A	N/A
Material Assessment Score:		N/A
Priority Assessment Score:		N/A
Action:	N/A	
Comments:	N/A

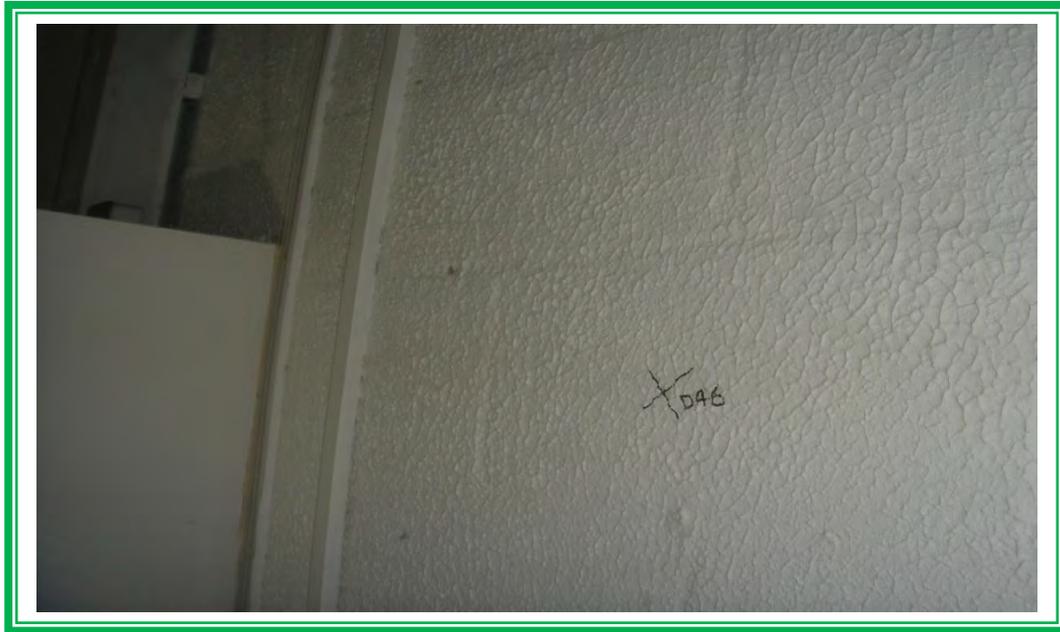
Location: 0/003 Office

Material Description:	Textured Coating to Walls	
Identification:	Sampled - No Asbestos Detected	
Approx. quantity:	22M2	
Accessibility	N/A	Assessment Score
Product type:	N/A	N/A
Extent of Damage:	N/A	N/A
Surface Treatment:	N/A	N/A
Asbestos type:	N/A	N/A
Material Assessment Score:		N/A
Priority Assessment Score:		N/A
Action:	N/A	
Comments:	Modern Electrics

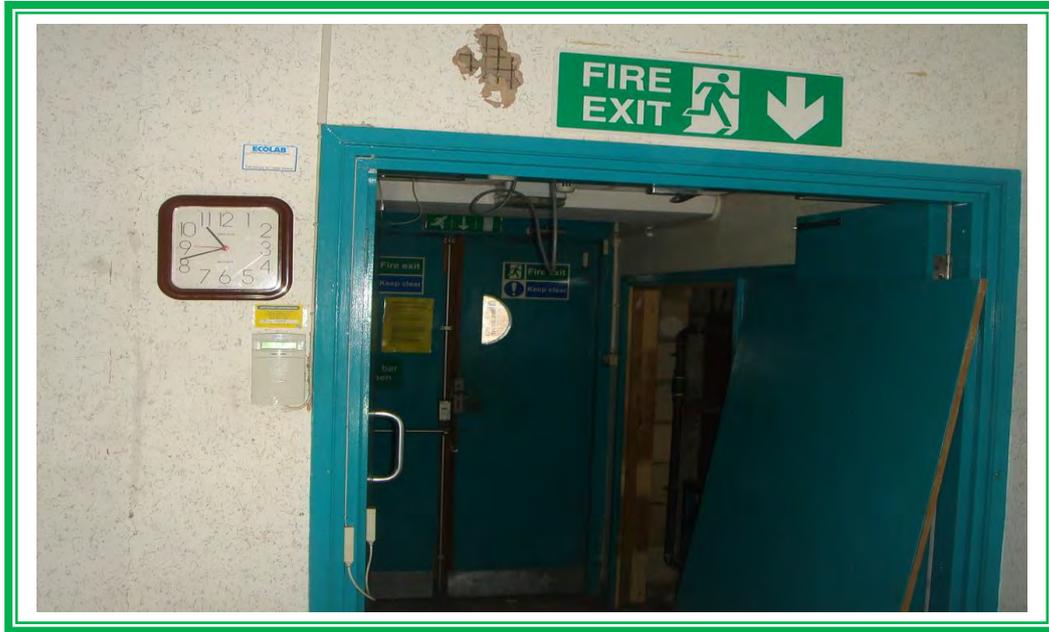
Location: 0/004 Stairwell Lobby, Lobby and Tank Room

Material Description:	Visual Inspection – No Suspect Materials Found	
Identification:	N/A	
Approx. quantity:	N/A	
Accessibility	N/A	Assessment Score
Product type:	N/A	N/A
Extent of Damage:	N/A	N/A
Surface Treatment:	N/A	N/A
Asbestos type:	N/A	N/A
Material Assessment Score:		N/A
Priority Assessment Score:		N/A
Action:	N/A	
Comments:	N/A

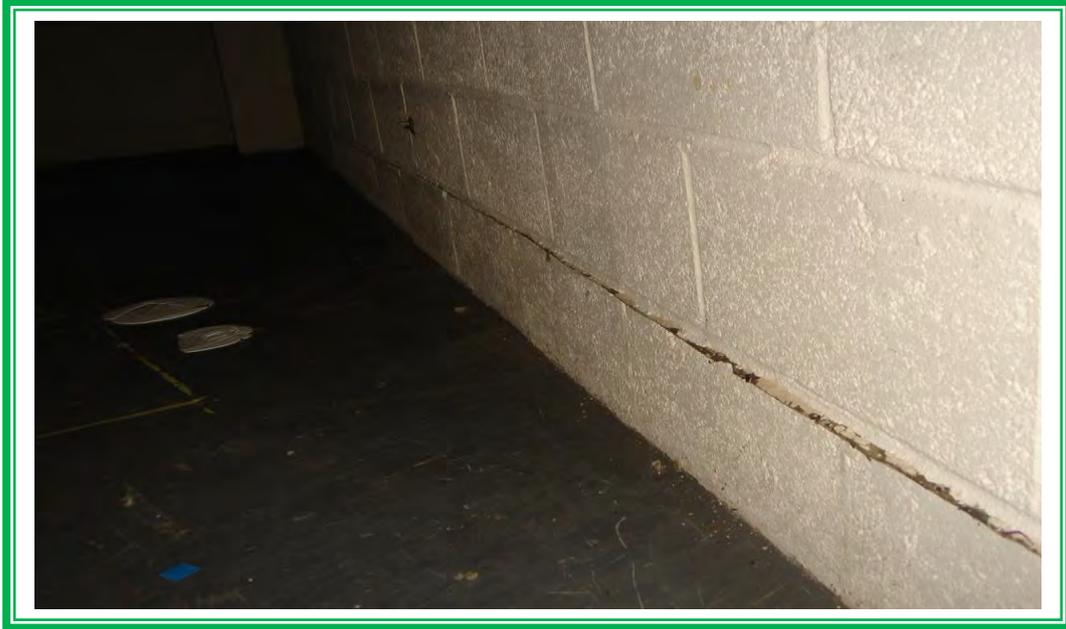
Location: 0/005 Store

Material Description:	Visual Inspection – No Suspect Materials Found	
Identification:	N/A	
Approx. quantity:	N/A	
Accessibility	N/A	Assessment Score
Product type:	N/A	N/A
Extent of Damage:	N/A	N/A
Surface Treatment:	N/A	N/A
Asbestos type:	N/A	N/A
Material Assessment Score:		N/A
Priority Assessment Score:		N/A
Action:	N/A	
Comments:	N/A

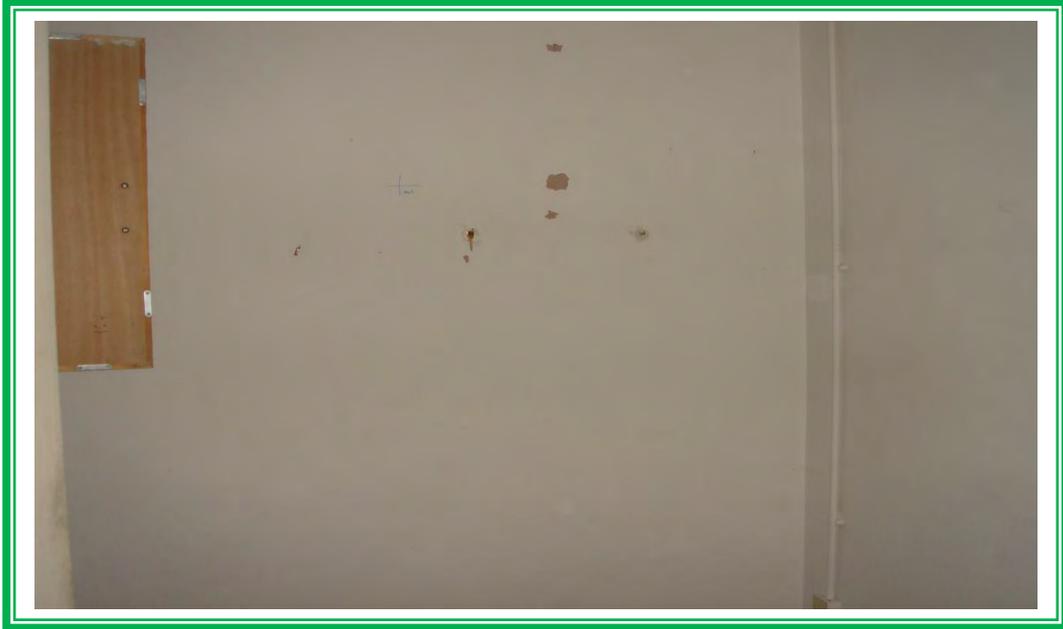
Location: 0/006 Office

Material Description:	Visual Inspection – No Suspect Materials Found	
Identification:	N/A	
Approx. quantity:	N/A	
Accessibility	N/A	Assessment Score
Product type:	N/A	N/A
Extent of Damage:	N/A	N/A
Surface Treatment:	N/A	N/A
Asbestos type:	N/A	N/A
Material Assessment Score:		N/A
Priority Assessment Score:		N/A
Action:	N/A	
Comments:	Modern Electrics

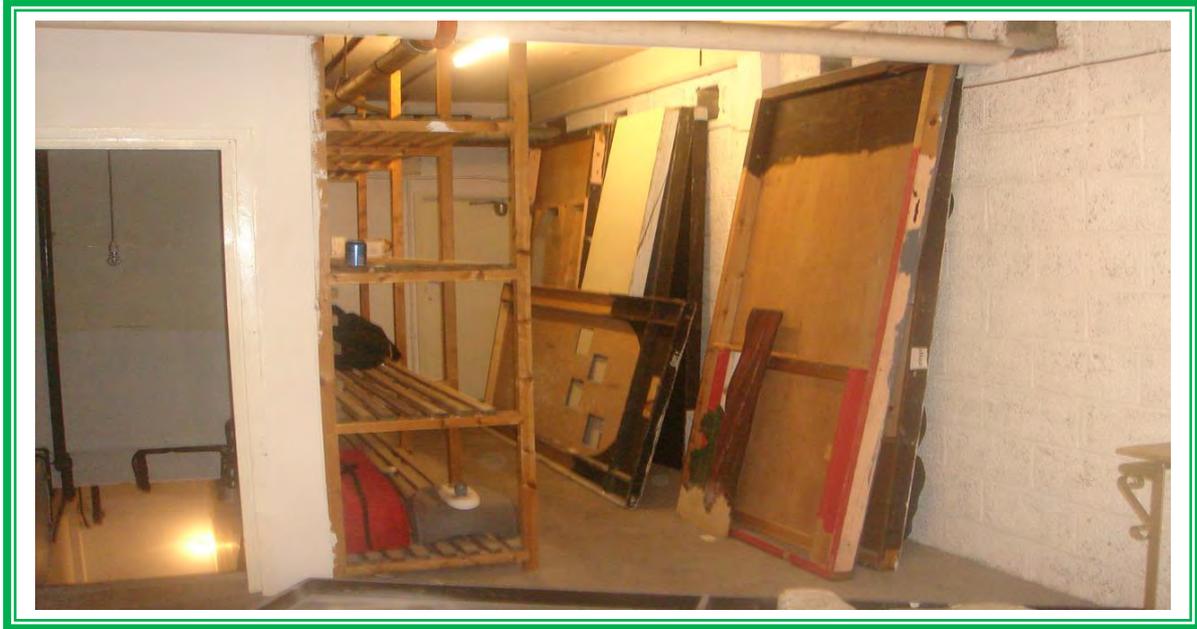
Location: 1/001 Store

Material Description:	Visual Inspection – No Suspect Materials Found	
Identification:	N/A	
Approx. quantity:	N/A	
Accessibility	N/A	Assessment Score
Product type:	N/A	N/A
Extent of Damage:	N/A	N/A
Surface Treatment:	N/A	N/A
Asbestos type:	N/A	N/A
Material Assessment Score:		N/A
Priority Assessment Score:		N/A
Action:	N/A	
Comments:	N/A

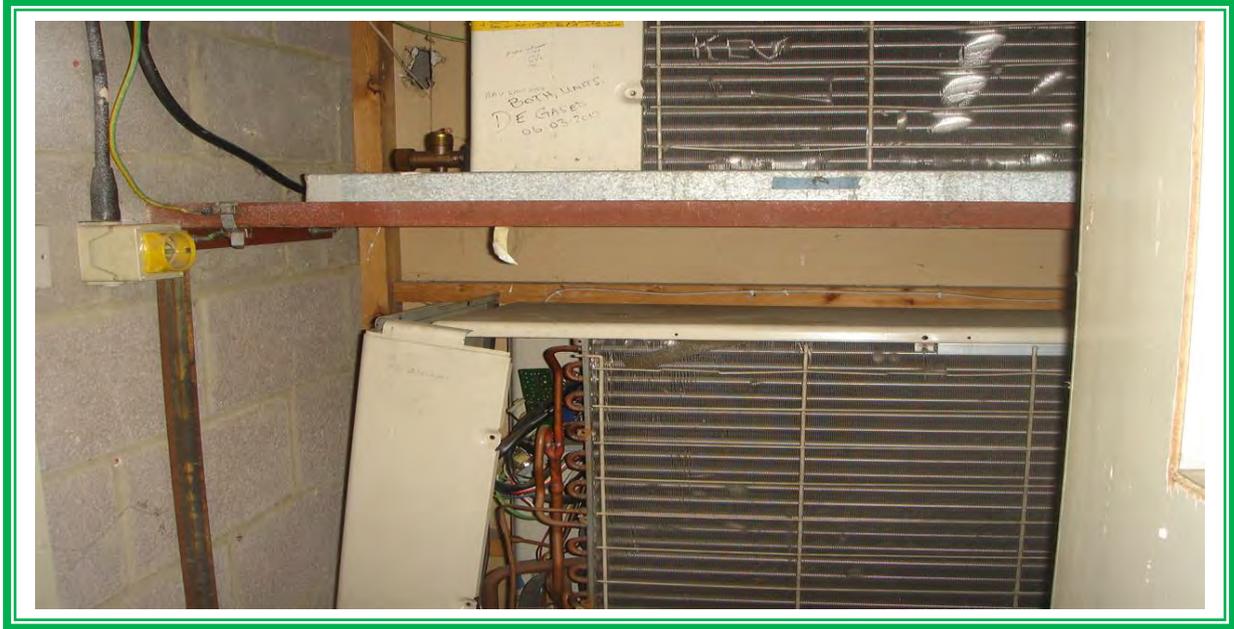
Location: 1/001A Cupboard

Material Description:	Visual Inspection – No Suspect Materials Found	
Identification:	N/A	
Approx. quantity:	N/A	
Accessibility	N/A	Assessment Score
Product type:	N/A	N/A
Extent of Damage:	N/A	N/A
Surface Treatment:	N/A	N/A
Asbestos type:	N/A	N/A
Material Assessment Score:		N/A
Priority Assessment Score:		N/A
Action:	N/A	
Comments:	N/A

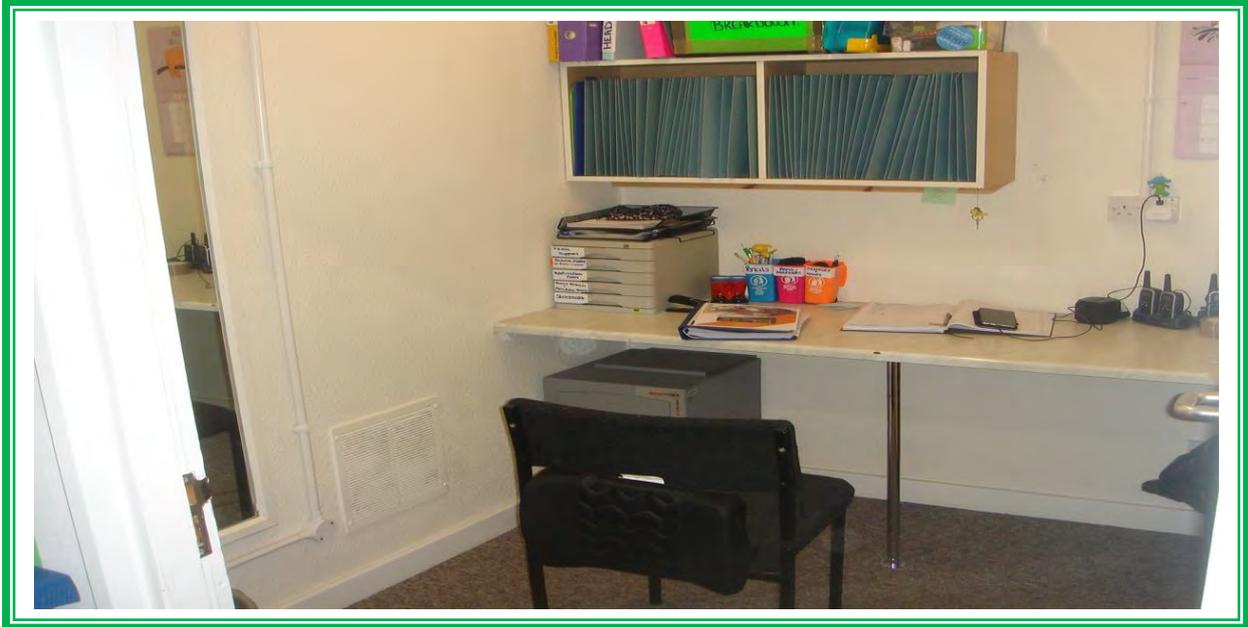
Location: 1/002 Office

Material Description:	Visual Inspection – No Suspect Materials Found	
Identification:	N/A	
Approx. quantity:	N/A	
Accessibility	N/A	Assessment Score
Product type:	N/A	N/A
Extent of Damage:	N/A	N/A
Surface Treatment:	N/A	N/A
Asbestos type:	N/A	N/A
Material Assessment Score:		N/A
Priority Assessment Score:		N/A
Action:	N/A	
Comments:	N/A

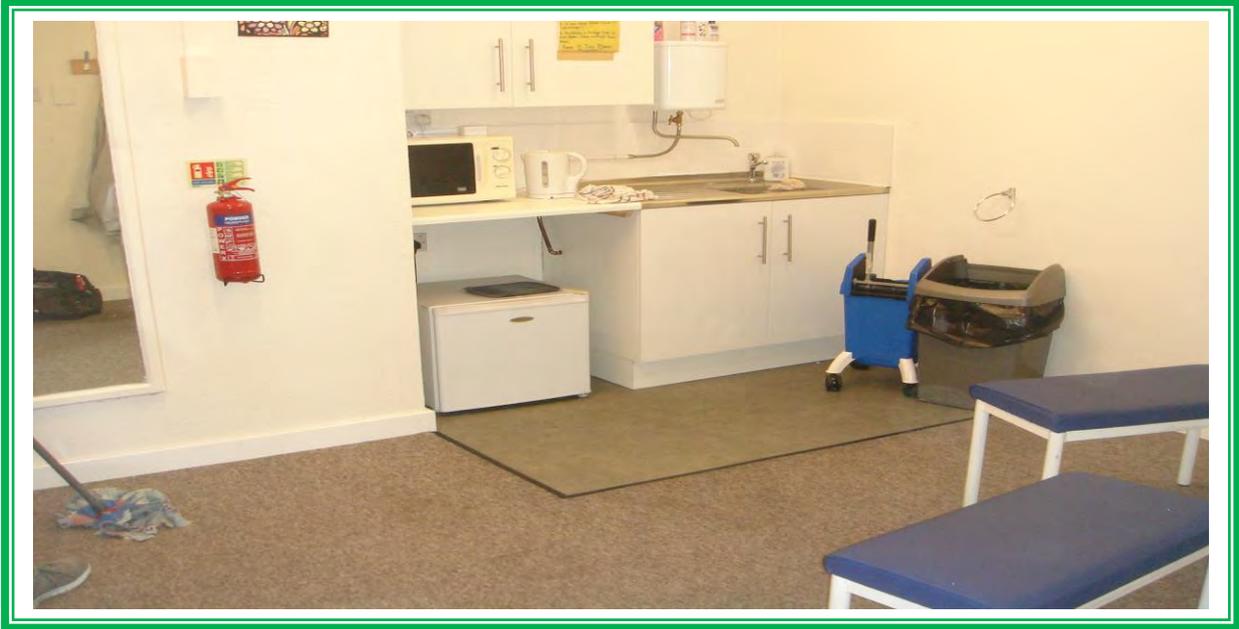
Location: 1/003 Kitchen

Material Description:	Visual Inspection – No Suspect Materials Found	
Identification:	N/A	
Approx. quantity:	N/A	
Accessibility	N/A	Assessment Score
Product type:	N/A	N/A
Extent of Damage:	N/A	N/A
Surface Treatment:	N/A	N/A
Asbestos type:	N/A	N/A
Material Assessment Score:		N/A
Priority Assessment Score:		N/A
Action:	N/A	
Comments:	N/A

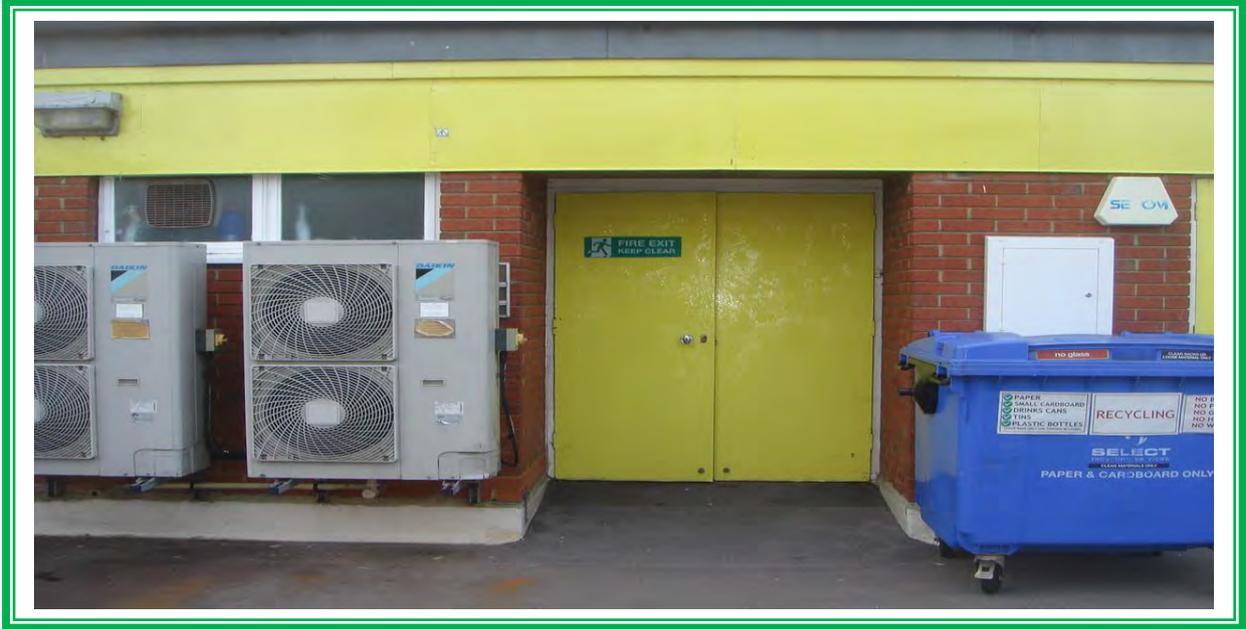
Location: 99/001

Material Description:	Visual Inspection – No Suspect Materials Found	
Identification:	N/A	
Approx. quantity:	N/A	
Accessibility	N/A	Assessment Score
Product type:	N/A	N/A
Extent of Damage:	N/A	N/A
Surface Treatment:	N/A	N/A
Asbestos type:	N/A	N/A
Material Assessment Score:		N/A
Priority Assessment Score:		N/A
Action:	N/A	
Comments:	N/A

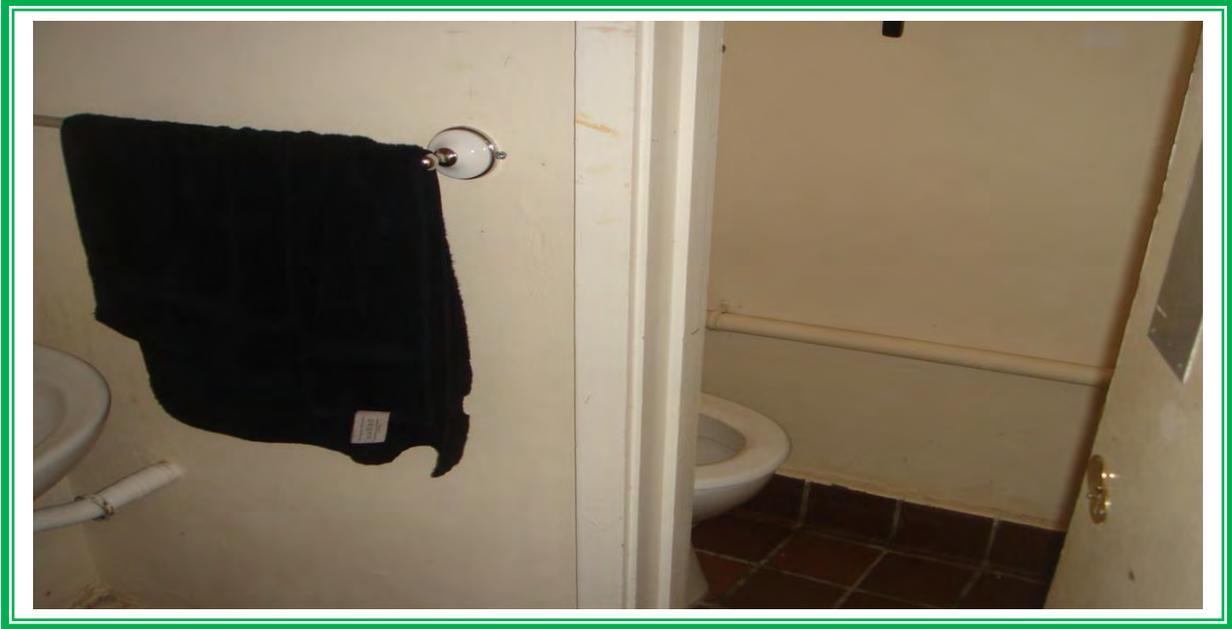
Location: 1/002 WC

Material Description:	Visual Inspection – No Suspect Materials Found	
Identification:	N/A	
Approx. quantity:	N/A	
Accessibility	N/A	Assessment Score
Product type:	N/A	N/A
Extent of Damage:	N/A	N/A
Surface Treatment:	N/A	N/A
Asbestos type:	N/A	N/A
Material Assessment Score:		N/A
Priority Assessment Score:		N/A
Action:	N/A	
Comments:	N/A

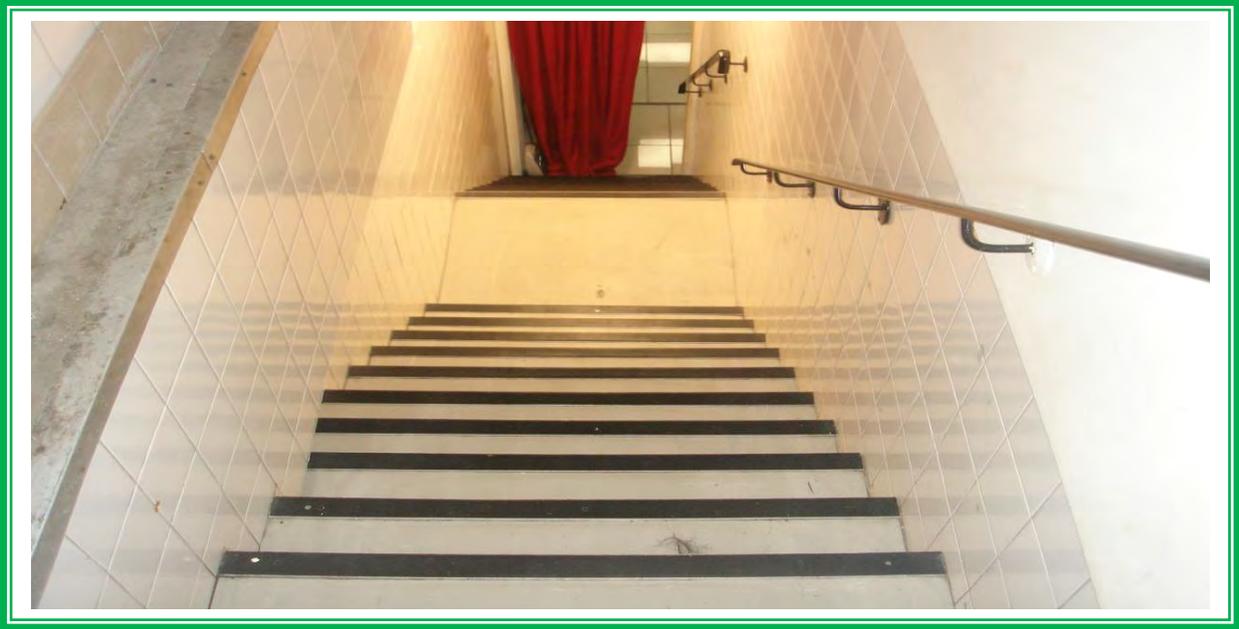
Location: 1/003 Stairs

Material Description:	Vinyl Floor Sheets	
Identification:	As Per Sample NE/1 – No Asbestos Detected	
Approx. quantity:	10M2	
Accessibility	N/A	Assessment Score
Product type:	N/A	N/A
Extent of Damage:	N/A	N/A
Surface Treatment:	N/A	N/A
Asbestos type:	N/A	N/A
Material Assessment Score:		N/A
Priority Assessment Score:		N/A
Action:	N/A	
Comments:	N/A

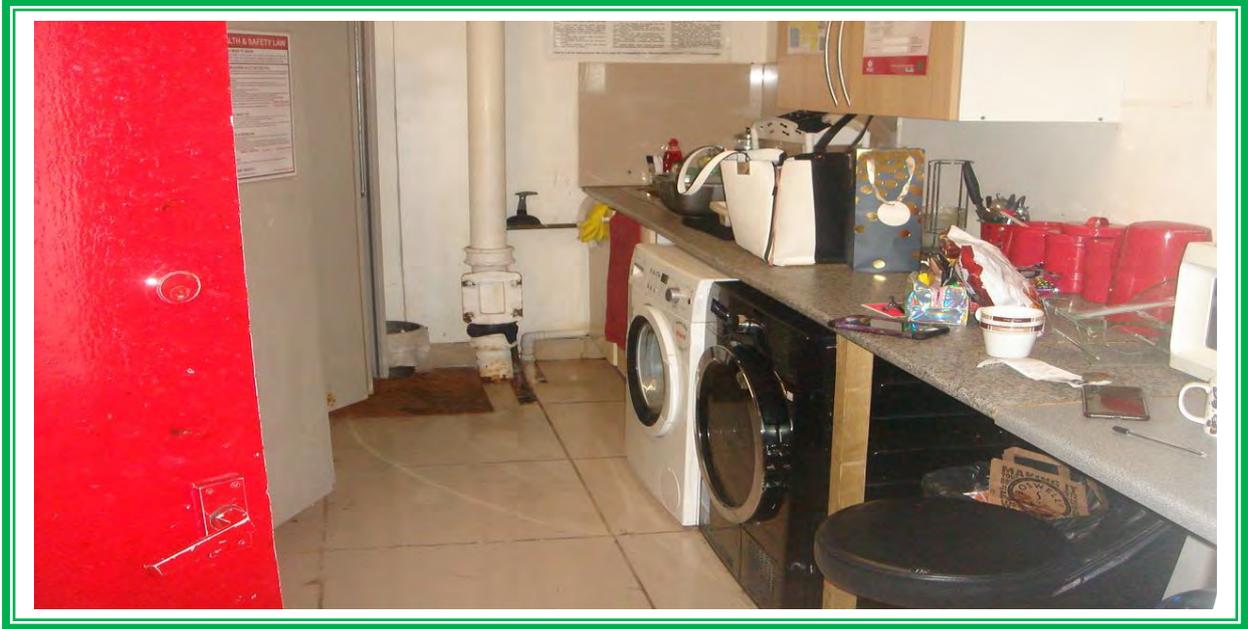
Location: 0/001 Kitchen

Material Description:	Visual Inspection – No Suspect Materials Found	
Identification:	N/A	
Approx. quantity:	N/A	
Accessibility	N/A	Assessment Score
Product type:	N/A	N/A
Extent of Damage:	N/A	N/A
Surface Treatment:	N/A	N/A
Asbestos type:	N/A	N/A
Material Assessment Score:		N/A
Priority Assessment Score:		N/A
Action:	N/A	
Comments:	N/A

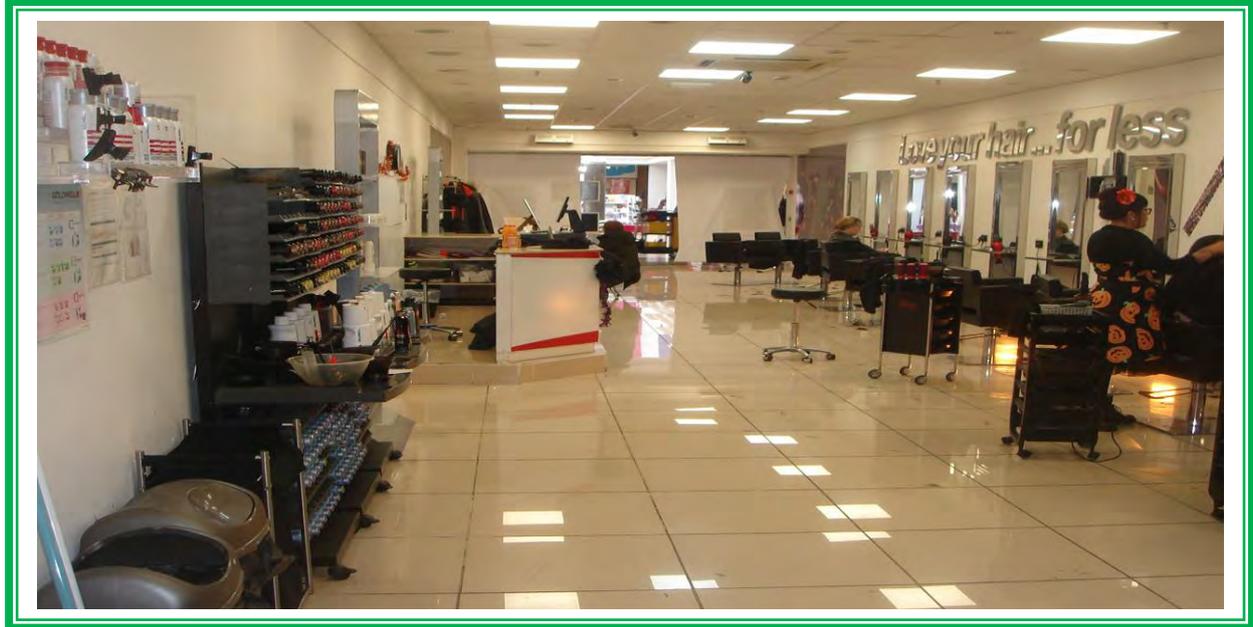
Location: 0/002 Shop Floor

Material Description:	Visual Inspection – No Suspect Materials Found	
Identification:	N/A	
Approx. quantity:	N/A	
Accessibility	N/A	Assessment Score
Product type:	N/A	N/A
Extent of Damage:	N/A	N/A
Surface Treatment:	N/A	N/A
Asbestos type:	N/A	N/A
Material Assessment Score:		N/A
Priority Assessment Score:		N/A
Action:	N/A	
Comments:	N/A

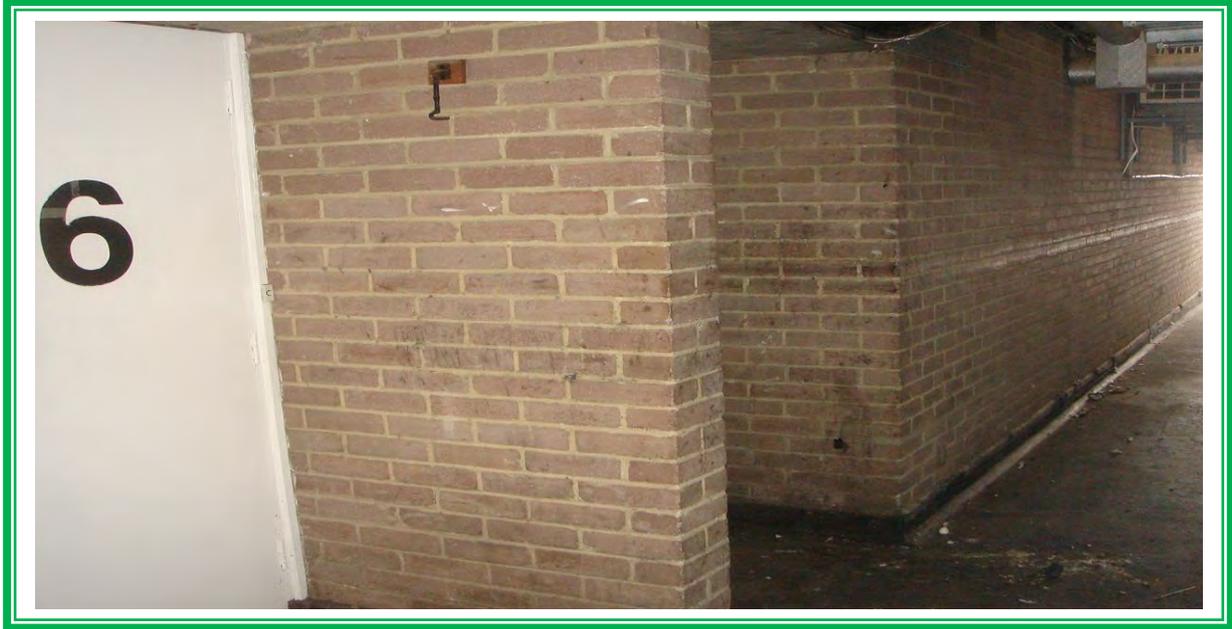
Location: 99/001

Material Description:	Visual Inspection – No Suspect Materials Found	
Identification:	N/A	
Approx. quantity:	N/A	
Accessibility	N/A	Assessment Score
Product type:	N/A	N/A
Extent of Damage:	N/A	N/A
Surface Treatment:	N/A	N/A
Asbestos type:	N/A	N/A
Material Assessment Score:		N/A
Priority Assessment Score:		N/A
Action:	N/A	
Comments:	N/A

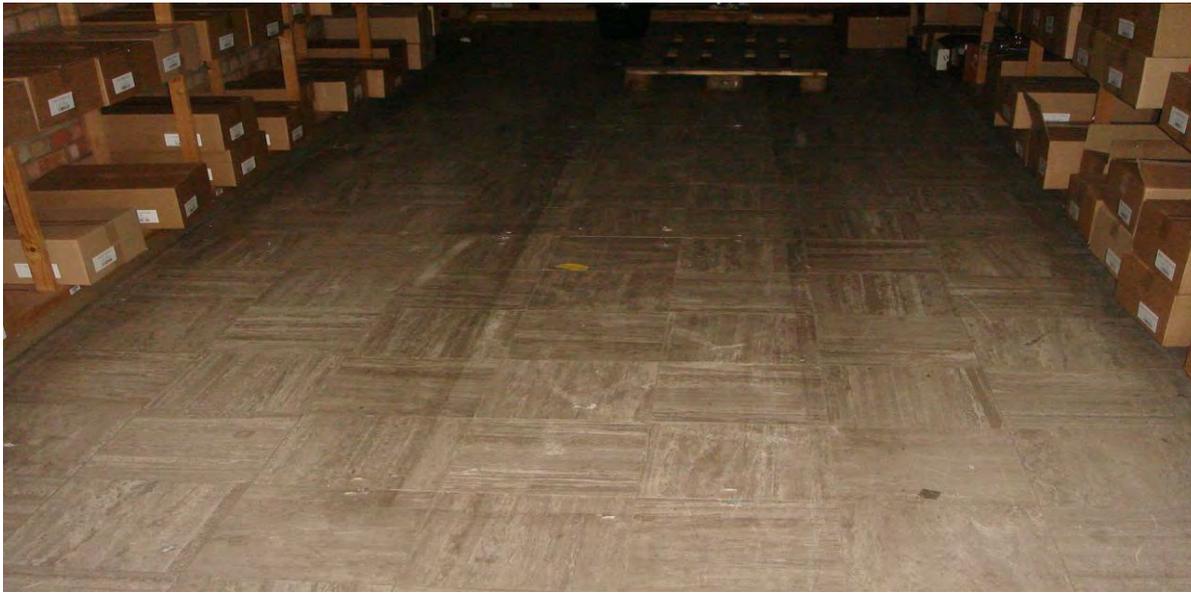
Location: 1/001 Store

Material Description:	Vinyl Floor Tiles	
Identification:	Sampled – No Asbestos Detected	
Approx. quantity:	50M2	
Accessibility	N/A	Assessment Score
Product type:	N/A	N/A
Extent of Damage:	N/A	N/A
Surface Treatment:	N/A	N/A
Asbestos type:	N/A	N/A
Material Assessment Score:		N/A
Priority Assessment Score:		N/A
Action:	N/A	
Comments:	N/A

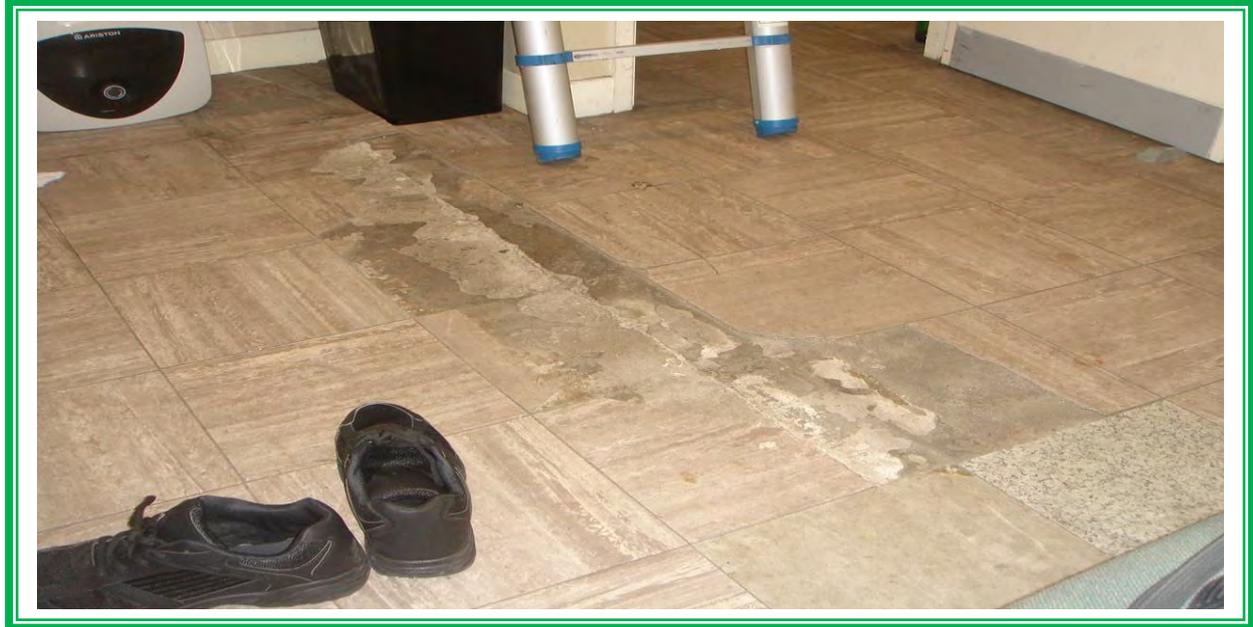
Location: 1/002 Kitchen

Material Description:	Vinyl Floor Tiles	
Identification:	As Per Sample NE/1 – No Asbestos Detected	
Approx. quantity:	9M2	
Accessibility	N/A	Assessment Score
Product type:	N/A	N/A
Extent of Damage:	N/A	N/A
Surface Treatment:	N/A	N/A
Asbestos type:	N/A	N/A
Material Assessment Score:		N/A
Priority Assessment Score:		N/A
Action:	N/A	
Comments:	N/A

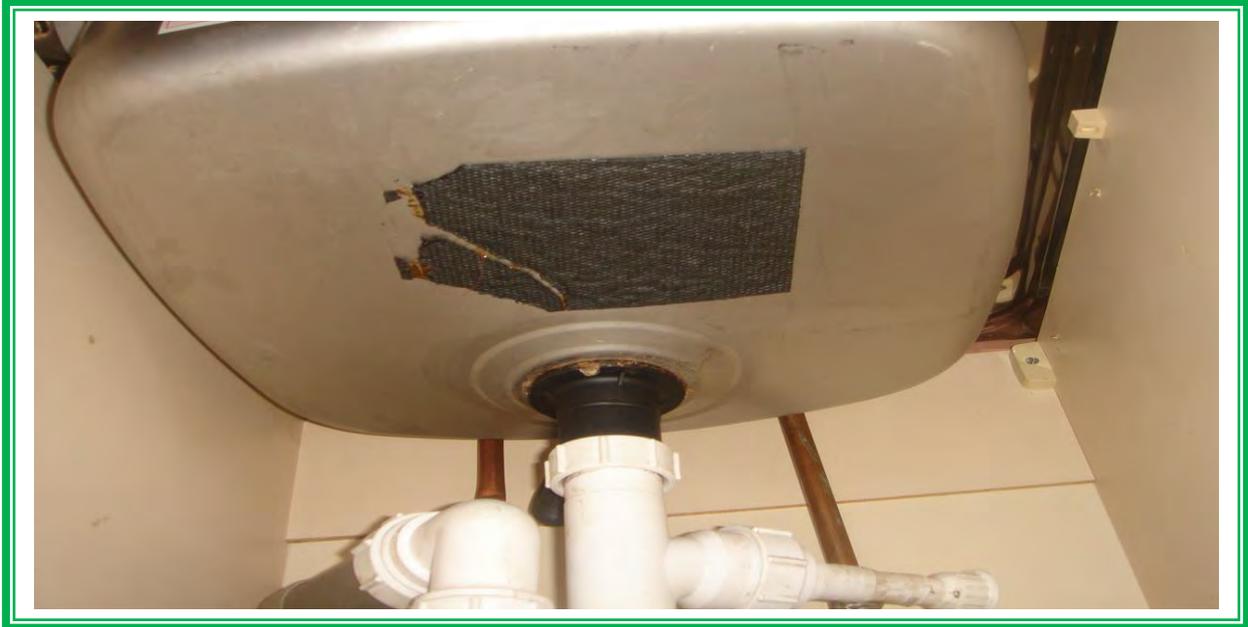
Location: 1/002 Kitchen

Material Description:	Sink Pad	
Identification:	Sampled - No Asbestos Detected	
Approx. quantity:	X 2	
Accessibility	N/A	Assessment Score
Product type:	N/A	N/A
Extent of Damage:	N/A	N/A
Surface Treatment:	N/A	N/A
Asbestos type:	N/A	N/A
Material Assessment Score:		N/A
Priority Assessment Score:		N/A
Action:	N/A	
Comments:	N/A
