Project Number 3113

Management  
Asbestos Survey Report

Kennet Centre, Market Street, Newbury,  
Berkshire, RG14 5EN

1-3 The Mall

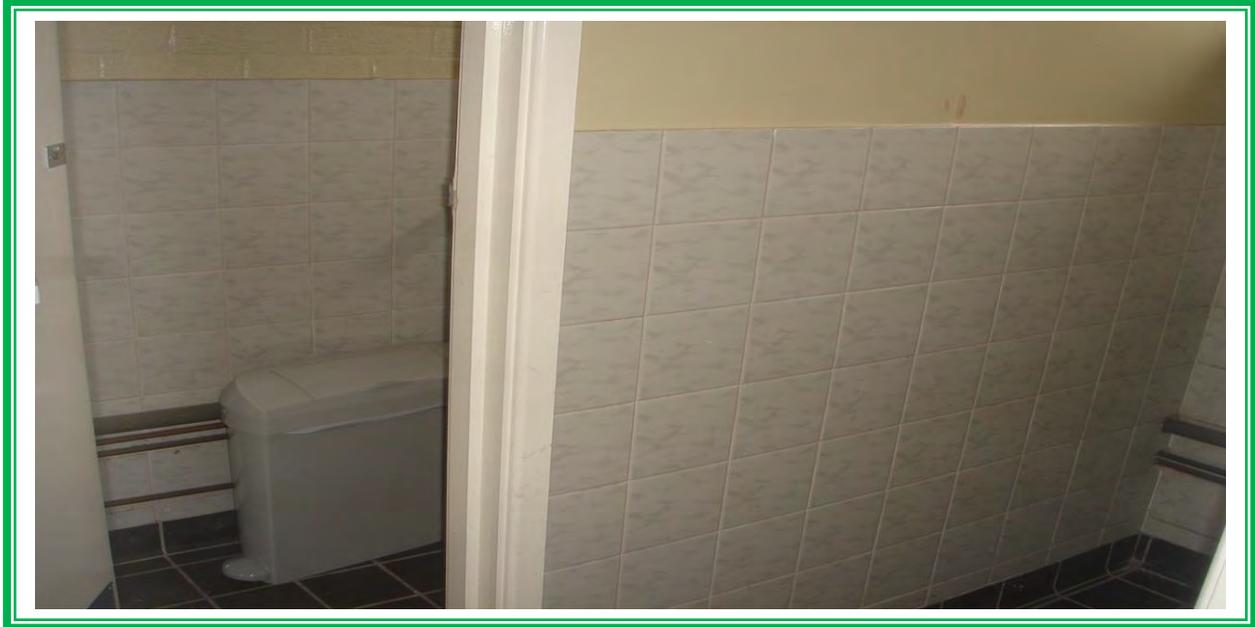
Location: 1/003 WC

Material Description:	Visual Inspection – No Suspect Materials Found	
Identification:	N/A	
Approx. quantity:	N/A	
Accessibility	N/A	Assessment Score
Product type:	N/A	N/A
Extent of Damage:	N/A	N/A
Surface Treatment:	N/A	N/A
Asbestos type:	N/A	N/A
Material Assessment Score:		N/A
Priority Assessment Score:		N/A
Action:	N/A	
Comments:	N/A

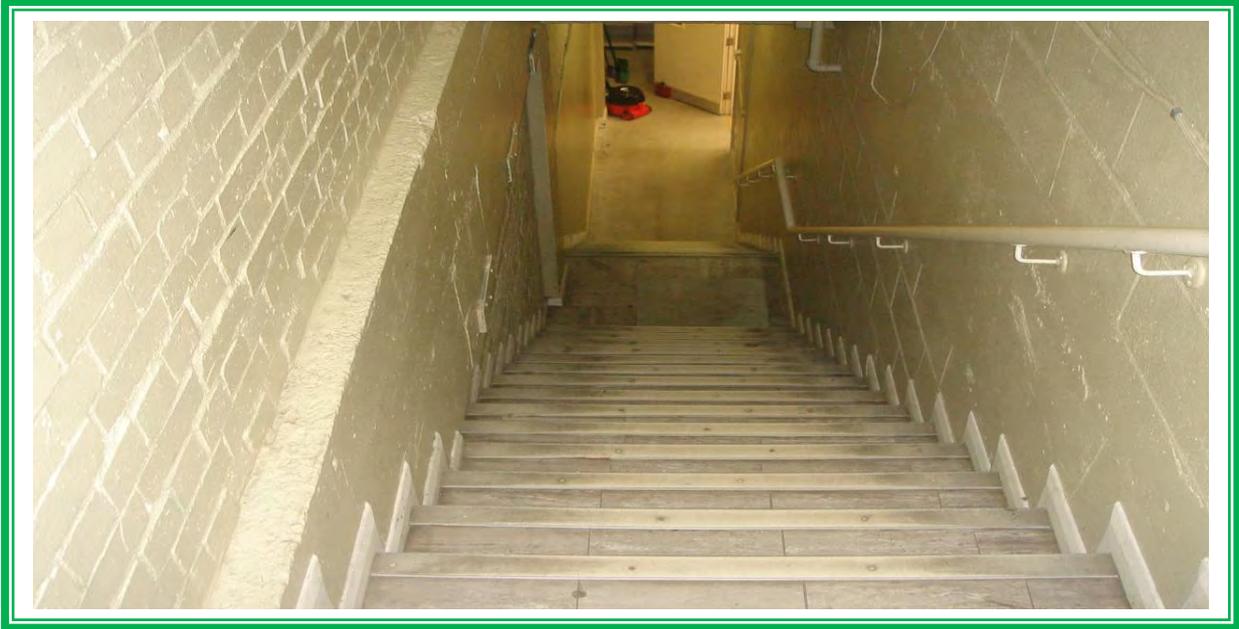
Location: 1/004 Stairs

Material Description:	Vinyl Floor Tiles	
Identification:	As Per Sample NE/1 – No Asbestos Detected	
Approx. quantity:	20M2	
Accessibility	N/A	Assessment Score
Product type:	N/A	N/A
Extent of Damage:	N/A	N/A
Surface Treatment:	N/A	N/A
Asbestos type:	N/A	N/A
Material Assessment Score:		N/A
Priority Assessment Score:		N/A
Action:	N/A	
Comments:	N/A

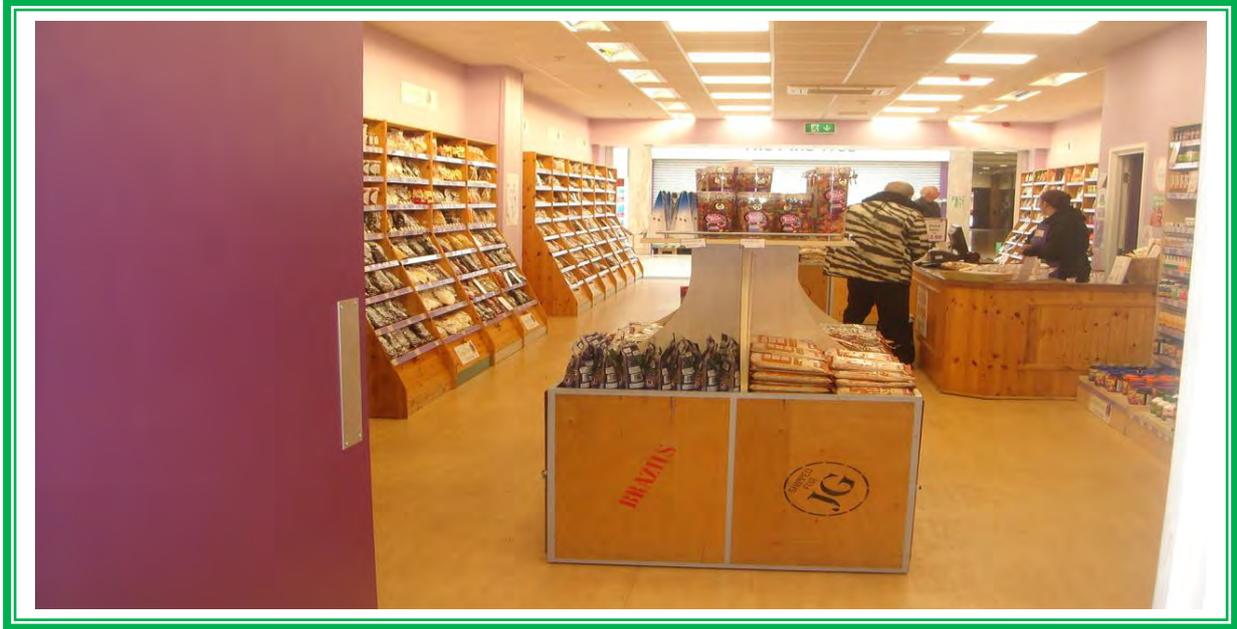
Location: 0/001 Shop Floor

Material Description:	Visual Inspection – No Suspect Materials Found	
Identification:	N/A	
Approx. quantity:	N/A	
Accessibility	N/A	Assessment Score
Product type:	N/A	N/A
Extent of Damage:	N/A	N/A
Surface Treatment:	N/A	N/A
Asbestos type:	N/A	N/A
Material Assessment Score:		N/A
Priority Assessment Score:		N/A
Action:	N/A	
Comments:	N/A

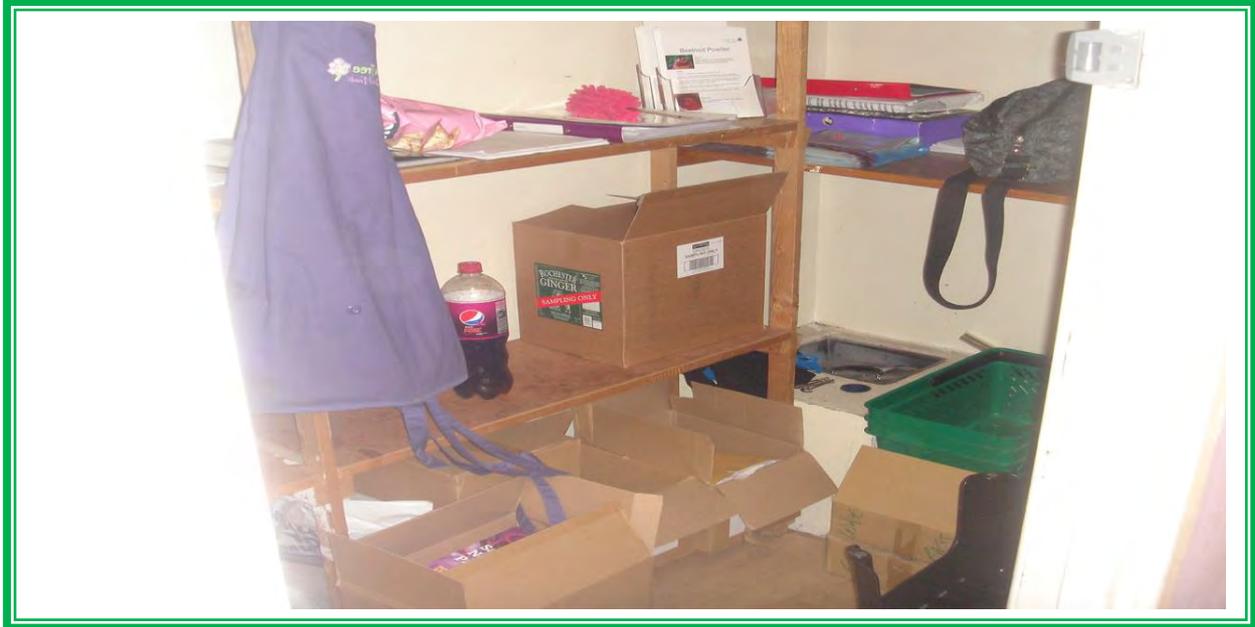
Location: 0/002 Cupboard

Material Description:	Visual Inspection – No Suspect Materials Found	
Identification:	N/A	
Approx. quantity:	N/A	
Accessibility	N/A	Assessment Score
Product type:	N/A	N/A
Extent of Damage:	N/A	N/A
Surface Treatment:	N/A	N/A
Asbestos type:	N/A	N/A
Material Assessment Score:		N/A
Priority Assessment Score:		N/A
Action:	N/A	
Comments:	N/A

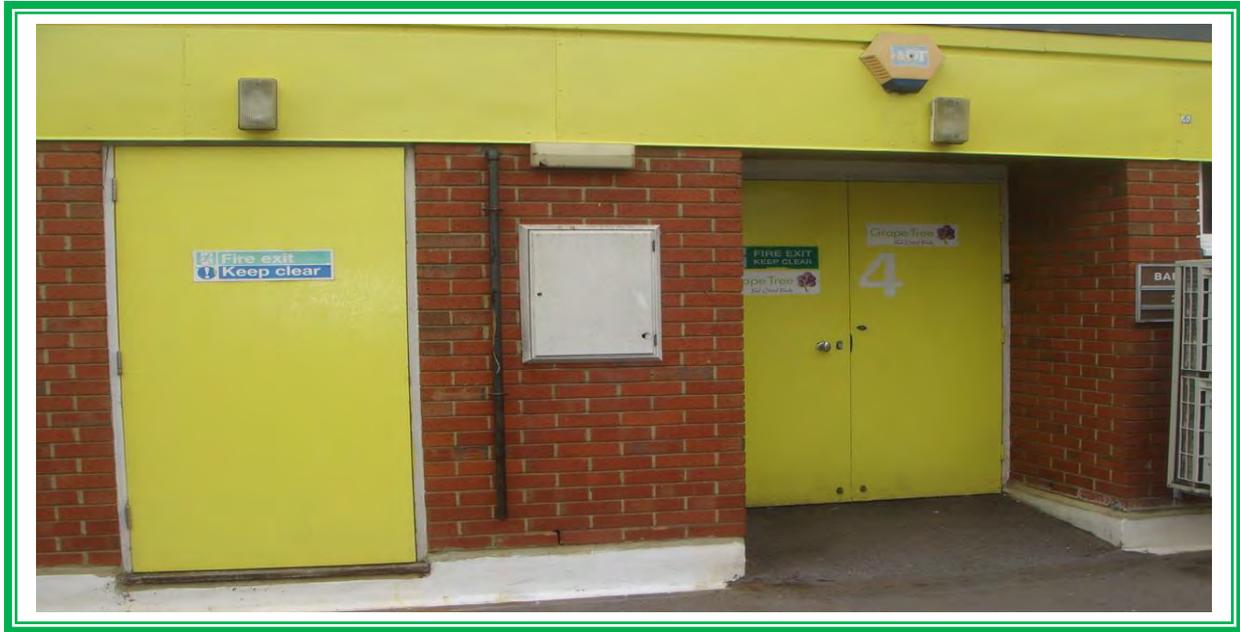
Location: 99/001

Material Description:	Visual Inspection – No Suspect Materials Found	
Identification:	N/A	
Approx. quantity:	N/A	
Accessibility	N/A	Assessment Score
Product type:	N/A	N/A
Extent of Damage:	N/A	N/A
Surface Treatment:	N/A	N/A
Asbestos type:	N/A	N/A
Material Assessment Score:		N/A
Priority Assessment Score:		N/A
Action:	N/A	
Comments:	N/A

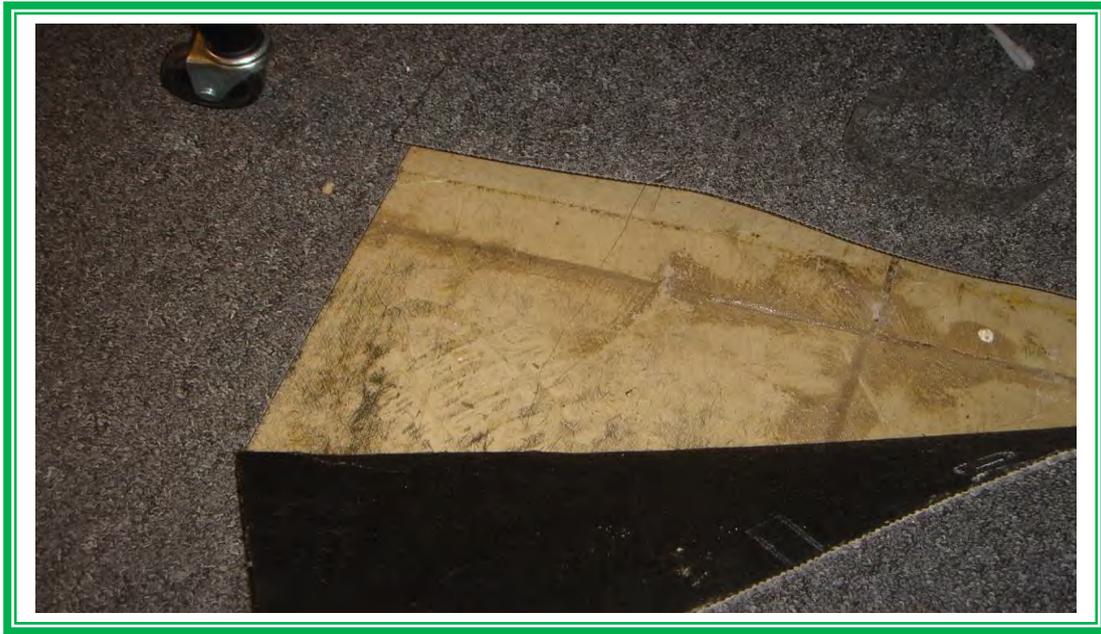
Item No: 1	Sample No: NE/1
Location: 1/001 Store

Material Description:	Vinyl Floor Tiles	
Identification:	Sampled – No Asbestos Detected	
Approx. quantity:	40M2	
Accessibility	N/A	Assessment Score
Product type:	N/A	N/A
Extent of Damage:	N/A	N/A
Surface Treatment:	N/A	N/A
Asbestos type:	N/A	N/A
Material Assessment Score:		N/A
Priority Assessment Score:		N/A
Action:	N/A	
Comments:	N/A

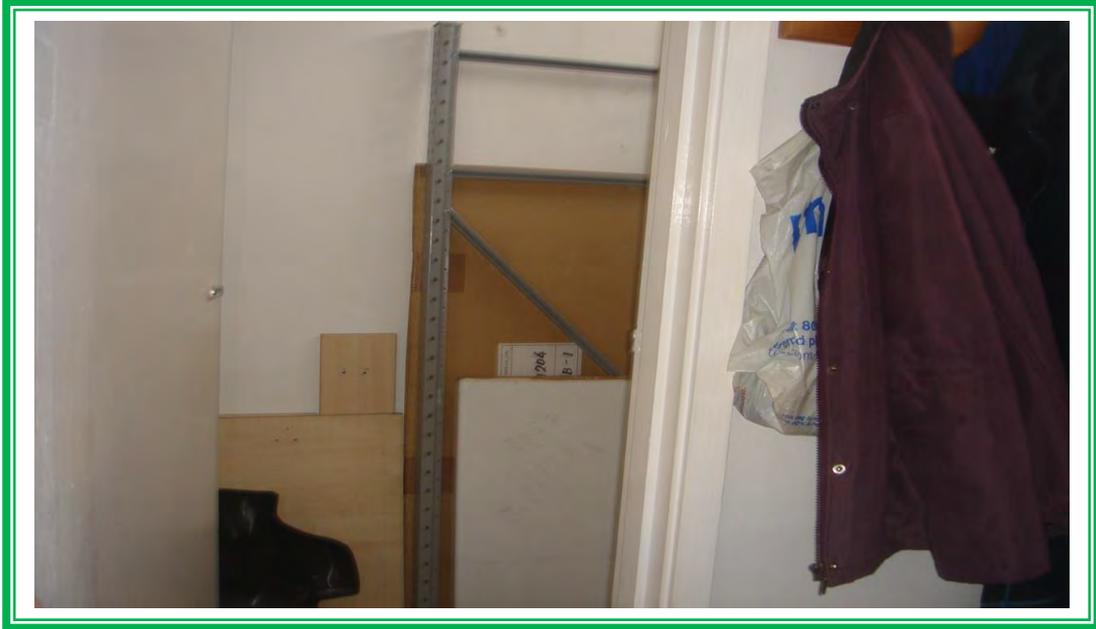
Location: 1/002 WC

Material Description:	Visual Inspection – No Suspect Materials Found	
Identification:	N/A	
Approx. quantity:	N/A	
Accessibility	N/A	Assessment Score
Product type:	N/A	N/A
Extent of Damage:	N/A	N/A
Surface Treatment:	N/A	N/A
Asbestos type:	N/A	N/A
Material Assessment Score:		N/A
Priority Assessment Score:		N/A
Action:	N/A	
Comments:	N/A

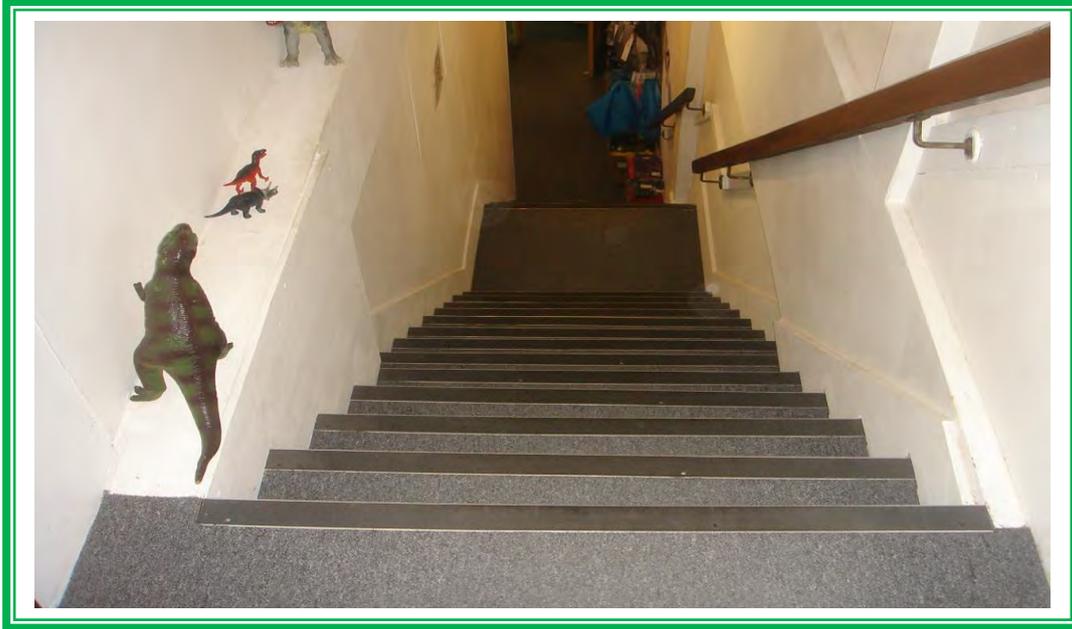
Location: 1/003 Stairs

Material Description:	Visual Inspection – No Suspect Materials Found	
Identification:	N/A	
Approx. quantity:	N/A	
Accessibility	N/A	Assessment Score
Product type:	N/A	N/A
Extent of Damage:	N/A	N/A
Surface Treatment:	N/A	N/A
Asbestos type:	N/A	N/A
Material Assessment Score:		N/A
Priority Assessment Score:		N/A
Action:	N/A	
Comments:	N/A

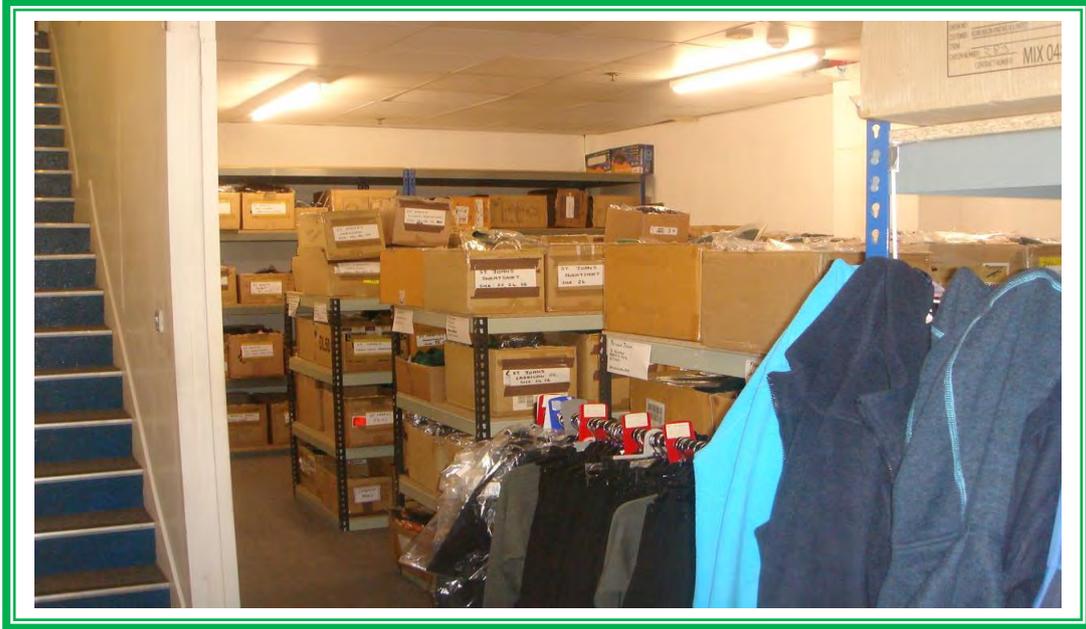
Location: 0/001 Store

Material Description:	Visual Inspection – No Suspect Materials Found	
Identification:	N/A	
Approx. quantity:	N/A	
Accessibility	N/A	Assessment Score
Product type:	N/A	N/A
Extent of Damage:	N/A	N/A
Surface Treatment:	N/A	N/A
Asbestos type:	N/A	N/A
Material Assessment Score:		N/A
Priority Assessment Score:		N/A
Action:	N/A	
Comments:	N/A

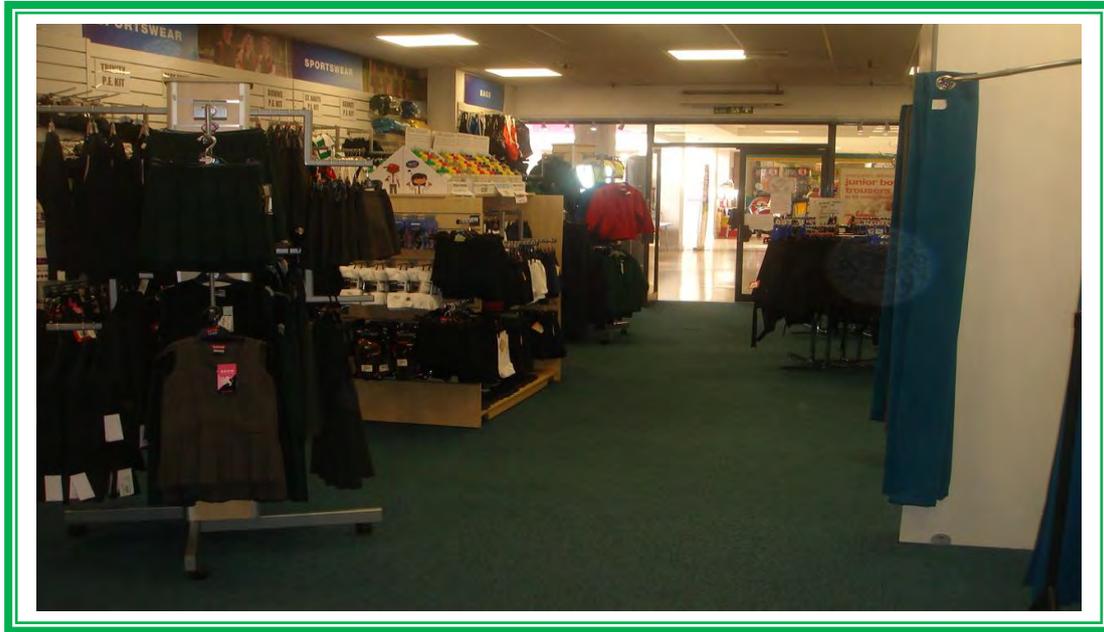
Location: 0/002 Shop Floor

Material Description:	Visual Inspection – No Suspect Materials Found	
Identification:	N/A	
Approx. quantity:	N/A	
Accessibility	N/A	Assessment Score
Product type:	N/A	N/A
Extent of Damage:	N/A	N/A
Surface Treatment:	N/A	N/A
Asbestos type:	N/A	N/A
Material Assessment Score:		N/A
Priority Assessment Score:		N/A
Action:	N/A	
Comments:	N/A

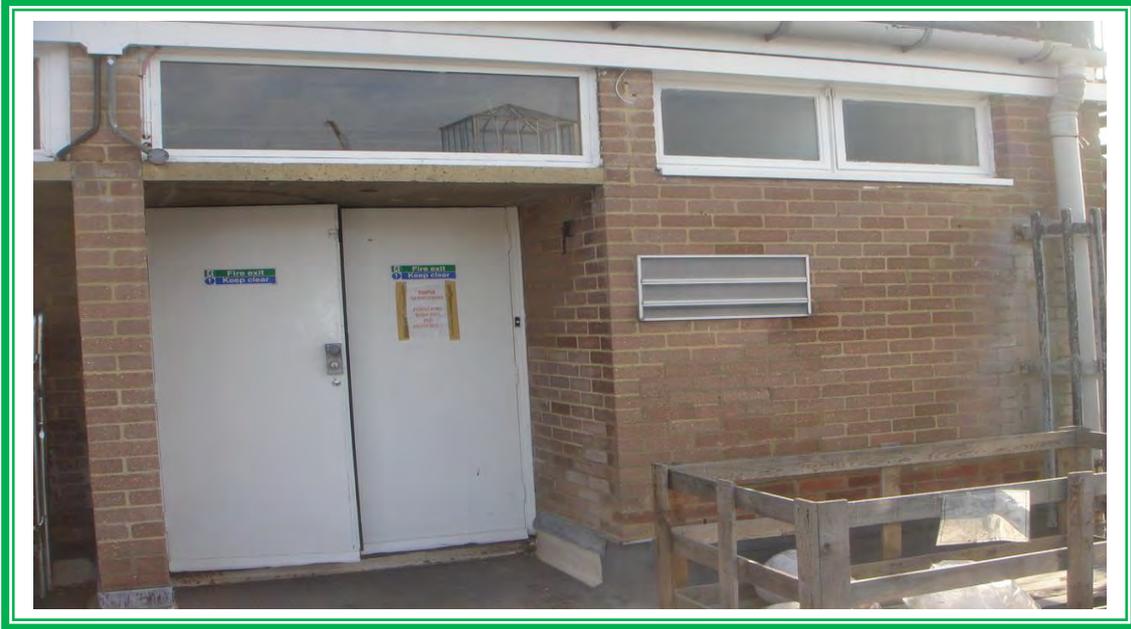
Location: 99/001 External

Material Description:	Visual Inspection – No Suspect Materials Found	
Identification:	N/A	
Approx. quantity:	N/A	
Accessibility	N/A	Assessment Score
Product type:	N/A	N/A
Extent of Damage:	N/A	N/A
Surface Treatment:	N/A	N/A
Asbestos type:	N/A	N/A
Material Assessment Score:		N/A
Priority Assessment Score:		N/A
Action:	N/A	
Comments:	N/A

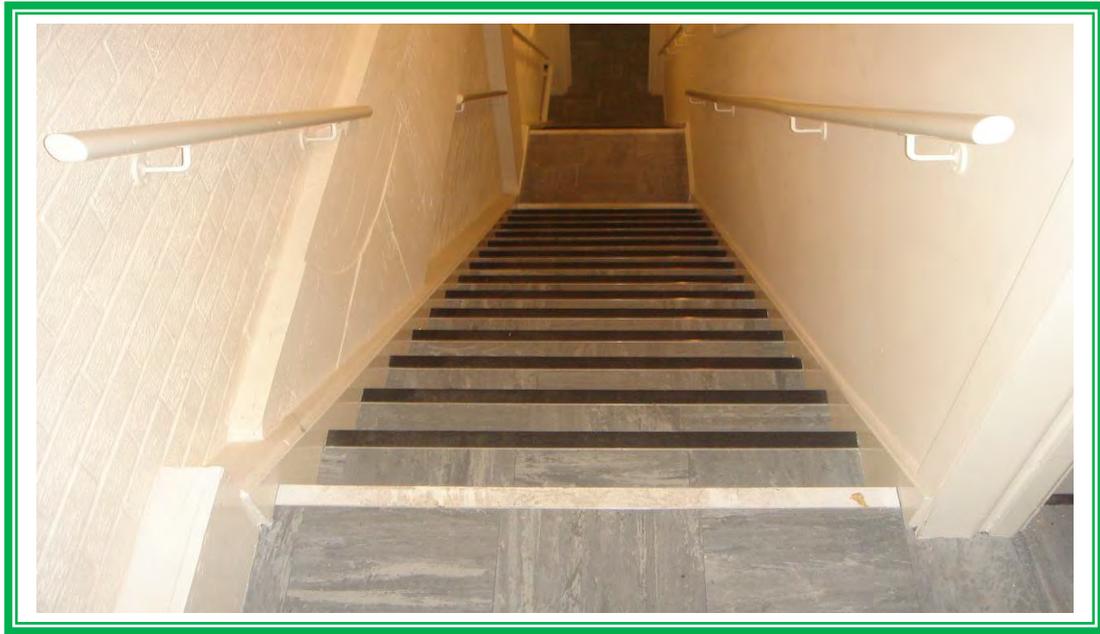
Item No: 1	Sample No: NE/1
Location: 1/001 Stairs

Material Description:	Vinyl Floor Tiles	
Identification:	Sampled – No Asbestos Detected	
Approx. quantity:	15M2	
Accessibility	N/A	Assessment Score
Product type:	N/A	N/A
Extent of Damage:	N/A	N/A
Surface Treatment:	N/A	N/A
Asbestos type:	N/A	N/A
Material Assessment Score:		N/A
Priority Assessment Score:		N/A
Action:	N/A	
Comments:	N/A

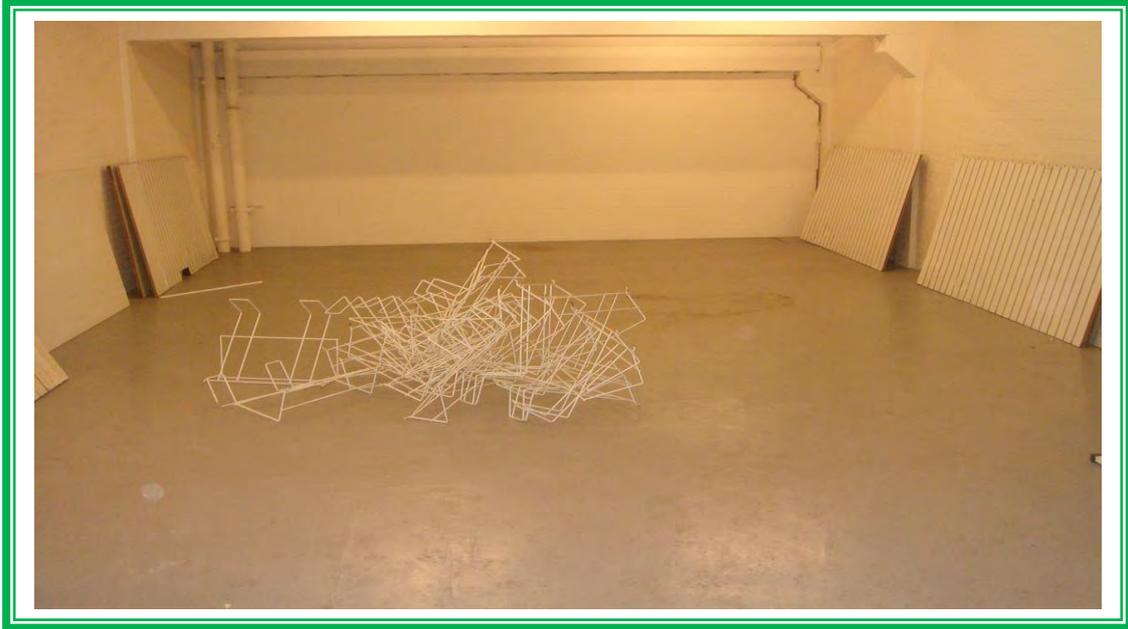
Location: 1/002 Store

Material Description:	Visual Inspection – No Suspect Materials Found	
Identification:	N/A	
Approx. quantity:	N/A	
Accessibility	N/A	Assessment Score
Product type:	N/A	N/A
Extent of Damage:	N/A	N/A
Surface Treatment:	N/A	N/A
Asbestos type:	N/A	N/A
Material Assessment Score:		N/A
Priority Assessment Score:		N/A
Action:	N/A	
Comments:	N/A

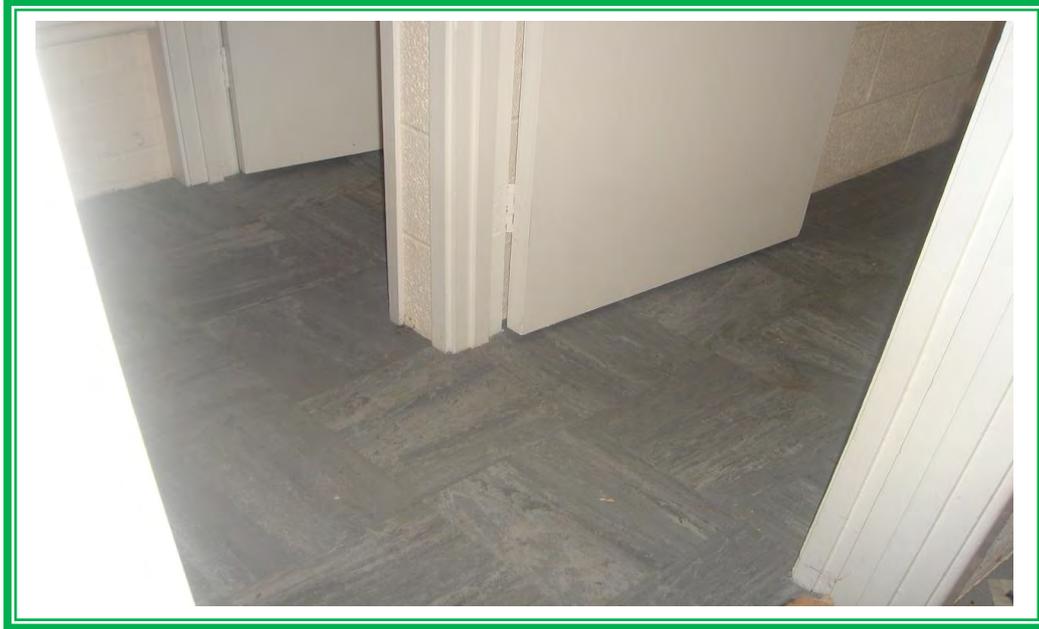
Location: 1/003 WC

Material Description:	Vinyl Floor Tiles	
Identification:	As Per Sample NE/1- No Asbestos Detected	
Approx. quantity:	6M2	
Accessibility	N/A	Assessment Score
Product type:	N/A	N/A
Extent of Damage:	N/A	N/A
Surface Treatment:	N/A	N/A
Asbestos type:	N/A	N/A
Material Assessment Score:		N/A
Priority Assessment Score:		N/A
Action:	N/A	
Comments:	N/A

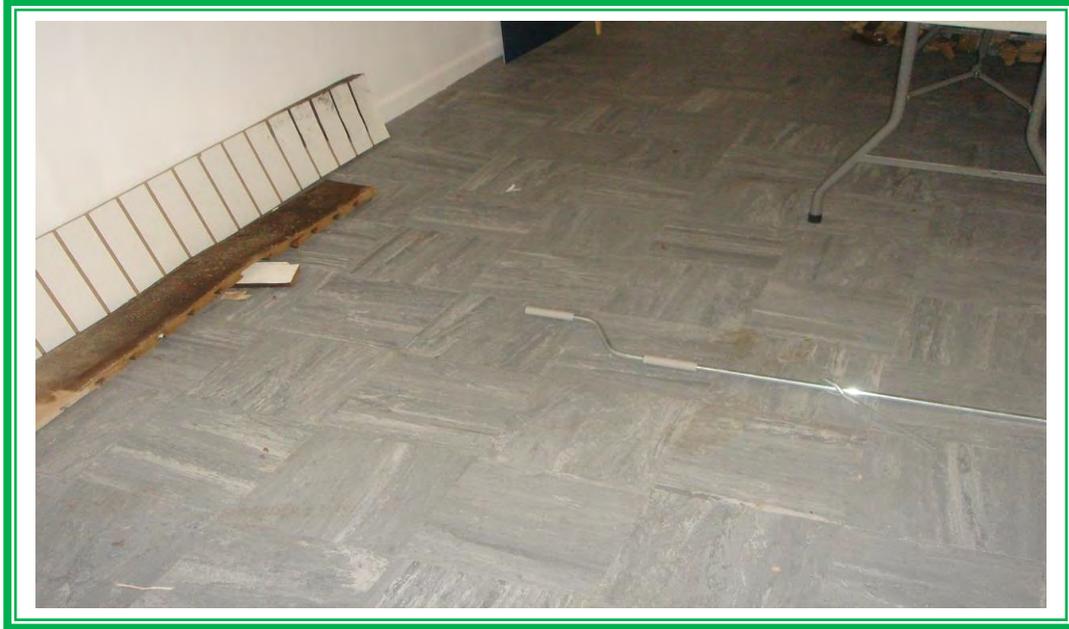
Location: 0/001 Store

Material Description:	Vinyl Floor Tiles	
Identification:	Sampled – No Asbestos Detected	
Approx. quantity:	12M2	
Accessibility	N/A	<i>Assessment Score</i>
Product type:	N/A	N/A
Extent of Damage:	N/A	N/A
Surface Treatment:	N/A	N/A
Asbestos type:	N/A	N/A
Material Assessment Score:		N/A
Priority Assessment Score:		N/A
Action:	N/A	
Comments:	N/A

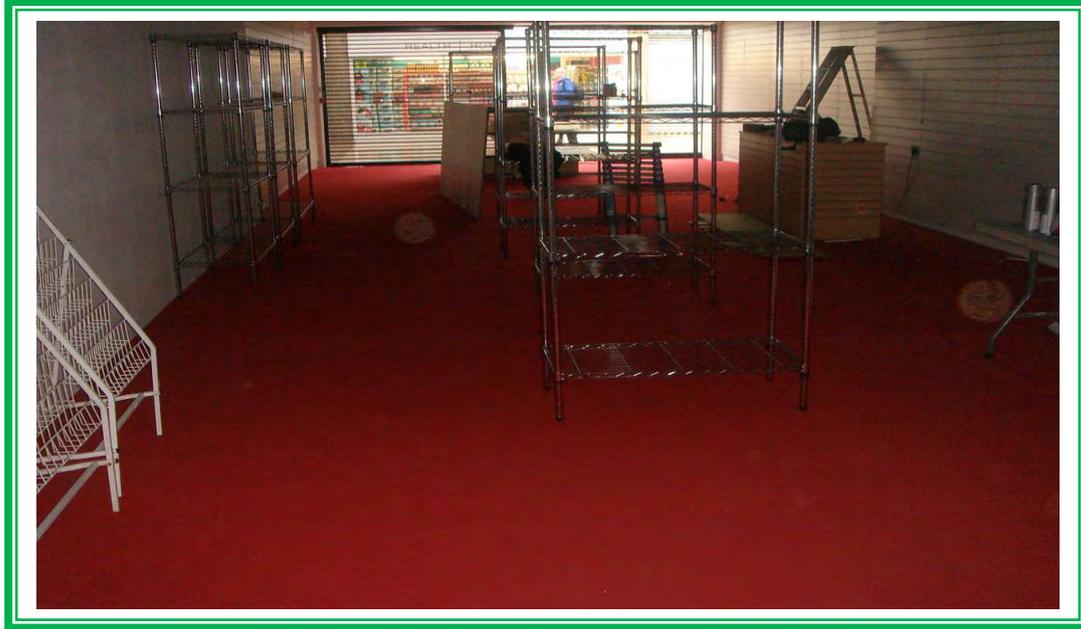
Location: 0/002 Shop Floor

Material Description:	Visual Inspection – No Suspect Materials Found	
Identification:	N/A	
Approx. quantity:	N/A	
Accessibility	N/A	Assessment Score
Product type:	N/A	N/A
Extent of Damage:	N/A	N/A
Surface Treatment:	N/A	N/A
Asbestos type:	N/A	N/A
Material Assessment Score:		N/A
Priority Assessment Score:		N/A
Action:	N/A	
Comments:	N/A

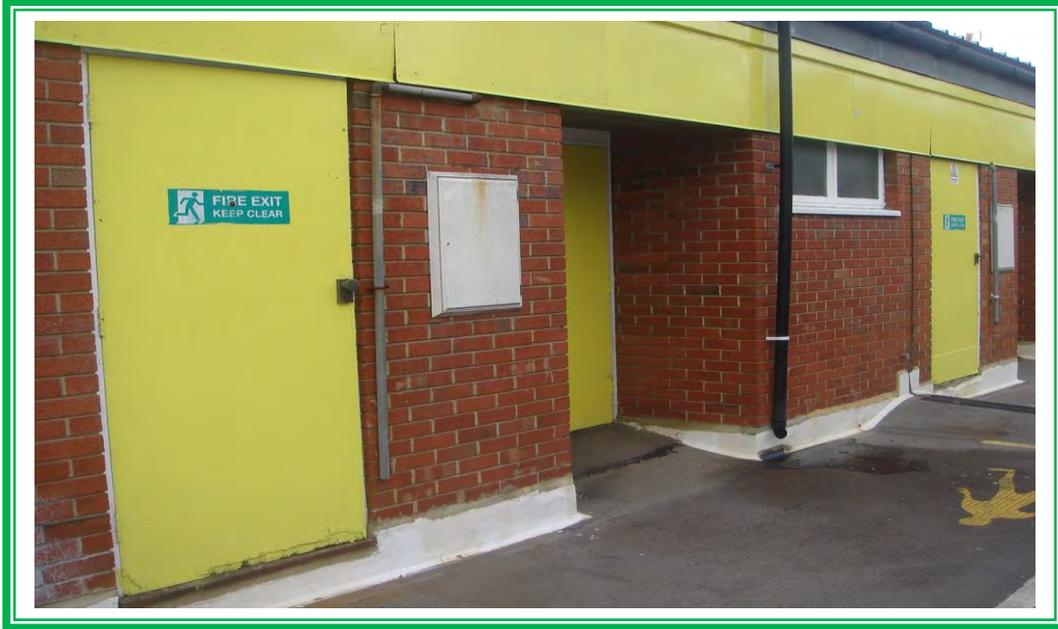
Location: 99/001 Externals

Material Description:	Visual Inspection – No Suspect Materials Found	
Identification:	N/A	
Approx. quantity:	N/A	
Accessibility	N/A	Assessment Score
Product type:	N/A	N/A
Extent of Damage:	N/A	N/A
Surface Treatment:	N/A	N/A
Asbestos type:	N/A	N/A
Material Assessment Score:		N/A
Priority Assessment Score:		N/A
Action:	N/A	
Comments:	N/A

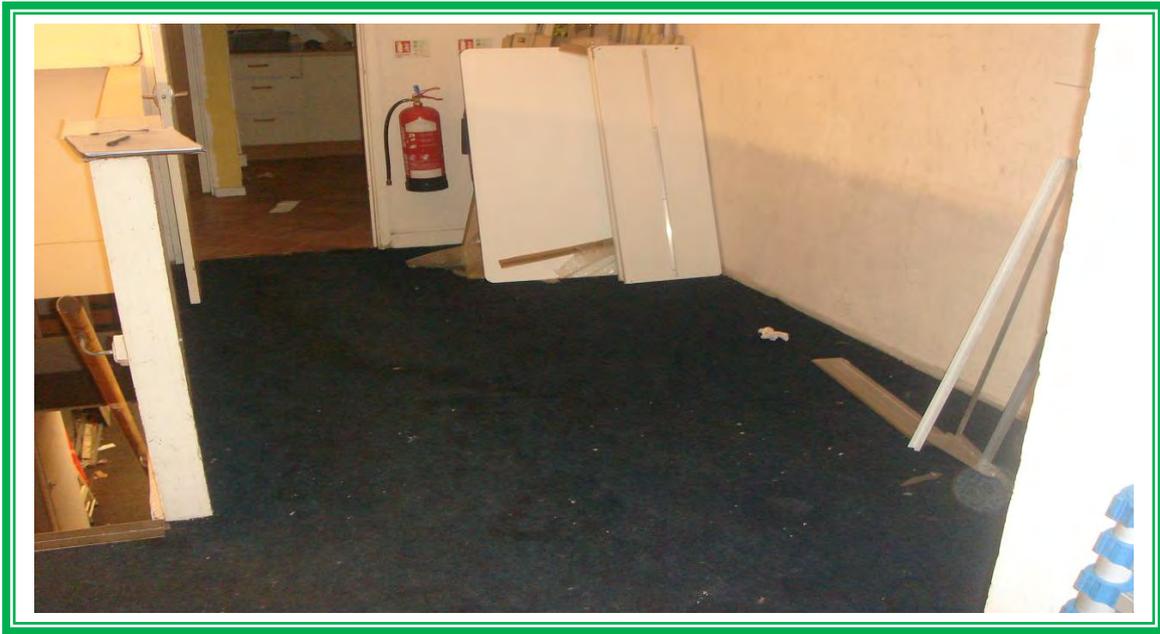
Location: 1/001 Store

Material Description:	Visual Inspection – No Suspect Materials Found	
Identification:	N/A	
Approx. quantity:	N/A	
Accessibility	N/A	Assessment Score
Product type:	N/A	N/A
Extent of Damage:	N/A	N/A
Surface Treatment:	N/A	N/A
Asbestos type:	N/A	N/A
Material Assessment Score:		N/A
Priority Assessment Score:		N/A
Action:	N/A	
Comments:	N/A

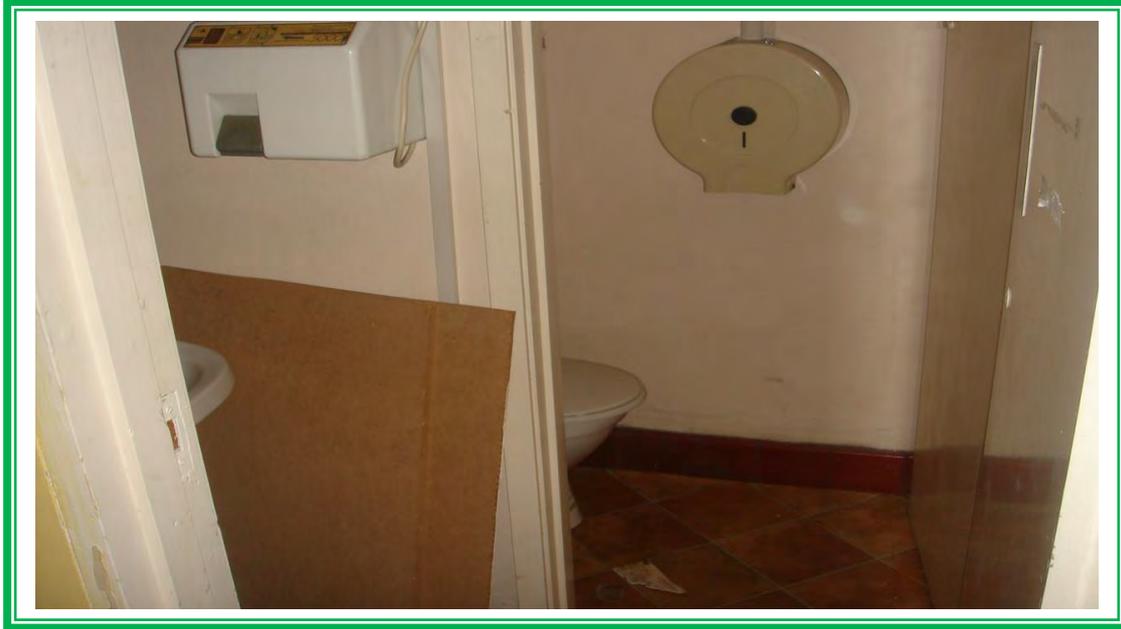
Location: 1/003 WC

Material Description:	Visual Inspection – No Suspect Materials Found	
Identification:	N/A	
Approx. quantity:	N/A	
Accessibility	N/A	Assessment Score
Product type:	N/A	N/A
Extent of Damage:	N/A	N/A
Surface Treatment:	N/A	N/A
Asbestos type:	N/A	N/A
Material Assessment Score:		N/A
Priority Assessment Score:		N/A
Action:	N/A	
Comments:	N/A

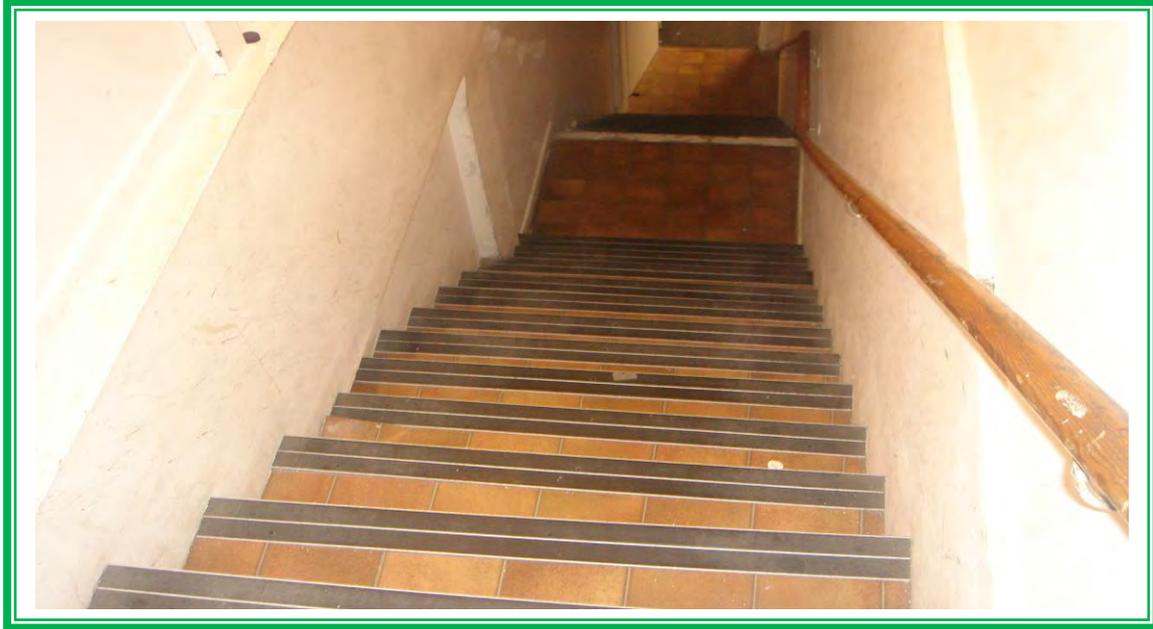
Location: 1/004 Stairs

Material Description:	Visual Inspection – No Suspect Materials Found	
Identification:	N/A	
Approx. quantity:	N/A	
Accessibility	N/A	Assessment Score
Product type:	N/A	N/A
Extent of Damage:	N/A	N/A
Surface Treatment:	N/A	N/A
Asbestos type:	N/A	N/A
Material Assessment Score:		N/A
Priority Assessment Score:		N/A
Action:	N/A	
Comments:	N/A

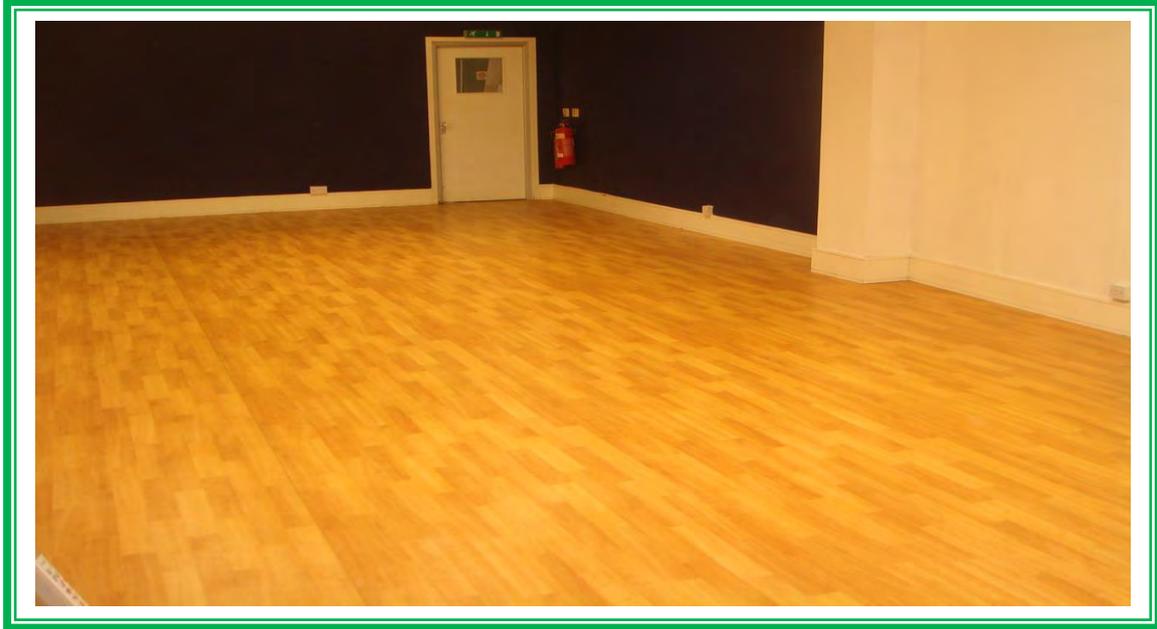
Location: 0/001 Shop Floor

Material Description:	Visual Inspection – No Suspect Materials Found	
Identification:	N/A	
Approx. quantity:	N/A	
Accessibility	N/A	Assessment Score
Product type:	N/A	N/A
Extent of Damage:	N/A	N/A
Surface Treatment:	N/A	N/A
Asbestos type:	N/A	N/A
Material Assessment Score:		N/A
Priority Assessment Score:		N/A
Action:	N/A	
Comments:	N/A

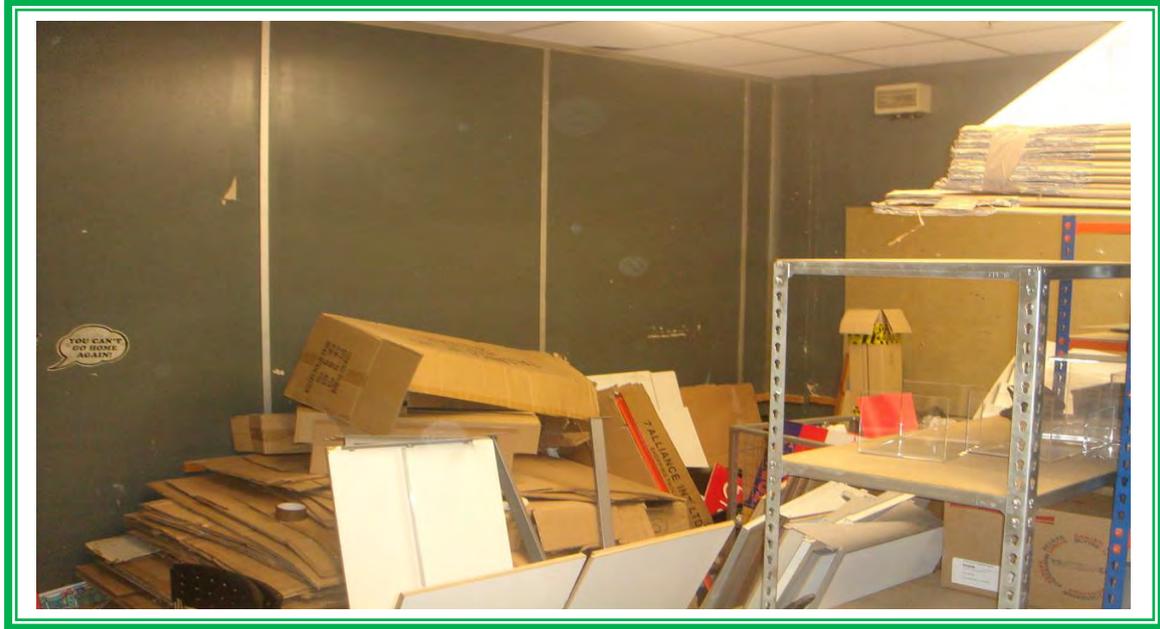
Location: 0/002 Store

Material Description:	Visual Inspection – No Suspect Materials Found	
Identification:	N/A	
Approx. quantity:	N/A	
Accessibility	N/A	Assessment Score
Product type:	N/A	N/A
Extent of Damage:	N/A	N/A
Surface Treatment:	N/A	N/A
Asbestos type:	N/A	N/A
Material Assessment Score:		N/A
Priority Assessment Score:		N/A
Action:	N/A	
Comments:	N/A

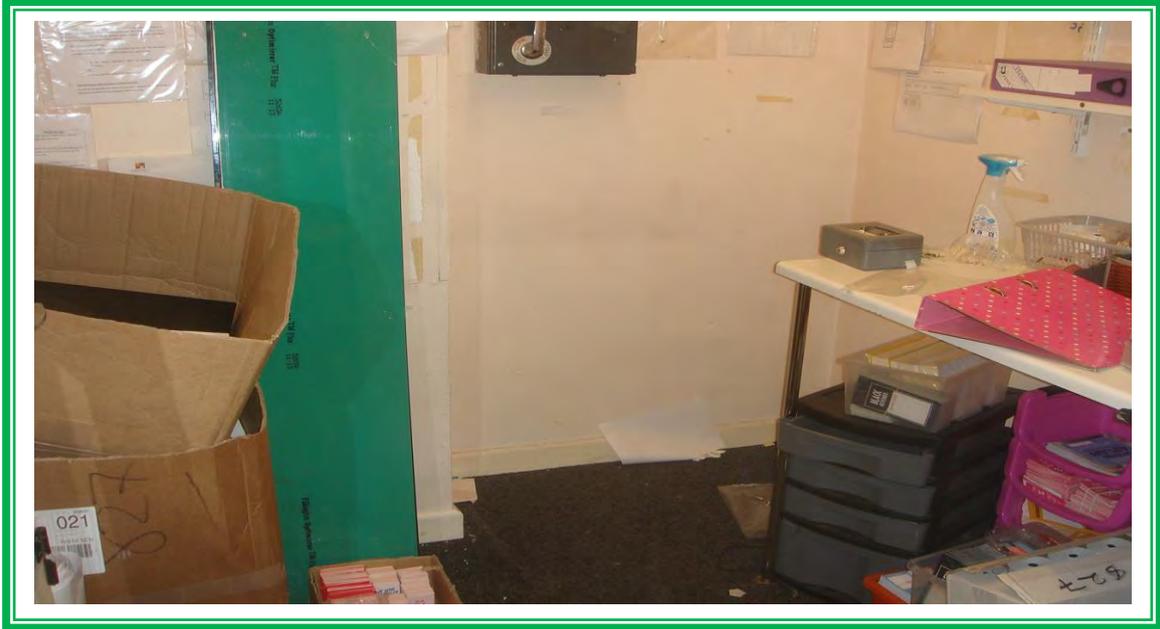
Location: 0/003 Office

Material Description:	Visual Inspection – No Suspect Materials Found	
Identification:	N/A	
Approx. quantity:	N/A	
Accessibility	N/A	Assessment Score
Product type:	N/A	N/A
Extent of Damage:	N/A	N/A
Surface Treatment:	N/A	N/A
Asbestos type:	N/A	N/A
Material Assessment Score:		N/A
Priority Assessment Score:		N/A
Action:	N/A	
Comments:	N/A

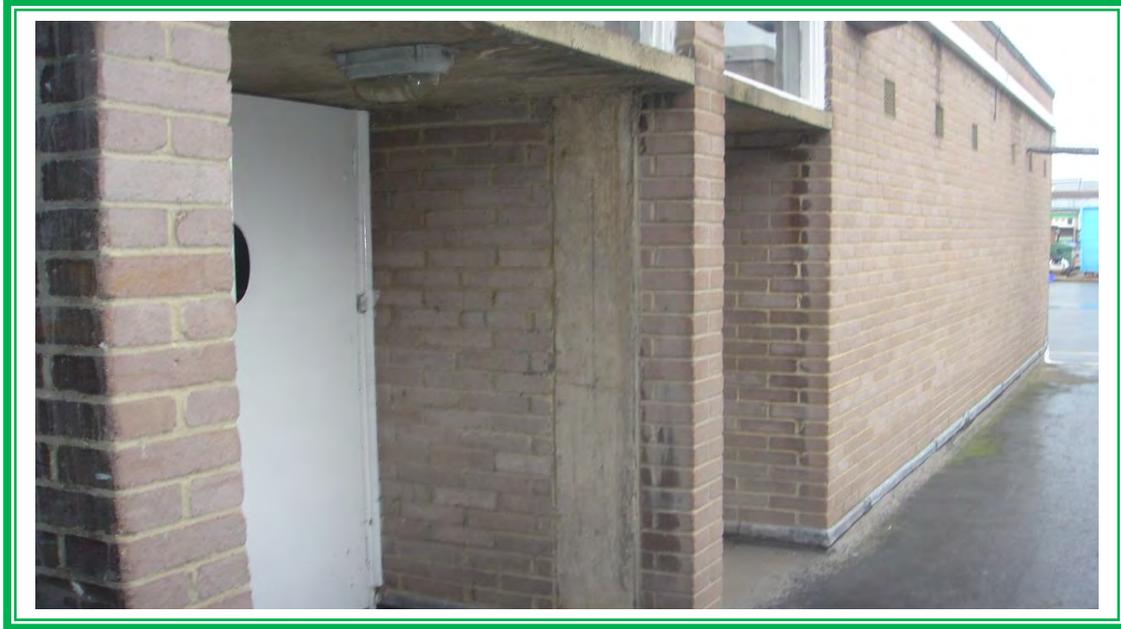
Location: 99/001 External

Material Description:	Visual Inspection – No Suspect Materials Found	
Identification:	N/A	
Approx. quantity:	N/A	
Accessibility	N/A	Assessment Score
Product type:	N/A	N/A
Extent of Damage:	N/A	N/A
Surface Treatment:	N/A	N/A
Asbestos type:	N/A	N/A
Material Assessment Score:		N/A
Priority Assessment Score:		N/A
Action:	N/A	
Comments:	N/A

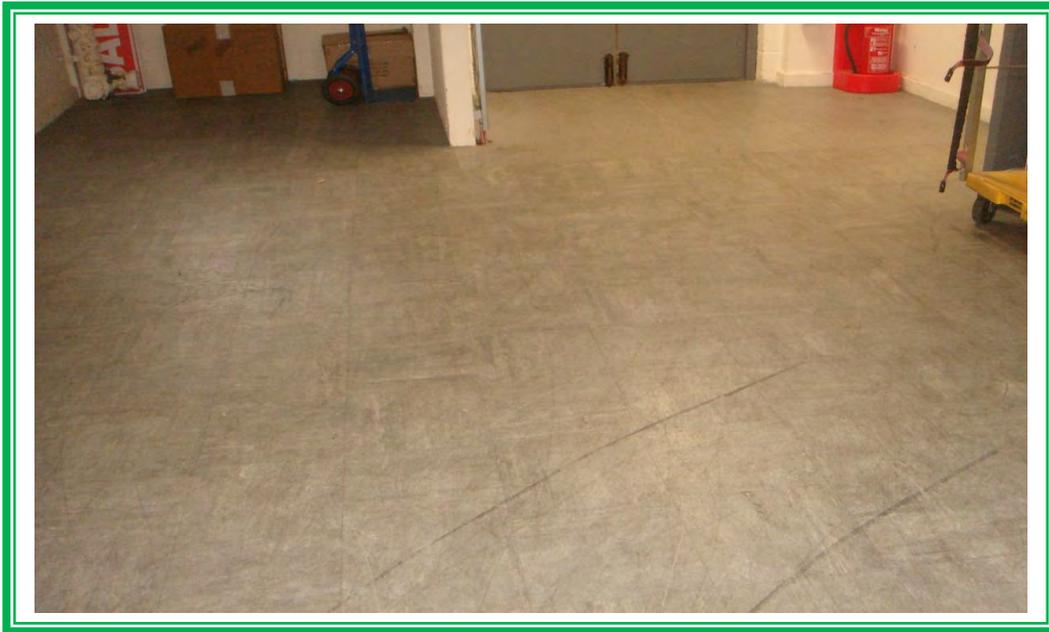
Location: 1/001 Store Area

Material Description:	Vinyl Floor Tiles	
Identification:	Sampled – No Asbestos Detected	
Approx. quantity:	50M2	
Accessibility	N/A	Assessment Score
Product type:	N/A	N/A
Extent of Damage:	N/A	N/A
Surface Treatment:	N/A	N/A
Asbestos type:	N/A	N/A
Material Assessment Score:		N/A
Priority Assessment Score:		N/A
Action:	N/A	
Comments:	N/A

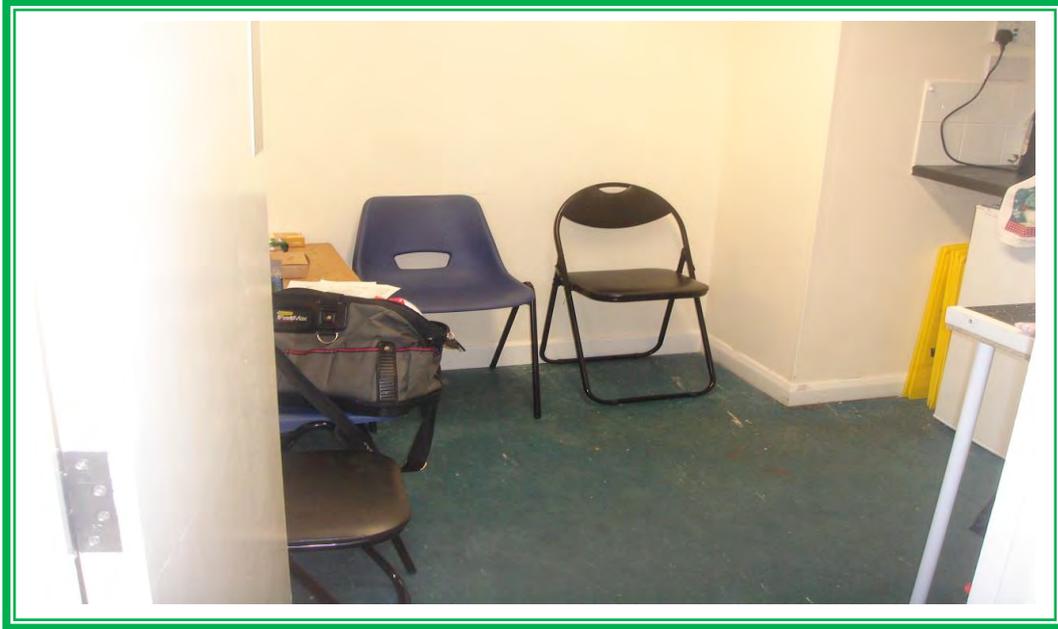
Location: 1/004 Kitchen

Material Description:	Visual Inspection – No Suspect Materials Found	
Identification:	N/A	
Approx. quantity:	N/A	
Accessibility	N/A	Assessment Score
Product type:	N/A	N/A
Extent of Damage:	N/A	N/A
Surface Treatment:	N/A	N/A
Asbestos type:	N/A	N/A
Material Assessment Score:		N/A
Priority Assessment Score:		N/A
Action:	N/A	
Comments:	N/A

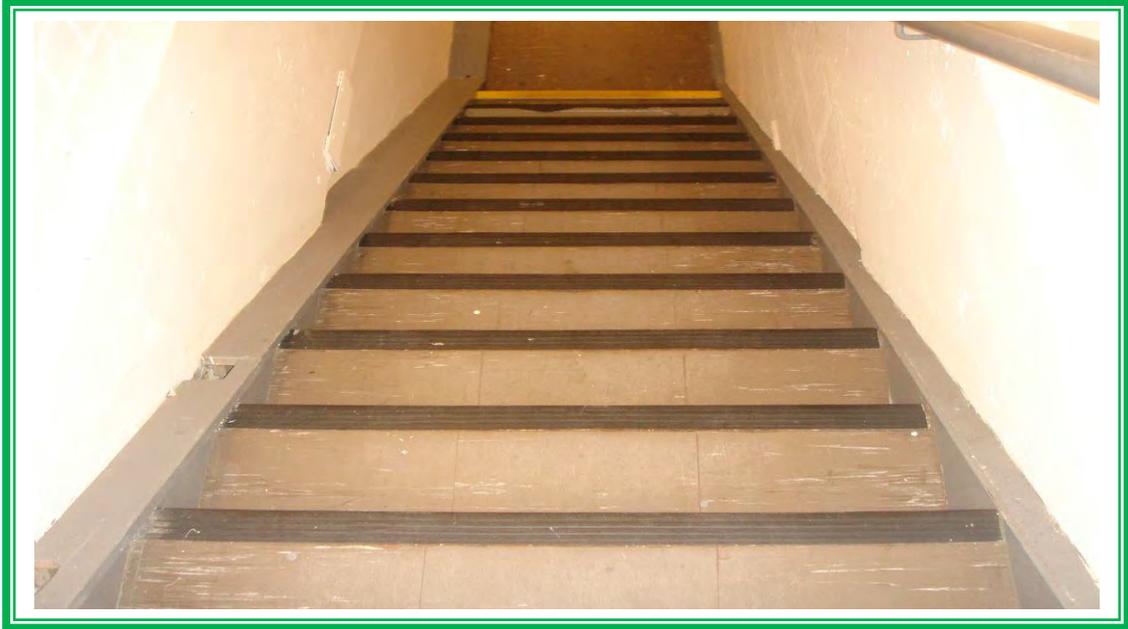
Location: 1/006 Stairs

Material Description:	Vinyl Floor Tiles	
Identification:	Sampled - No Asbestos Detected	
Approx. quantity:	10M2	
Accessibility	N/A	Assessment Score
Product type:	N/A	N/A
Extent of Damage:	N/A	N/A
Surface Treatment:	N/A	N/A
Asbestos type:	N/A	N/A
Material Assessment Score:		N/A
Priority Assessment Score:		N/A
Action:	N/A	
Comments:	N/A

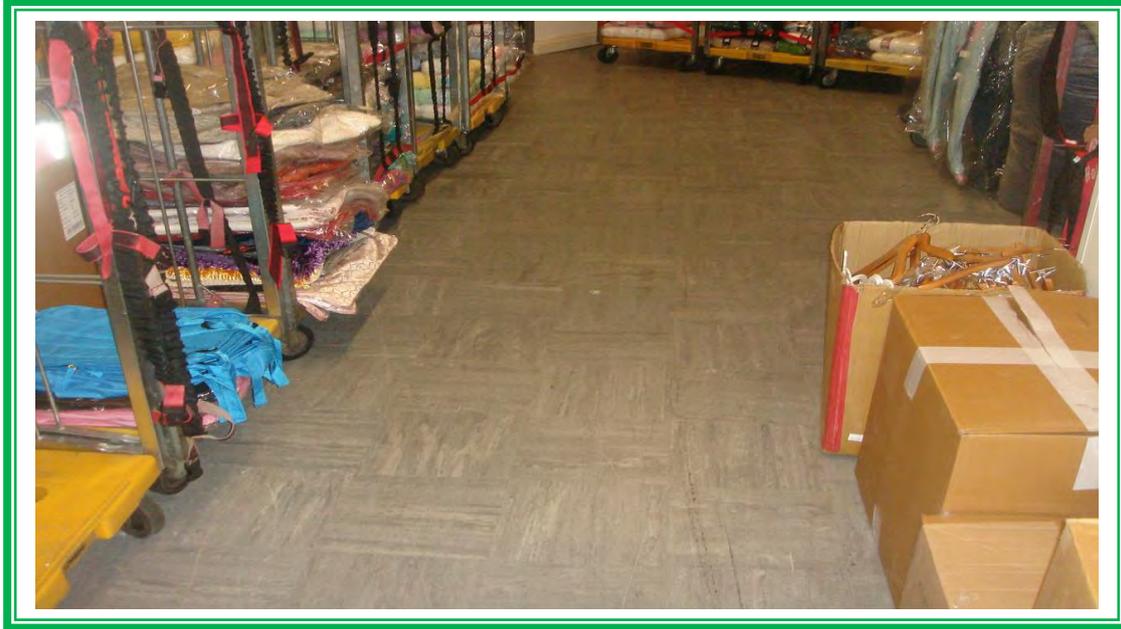
Location: 0/002 Stores

Material Description:	Vinyl Floor Tiles	
Identification:	As Per Sample NE/4 – No Asbestos Detected	
Approx. quantity:	40M2	
Accessibility	N/A	Assessment Score
Product type:	N/A	N/A
Extent of Damage:	N/A	N/A
Surface Treatment:	N/A	N/A
Asbestos type:	N/A	N/A
Material Assessment Score:		N/A
Priority Assessment Score:		N/A
Action:	N/A	
Comments:	N/A
