Project Number 3113

Management  
Asbestos Survey Report

Kennet Centre, Market Street, Newbury,  
Berkshire, RG14 5EN

1-3 The Mall

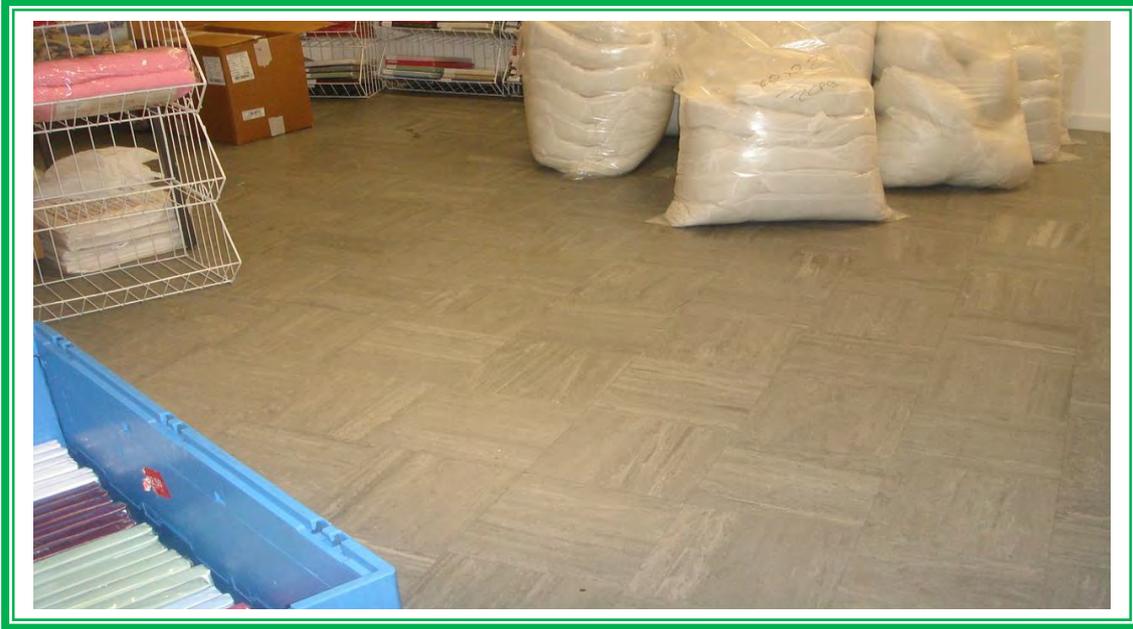
Location: 0/003 Stores

Material Description:	Vinyl Floor Tiles	
Identification:	As Per Sample NE/4 – No Asbestos Detected	
Approx. quantity:	30M2	
Accessibility	N/A	Assessment Score
Product type:	N/A	N/A
Extent of Damage:	N/A	N/A
Surface Treatment:	N/A	N/A
Asbestos type:	N/A	N/A
Material Assessment Score:		N/A
Priority Assessment Score:		N/A
Action:	N/A	
Comments:	N/A

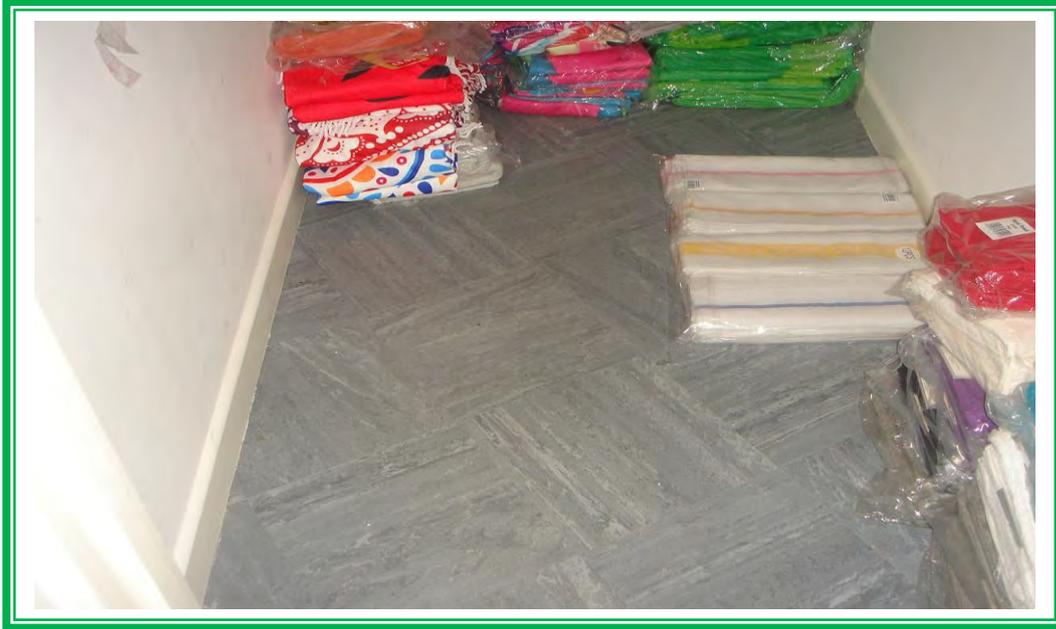
Location: 0/003A Cupboard

Material Description:	Vinyl Floor Tiles	
Identification:	As Per Sample NE/4 – No Asbestos Detected	
Approx. quantity:	2M2	
Accessibility	N/A	Assessment Score
Product type:	N/A	N/A
Extent of Damage:	N/A	N/A
Surface Treatment:	N/A	N/A
Asbestos type:	N/A	N/A
Material Assessment Score:		N/A
Priority Assessment Score:		N/A
Action:	N/A	
Comments:	N/A

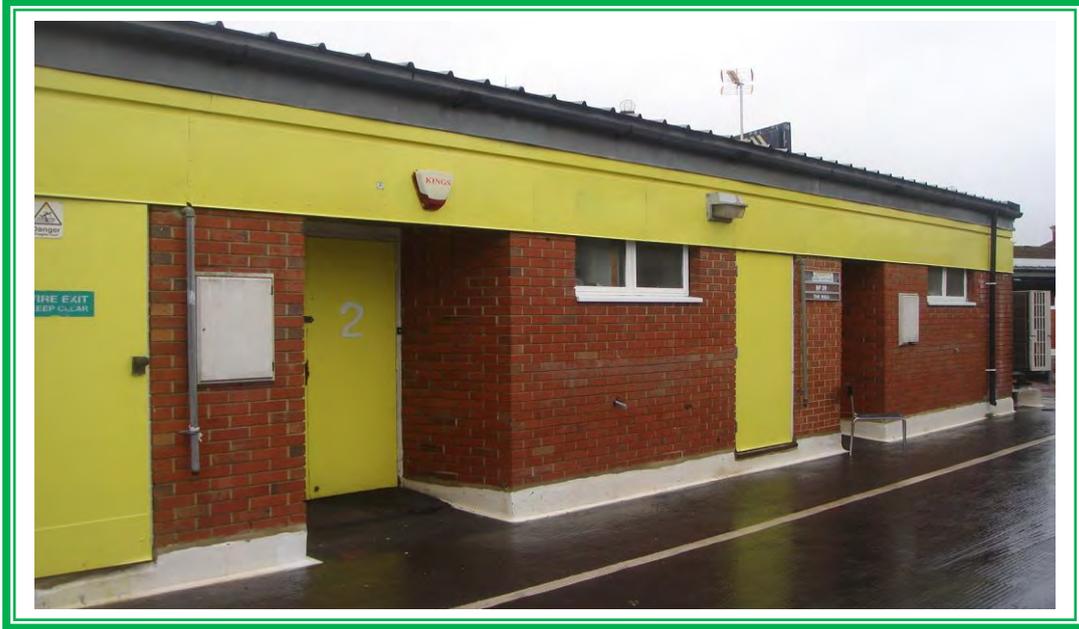
Location: 99/001 Externals

Material Description:	Visual Inspection – No Suspect Materials Found	
Identification:	N/A	
Approx. quantity:	N/A	
Accessibility	N/A	Assessment Score
Product type:	N/A	N/A
Extent of Damage:	N/A	N/A
Surface Treatment:	N/A	N/A
Asbestos type:	N/A	N/A
Material Assessment Score:		N/A
Priority Assessment Score:		N/A
Action:	N/A	
Comments:	N/A

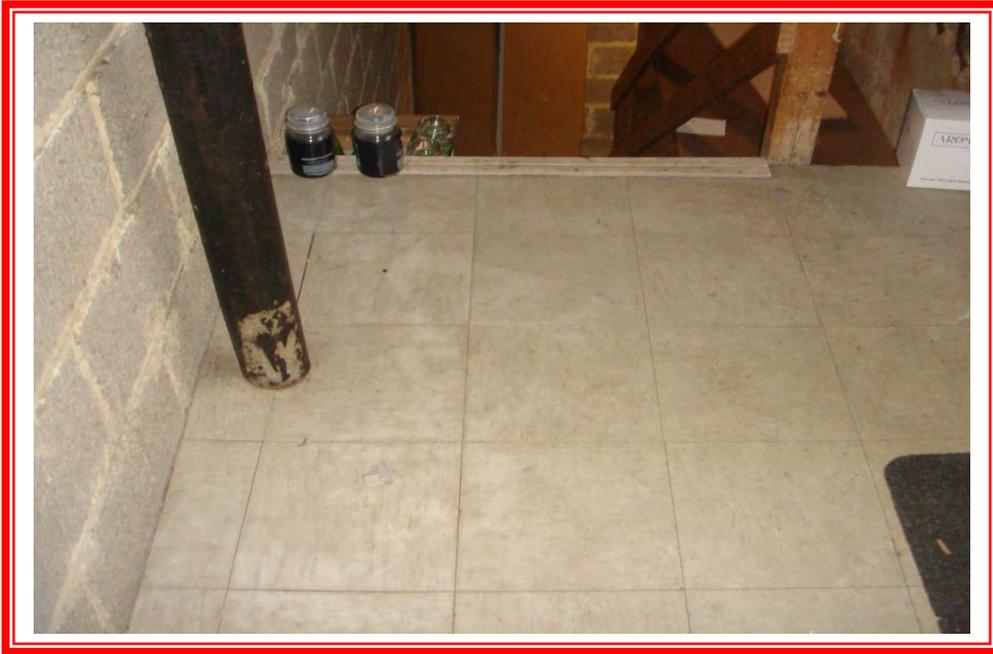
Item No: 1	Sample No: NE/1
Location: 1/001 Landing and Stairs

Material Description:	Vinyl Floor Tiles	
Identification:	Sampled - Asbestos Detected	
Approx. quantity:	20M2	
Accessibility	Low	Assessment Score
Product type:	Vinyl	1
Extent of Damage:	Minor	1
Surface Treatment:	Non-Friable	0
Asbestos type:	Chrysotile	1
Material Assessment Score:		3
Priority Assessment Score:		Negligible
Action:	Manage	
Comments:	N/A

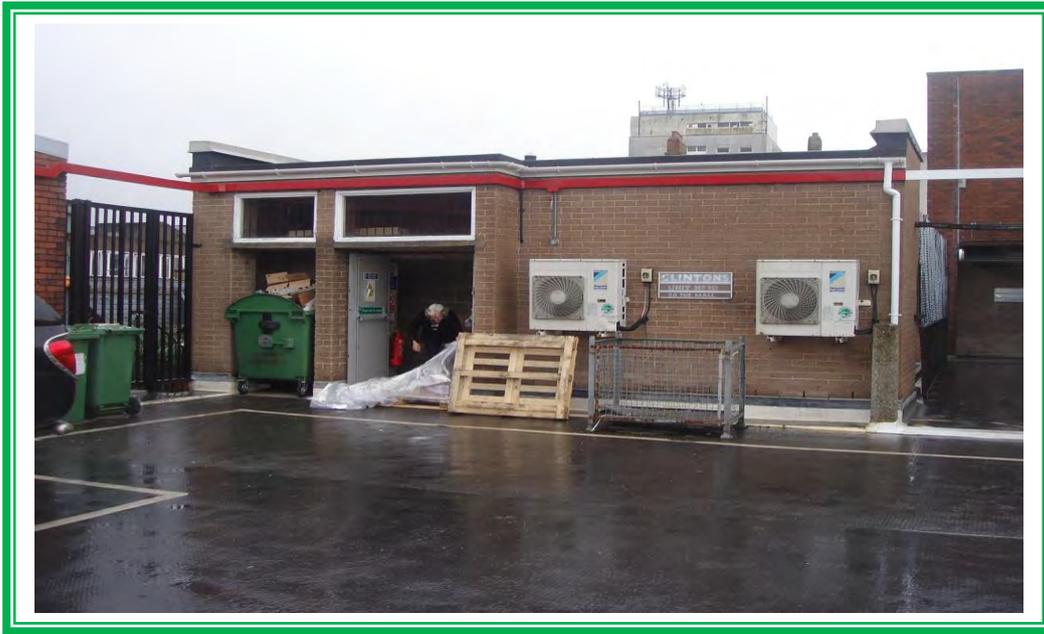
Location: 99/001 External

Material Description:	Visual Inspection – No Suspect Materials Found	
Identification:	N/A	
Approx. quantity:	N/A	
Accessibility	N/A	Assessment Score
Product type:	N/A	N/A
Extent of Damage:	N/A	N/A
Surface Treatment:	N/A	N/A
Asbestos type:	N/A	N/A
Material Assessment Score:		N/A
Priority Assessment Score:		N/A
Action:	N/A	
Comments:	N/A

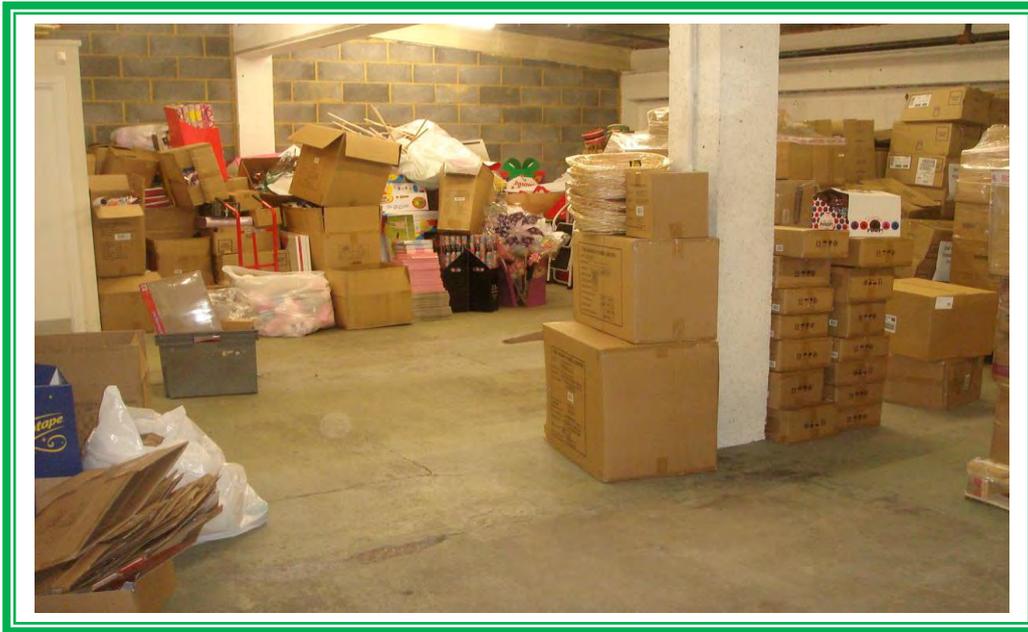
Location: 1/001 Store

Material Description:	Visual Inspection – No Suspect Materials Found	
Identification:	N/A	
Approx. quantity:	N/A	
Accessibility	N/A	Assessment Score
Product type:	N/A	N/A
Extent of Damage:	N/A	N/A
Surface Treatment:	N/A	N/A
Asbestos type:	N/A	N/A
Material Assessment Score:		N/A
Priority Assessment Score:		N/A
Action:	N/A	
Comments:	N/A

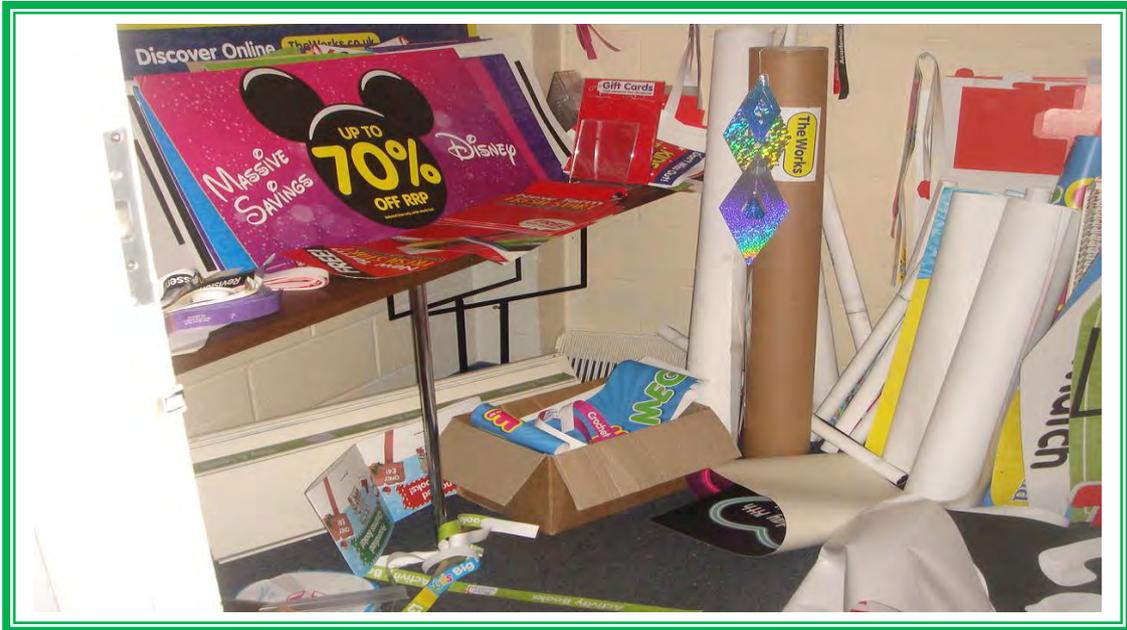
Location: 1/003 Store

Material Description:	Visual Inspection – No Suspect Materials Found	
Identification:	N/A	
Approx. quantity:	N/A	
Accessibility	N/A	Assessment Score
Product type:	N/A	N/A
Extent of Damage:	N/A	N/A
Surface Treatment:	N/A	N/A
Asbestos type:	N/A	N/A
Material Assessment Score:		N/A
Priority Assessment Score:		N/A
Action:	N/A	
Comments:	N/A

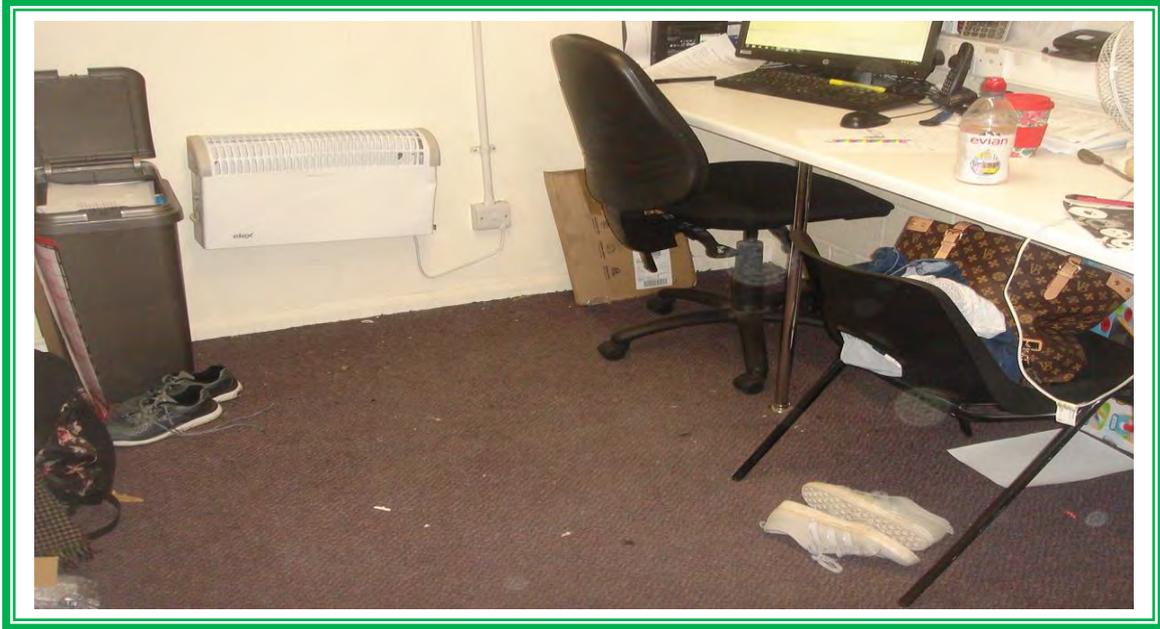
Location: 1/004 Office

Material Description:	Visual Inspection – No Suspect Materials Found	
Identification:	N/A	
Approx. quantity:	N/A	
Accessibility	N/A	Assessment Score
Product type:	N/A	N/A
Extent of Damage:	N/A	N/A
Surface Treatment:	N/A	N/A
Asbestos type:	N/A	N/A
Material Assessment Score:		N/A
Priority Assessment Score:		N/A
Action:	N/A	
Comments:	N/A

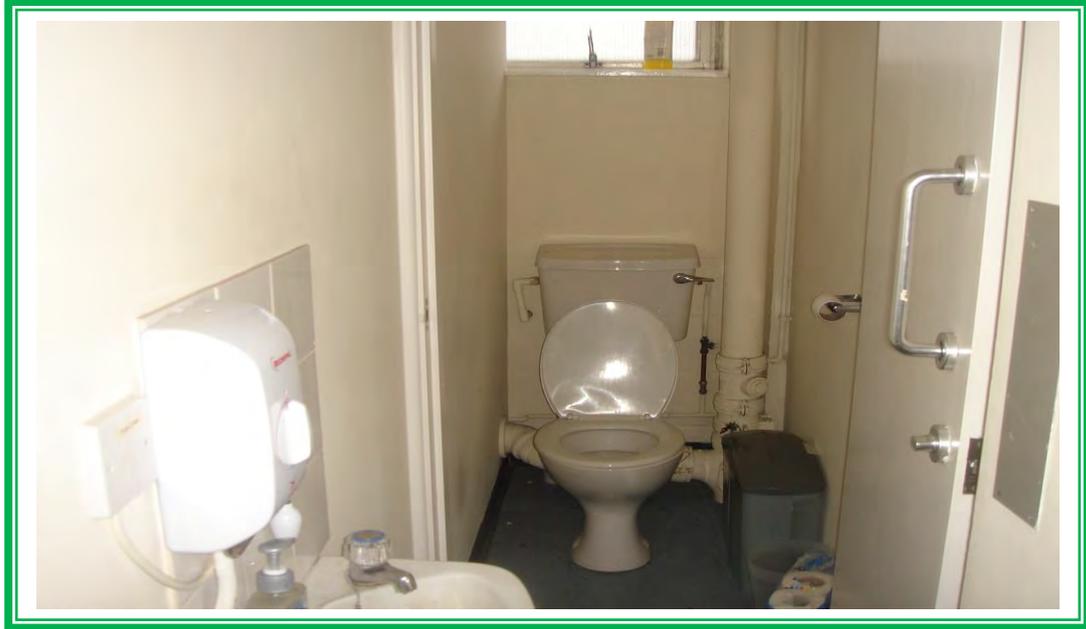
Location: 1/005 WC

Material Description:	Visual Inspection – No Suspect Materials Found	
Identification:	N/A	
Approx. quantity:	N/A	
Accessibility	N/A	Assessment Score
Product type:	N/A	N/A
Extent of Damage:	N/A	N/A
Surface Treatment:	N/A	N/A
Asbestos type:	N/A	N/A
Material Assessment Score:		N/A
Priority Assessment Score:		N/A
Action:	N/A	
Comments:	N/A

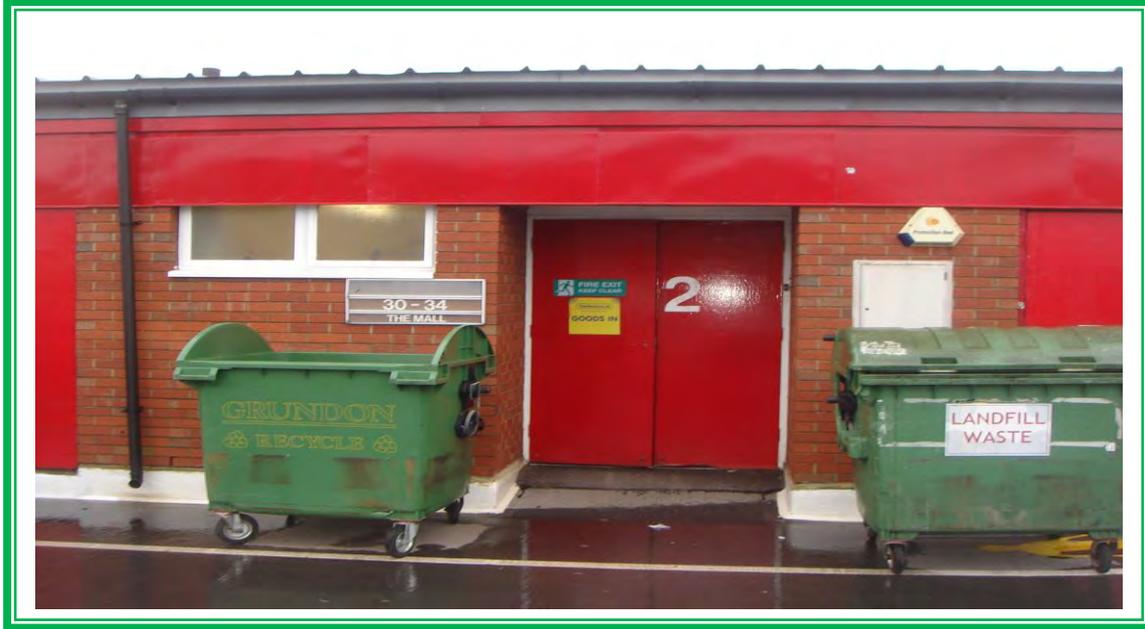
Location: 99/001 External

Material Description:	Visual Inspection – No Suspect Materials Found	
Identification:	N/A	
Approx. quantity:	N/A	
Accessibility	N/A	Assessment Score
Product type:	N/A	N/A
Extent of Damage:	N/A	N/A
Surface Treatment:	N/A	N/A
Asbestos type:	N/A	N/A
Material Assessment Score:		N/A
Priority Assessment Score:		N/A
Action:	N/A	
Comments:	N/A

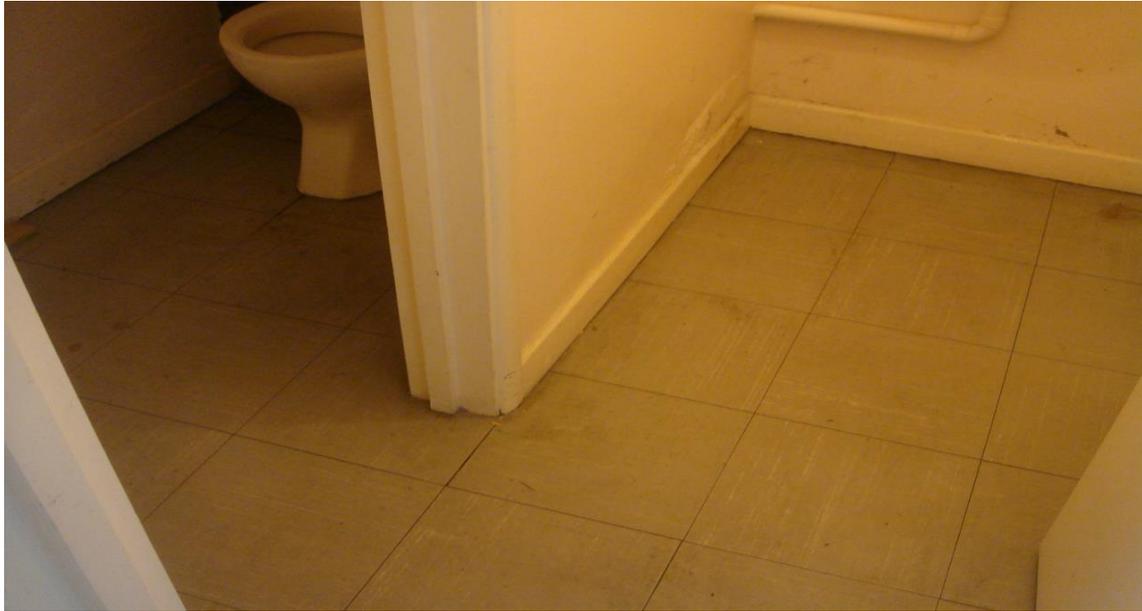
Location: 1/003

Material Description:	Vinyl floor Tiles	
Identification:	As Per Sample NE/1 - Asbestos Detected	
Approx. quantity:	2M2	
Accessibility	Low	Assessment Score
Product type:	Vinyl	1
Extent of Damage:	Low	1
Surface Treatment:	Non-Friable	0
Asbestos type:	Chrysotile	1
Material Assessment Score:		3
Priority Assessment Score:		Negligible
Action:	Manage	
Comments:	N/A

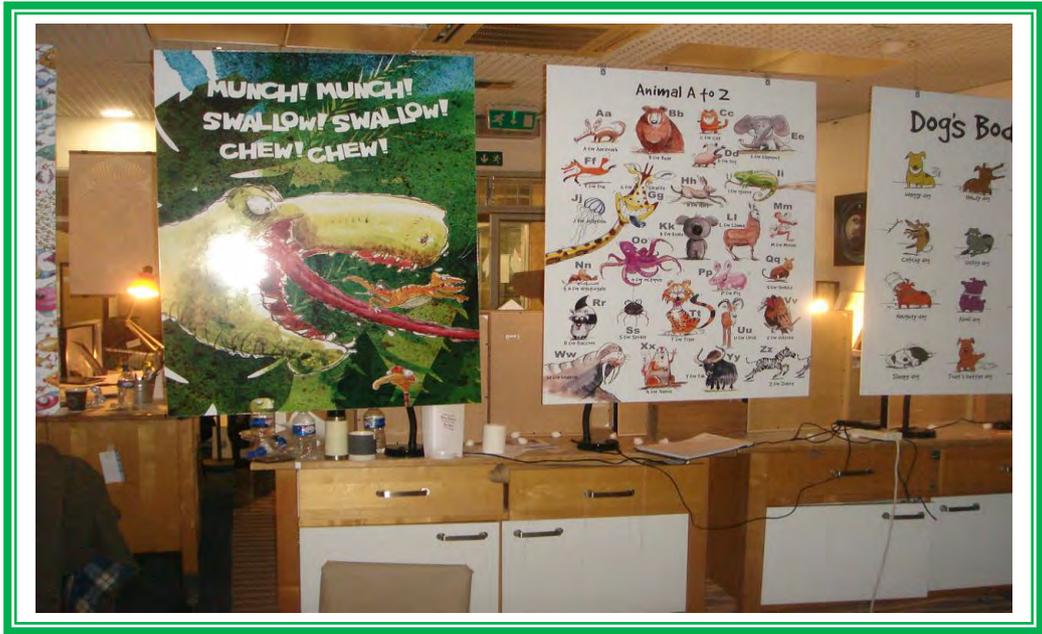
Item No: 5	Sample No: N/A
Location: 0/001 Shop Floor

Material Description:	Visual Inspection – No Suspect Materials Found	
Identification:	N/A	
Approx. quantity:	N/A	
Accessibility	N/A	Assessment Score
Product type:	N/A	N/A
Extent of Damage:	N/A	N/A
Surface Treatment:	N/A	N/A
Asbestos type:	N/A	N/A
Material Assessment Score:		N/A
Priority Assessment Score:		N/A
Action:	N/A	
Comments:	N/A

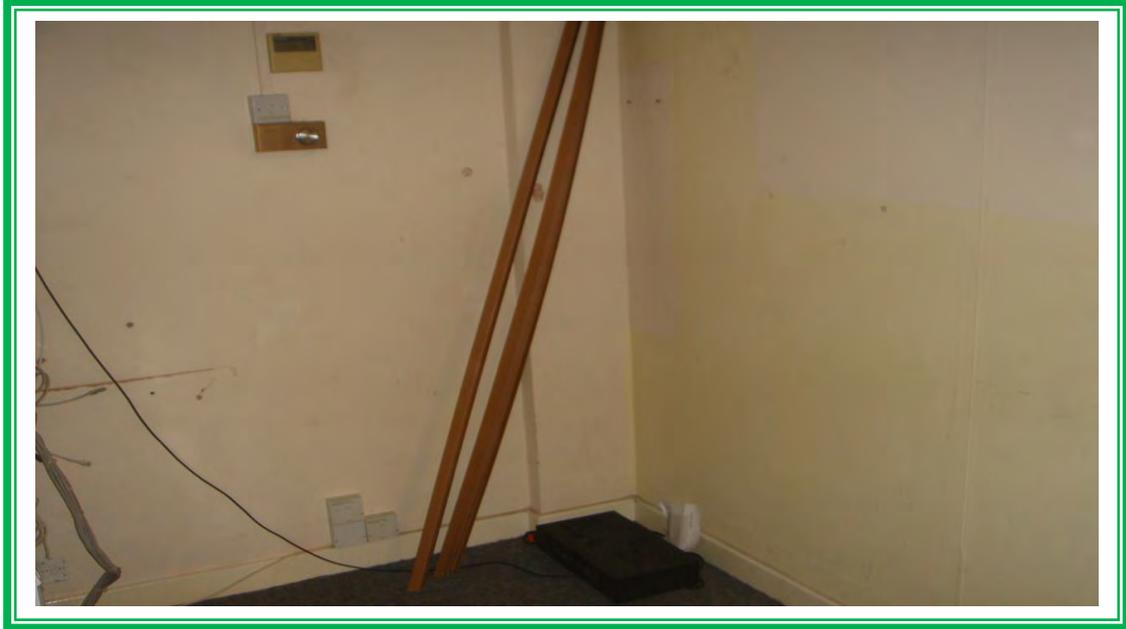
Location: 0/004 Office

Material Description:	Visual Inspection – No Suspect Materials Found	
Identification:	N/A	
Approx. quantity:	N/A	
Accessibility	N/A	<i>Assessment Score</i>
Product type:	N/A	N/A
Extent of Damage:	N/A	N/A
Surface Treatment:	N/A	N/A
Asbestos type:	N/A	N/A
Material Assessment Score:		N/A
Priority Assessment Score:		N/A
Action:	N/A	
Comments:	N/A

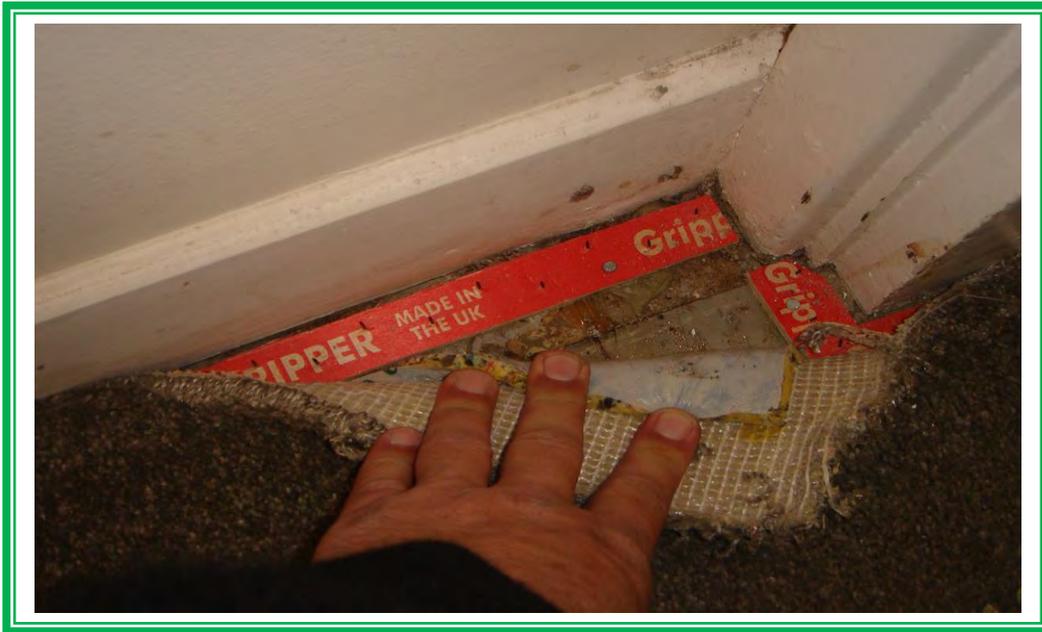
Location: 1/001 Lobby

Material Description:	Vinyl Floor Tiles	
Identification:	Sampled – No Asbestos Detected	
Approx. quantity:	2M2	
Accessibility	N/A	Assessment Score
Product type:	N/A	N/A
Extent of Damage:	N/A	N/A
Surface Treatment:	N/A	N/A
Asbestos type:	N/A	N/A
Material Assessment Score:		N/A
Priority Assessment Score:		N/A
Action:	N/A	
Comments:	N/A

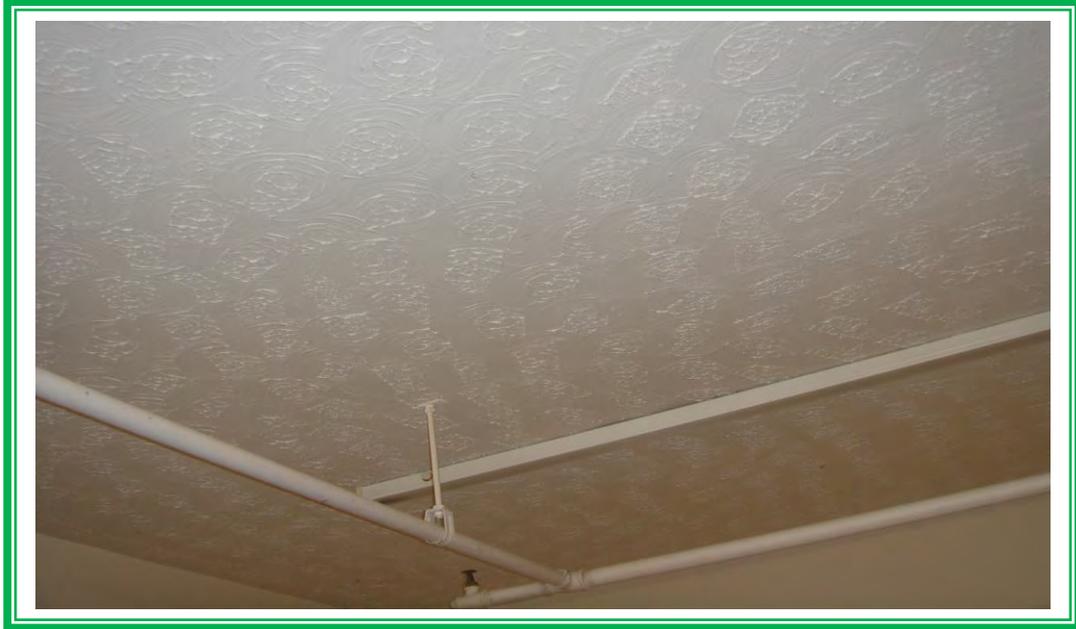
Location: 1/003 Kitchen

Material Description:	Textured Coating	
Identification:	As Per Sample NE/2- No Asbestos Detected	
Approx. quantity:	12M2	
Accessibility	N/A	Assessment Score
Product type:	N/A	N/A
Extent of Damage:	N/A	N/A
Surface Treatment:	N/A	N/A
Asbestos type:	N/A	N/A
Material Assessment Score:		N/A
Priority Assessment Score:		N/A
Action:	N/A	
Comments:	N/A

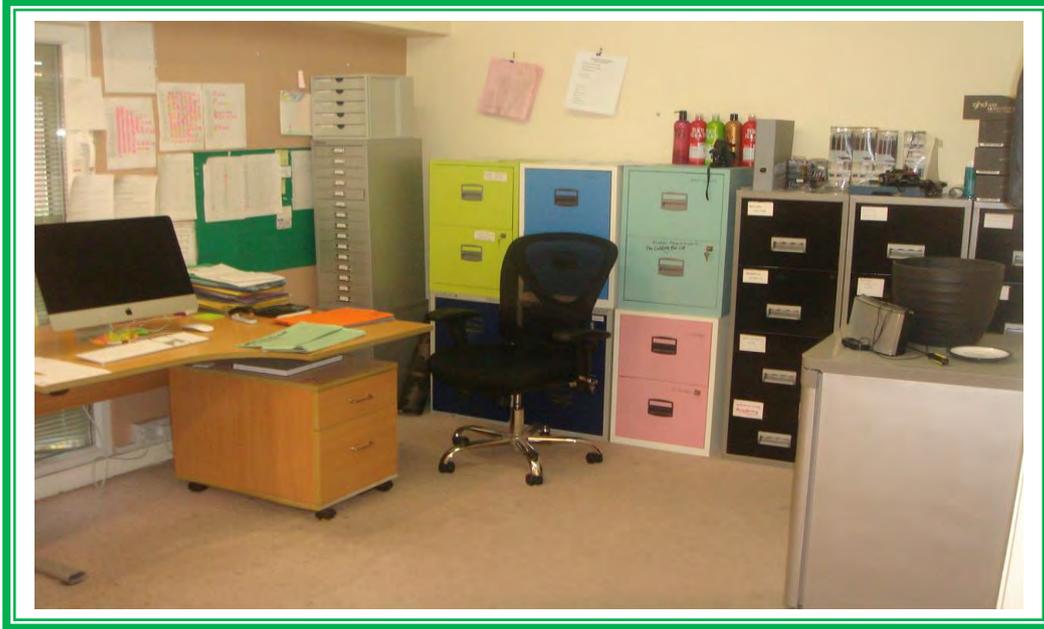
Location: 1/007 Office

Material Description:	Visual Inspection – No Suspect Materials Found	
Identification:	N/A	
Approx. quantity:	N/A	
Accessibility	N/A	Assessment Score
Product type:	N/A	N/A
Extent of Damage:	N/A	N/A
Surface Treatment:	N/A	N/A
Asbestos type:	N/A	N/A
Material Assessment Score:		N/A
Priority Assessment Score:		N/A
Action:	N/A	
Comments:	N/A

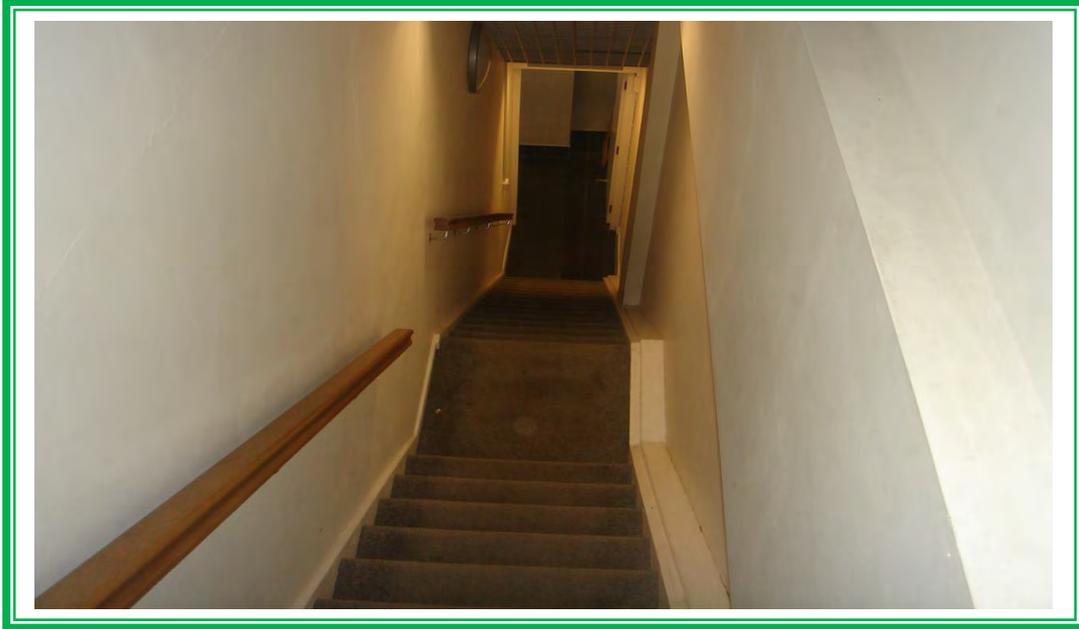
Location: 1/012 Stairs

Material Description:	Visual Inspection – No Suspect Materials Found	
Identification:	N/A	
Approx. quantity:	N/A	
Accessibility	N/A	Assessment Score
Product type:	N/A	N/A
Extent of Damage:	N/A	N/A
Surface Treatment:	N/A	N/A
Asbestos type:	N/A	N/A
Material Assessment Score:		N/A
Priority Assessment Score:		N/A
Action:	N/A	
Comments:	N/A

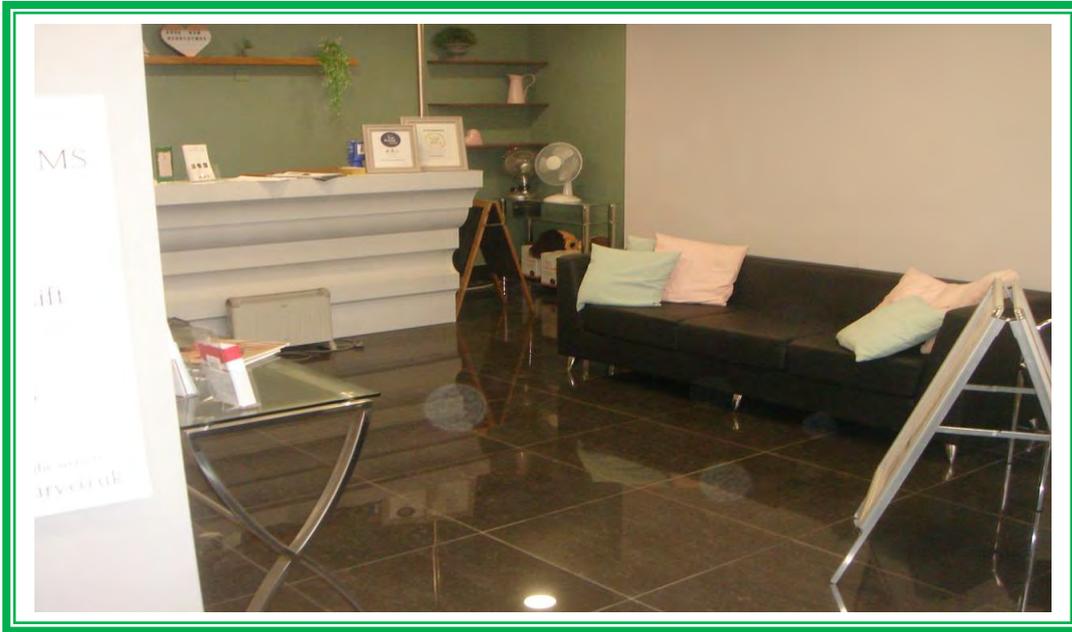
Location: 0/001 Reception

Material Description:	Visual Inspection – No Suspect Materials Found	
Identification:	N/A	
Approx. quantity:	N/A	
Accessibility	N/A	Assessment Score
Product type:	N/A	N/A
Extent of Damage:	N/A	N/A
Surface Treatment:	N/A	N/A
Asbestos type:	N/A	N/A
Material Assessment Score:		N/A
Priority Assessment Score:		N/A
Action:	N/A	
Comments:	N/A

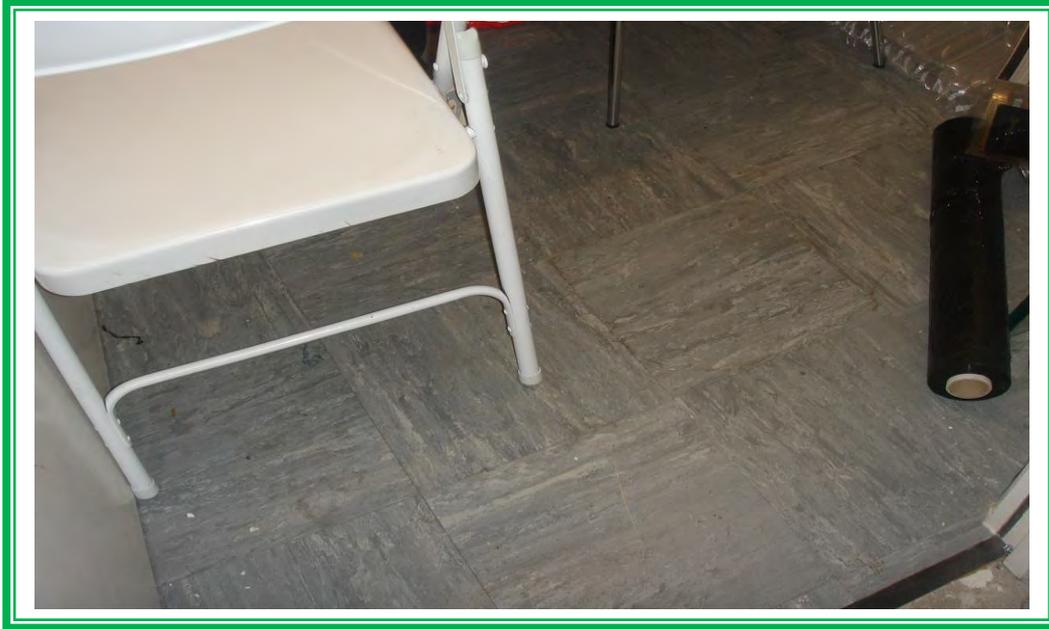
Location: 1/004 Office

Material Description:	Vinyl Floor Tiles	
Identification:	As Per Sample NE/2 – No Asbestos Detected	
Approx. quantity:	2M2	
Accessibility	N/A	Assessment Score
Product type:	N/A	N/A
Extent of Damage:	N/A	N/A
Surface Treatment:	N/A	N/A
Asbestos type:	N/A	N/A
Material Assessment Score:		N/A
Priority Assessment Score:		N/A
Action:	N/A	
Comments:	N/A

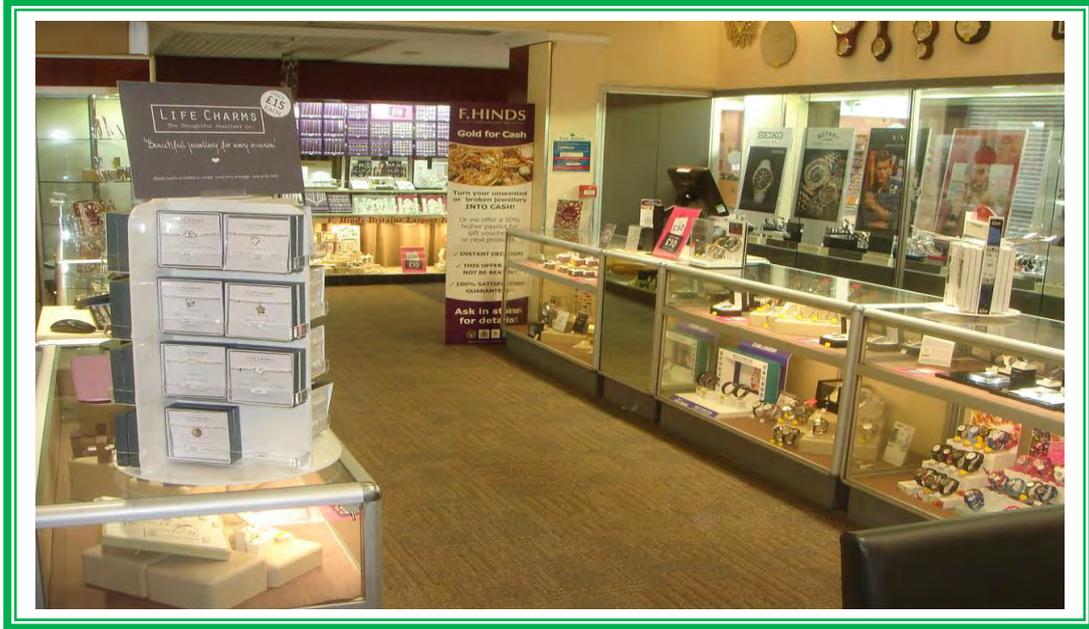
Location: 0/003 Shop Floor

Material Description:	Visual Inspection – No Suspect Materials Found	
Identification:	N/A	
Approx. quantity:	N/A	
Accessibility	N/A	Assessment Score
Product type:	N/A	N/A
Extent of Damage:	N/A	N/A
Surface Treatment:	N/A	N/A
Asbestos type:	N/A	N/A
Material Assessment Score:		N/A
Priority Assessment Score:		N/A
Action:	N/A	
Comments:	N/A

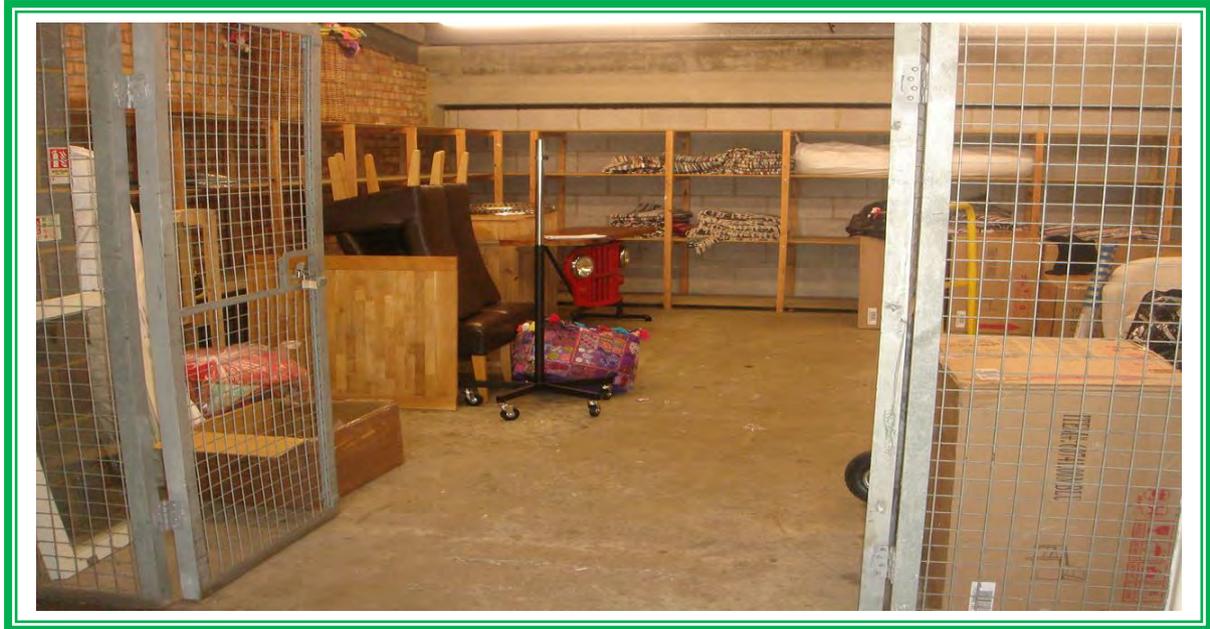
Location: 1/001 Store

Material Description:	Visual Inspection – No Suspect Materials Found	
Identification:	N/A	
Approx. quantity:	N/A	
Accessibility	N/A	Assessment Score
Product type:	N/A	N/A
Extent of Damage:	N/A	N/A
Surface Treatment:	N/A	N/A
Asbestos type:	N/A	N/A
Material Assessment Score:		N/A
Priority Assessment Score:		N/A
Action:	N/A	
Comments:	N/A

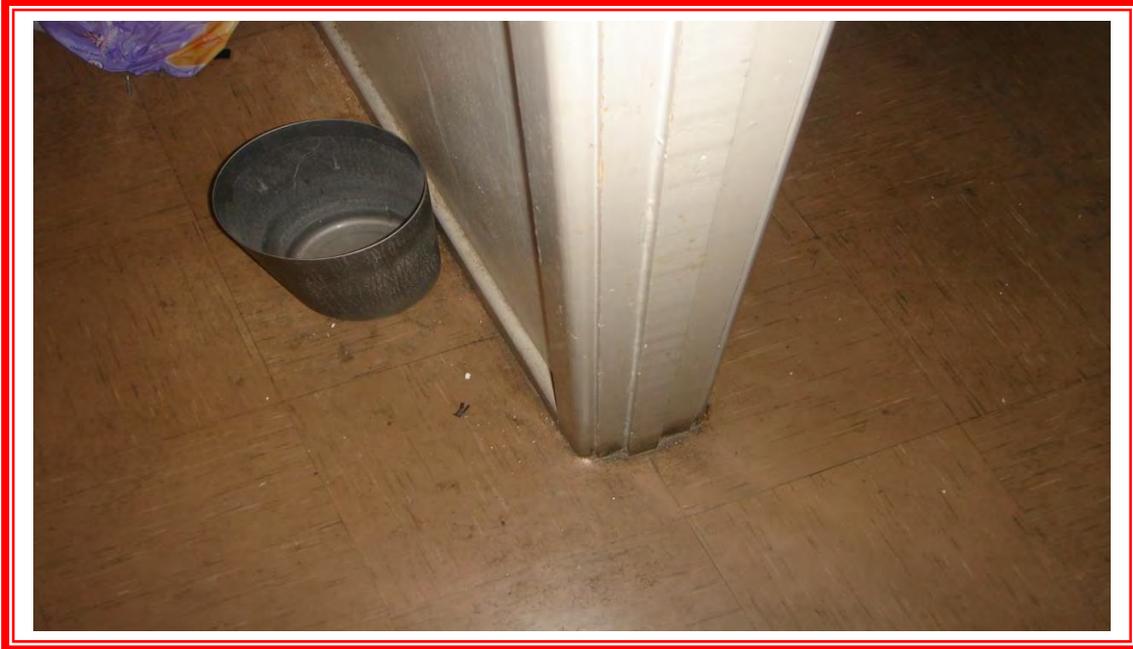
Location: 1/004 WC

Material Description:	Vinyl Floor Tiles	
Identification:	As Per Sample NE/1 - Asbestos Detected	
Approx. quantity:	2M2	
Accessibility	Low	Assessment Score
Product type:	Vinyl	1
Extent of Damage:	Low	1
Surface Treatment:	Non-Friable	0
Asbestos type:	Chrysotile	1
Material Assessment Score:		3
Priority Assessment Score:		Negligible
Action:	Manage	
Comments:	N/A

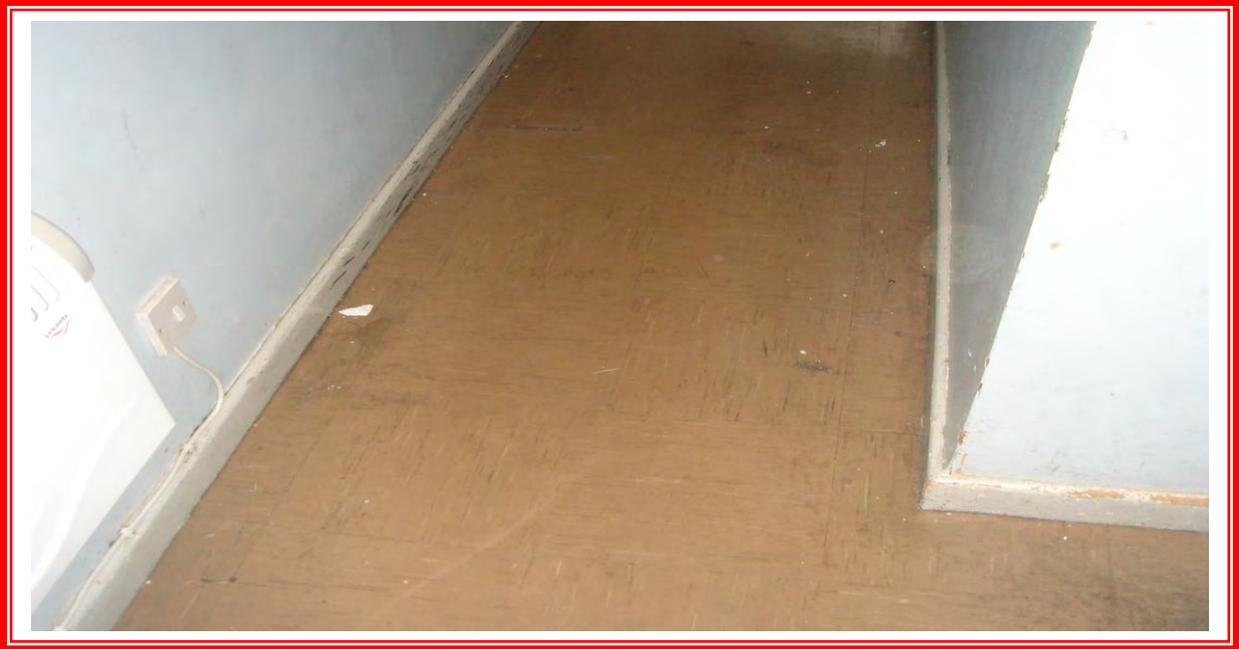
Location: 1/005 Office

Material Description:	Vinyl Floor Tiles	
Identification:	Sampled - Asbestos Detected	
Approx. quantity:	6M2	
Accessibility	Low	Assessment Score
Product type:	Vinyl	1
Extent of Damage:	Low	1
Surface Treatment:	Non-Friable	0
Asbestos type:	Chrysotile	1
Material Assessment Score:		3
Priority Assessment Score:		Negligible
Action:	Manage	
Comments:	N/A

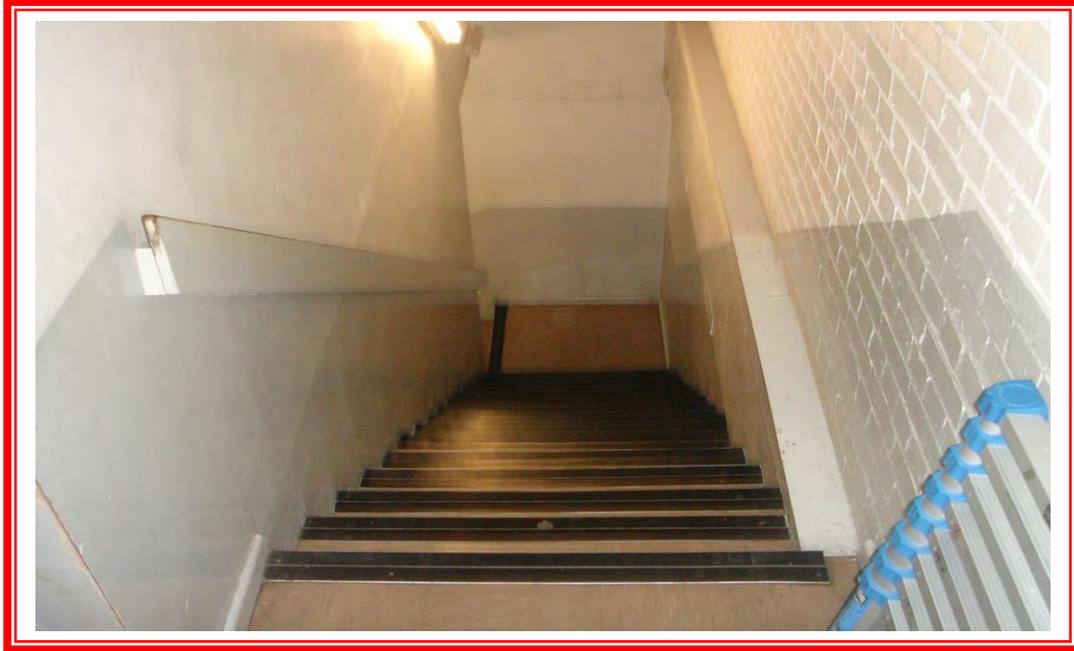
Location: 1/009 Stairs

Material Description:	Vinyl Floor Tiles	
Identification:	As Per Sample NE/2 - Asbestos Detected	
Approx. quantity:	30M2	
Accessibility	Low	Assessment Score
Product type:	Vinyl	1
Extent of Damage:	Low	1
Surface Treatment:	Non-Friable	0
Asbestos type:	Chrysotile	1
Material Assessment Score:		3
Priority Assessment Score:		Negligible
Action:	Manage	
Comments:	N/A

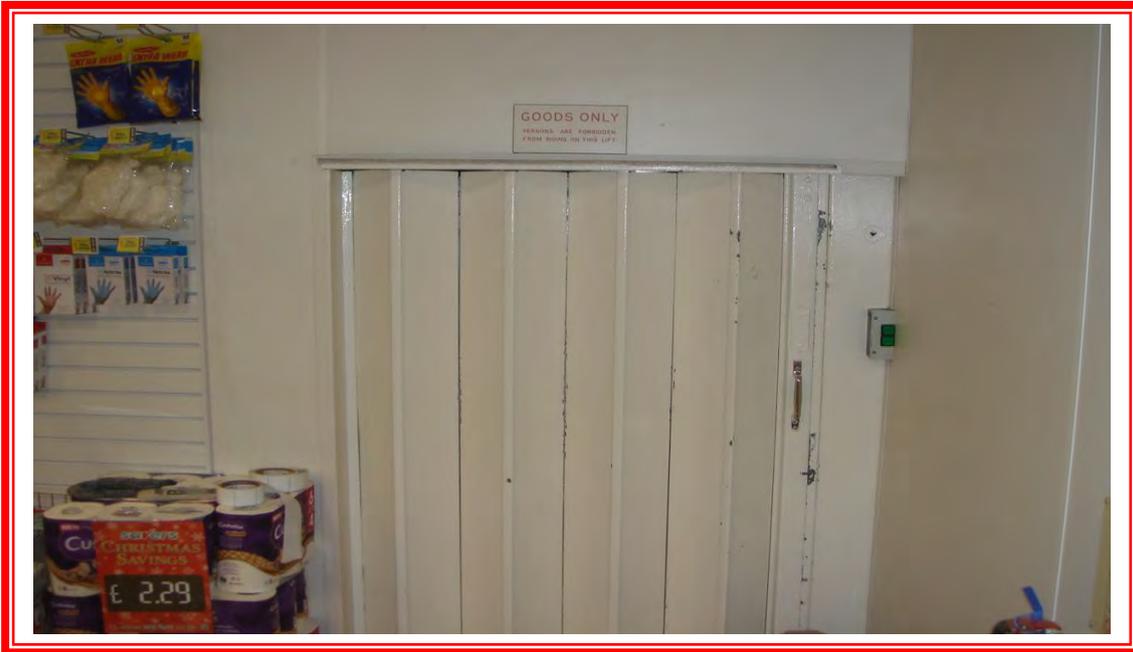
Location: 0/002 Lift and Shaft

Material Description:	No Access	
Identification:	Presumed to Contain Asbestos	
Approx. quantity:	Unknown	
Accessibility	Low	Assessment Score
Product type:	No Access	3
Extent of Damage:	No Access	3
Surface Treatment:	No Access	3
Asbestos type:	No Access	3
Material Assessment Score:		12
Priority Assessment Score:		High
Action:	Further Investigation Required	
Comments:	No access as no lift engineer was onsite

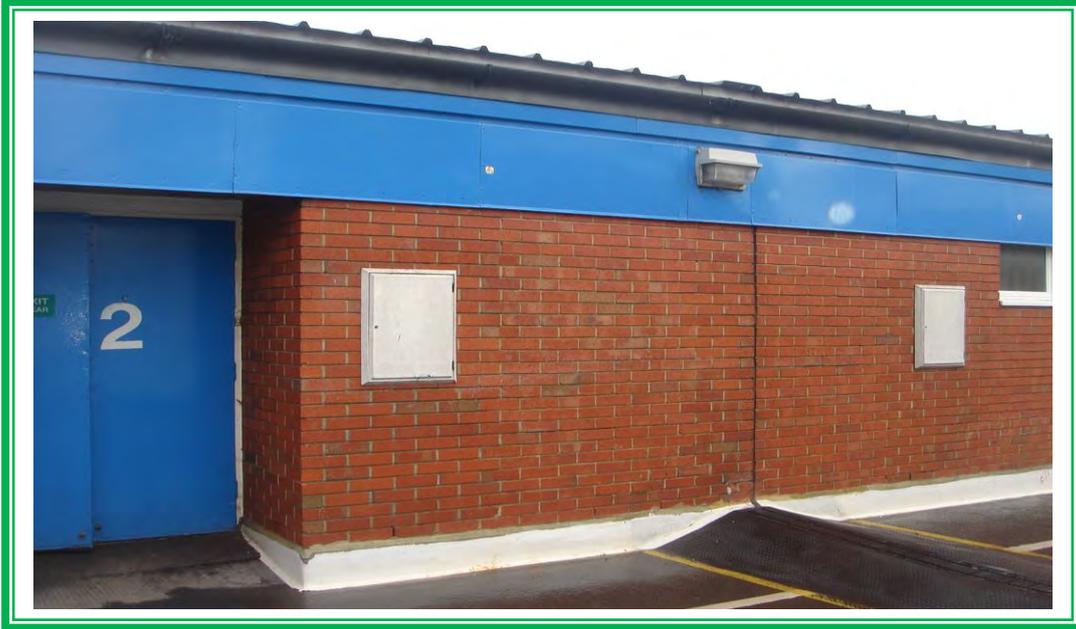
Location: 99/001

Material Description:	Visual Inspection – No Suspect Materials Found	
Identification:	N/A	
Approx. quantity:	N/A	
Accessibility	N/A	Assessment Score
Product type:	N/A	N/A
Extent of Damage:	N/A	N/A
Surface Treatment:	N/A	N/A
Asbestos type:	N/A	N/A
Material Assessment Score:		N/A
Priority Assessment Score:		N/A
Action:	N/A	
Comments:	N/A

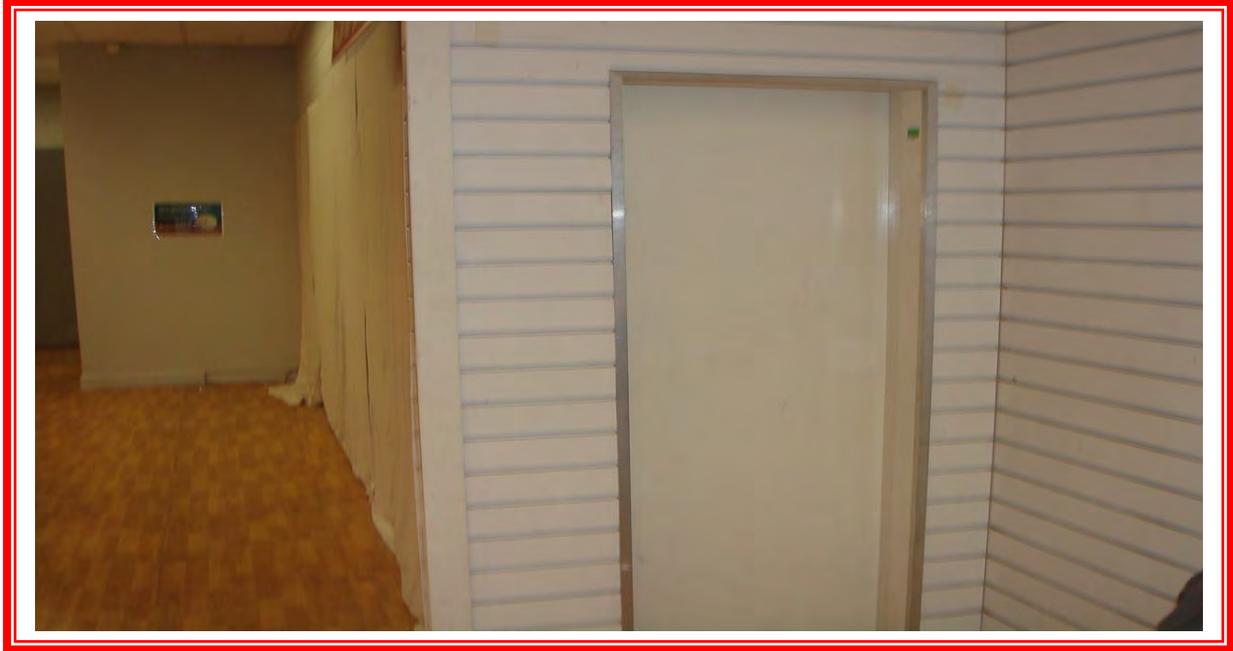
Location: 0/004 Cupboard

Material Description:	No Access	
Identification:	Presumed to Contain Asbestos	
Approx. quantity:	Unknown	
Accessibility	Low	Assessment Score
Product type:	No Access	3
Extent of Damage:	No Access	3
Surface Treatment:	No Access	3
Asbestos type:	No Access	3
Material Assessment Score:		12
Priority Assessment Score:		High
Action:	Further Investigation Required	
Comments:	No Access, no Keys at Time of Survey

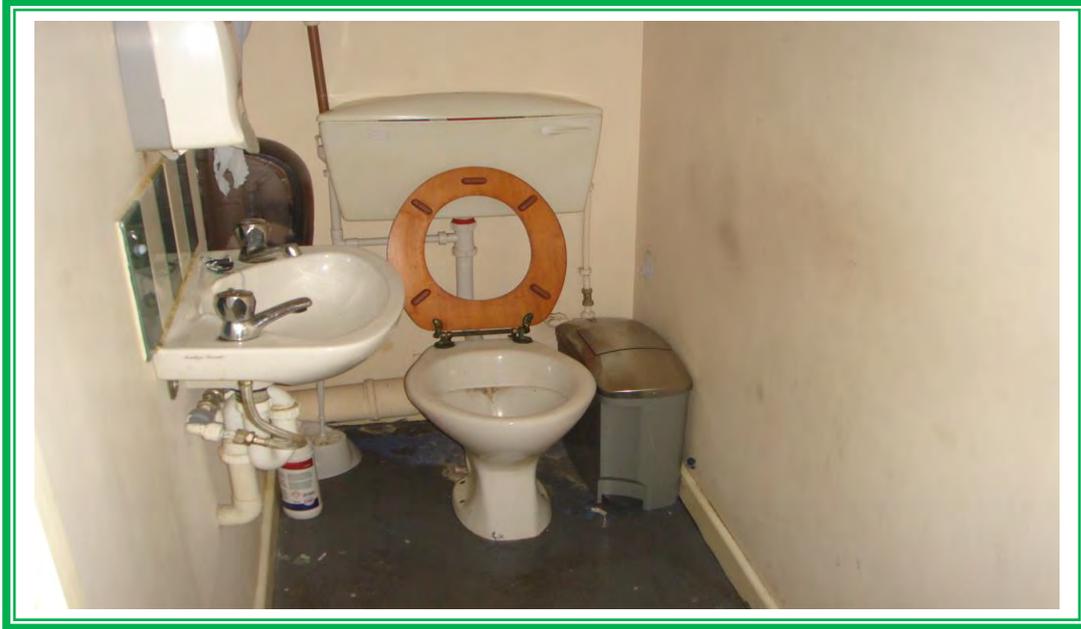
Location: 1/002 WC

Material Description:	Visual Inspection – No Suspect Materials Found	
Identification:	N/A	
Approx. quantity:	N/A	
Accessibility	N/A	Assessment Score
Product type:	N/A	N/A
Extent of Damage:	N/A	N/A
Surface Treatment:	N/A	N/A
Asbestos type:	N/A	N/A
Material Assessment Score:		N/A
Priority Assessment Score:		N/A
Action:	N/A	
Comments:	N/A
