Project Number 3113

Management  
Asbestos Survey Report

Kennet Centre, Market Street, Newbury,  
Berkshire, RG14 5EN

1-3 The Mall

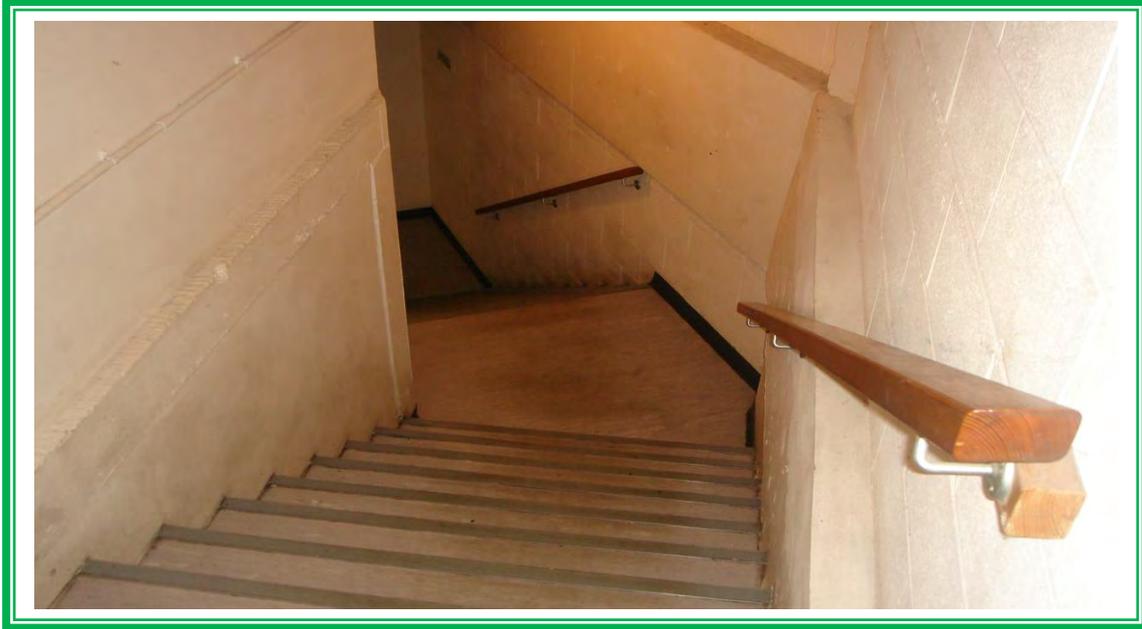
Location: 1/005 Stairs

Material Description:	Visual Inspection – No Suspect Materials Found	
Identification:	N/A	
Approx. quantity:	N/A	
Accessibility	N/A	Assessment Score
Product type:	N/A	N/A
Extent of Damage:	N/A	N/A
Surface Treatment:	N/A	N/A
Asbestos type:	N/A	N/A
Material Assessment Score:		N/A
Priority Assessment Score:		N/A
Action:	N/A	
Comments:	N/A

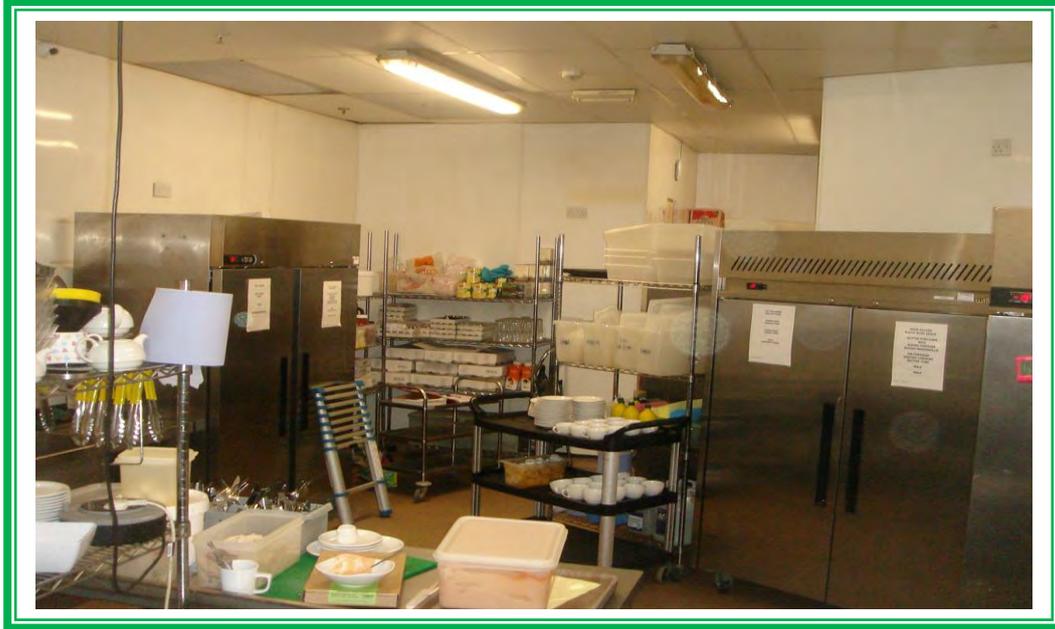
Location: 0/002 Kitchen

Material Description:	Visual Inspection – No Suspect Materials Found	
Identification:	N/A	
Approx. quantity:	N/A	
Accessibility	N/A	Assessment Score
Product type:	N/A	N/A
Extent of Damage:	N/A	N/A
Surface Treatment:	N/A	N/A
Asbestos type:	N/A	N/A
Material Assessment Score:		N/A
Priority Assessment Score:		N/A
Action:	N/A	
Comments:	N/A

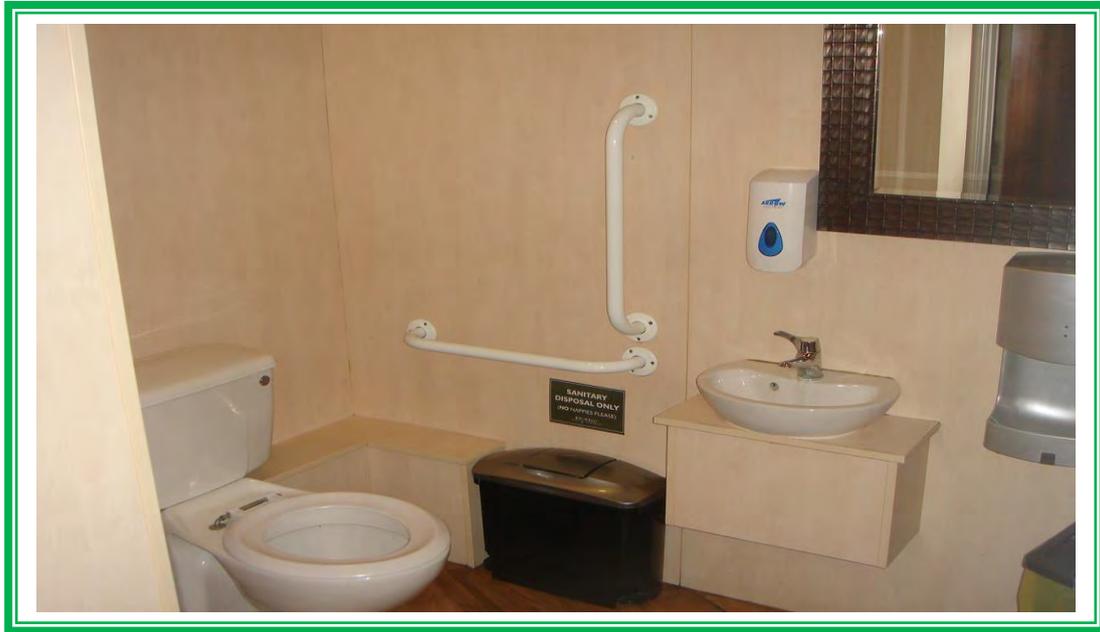
Location: 0/006 WC

Material Description:	Visual Inspection – No Suspect Materials Found	
Identification:	N/A	
Approx. quantity:	N/A	
Accessibility	N/A	Assessment Score
Product type:	N/A	N/A
Extent of Damage:	N/A	N/A
Surface Treatment:	N/A	N/A
Asbestos type:	N/A	N/A
Material Assessment Score:		N/A
Priority Assessment Score:		N/A
Action:	N/A	
Comments:	N/A

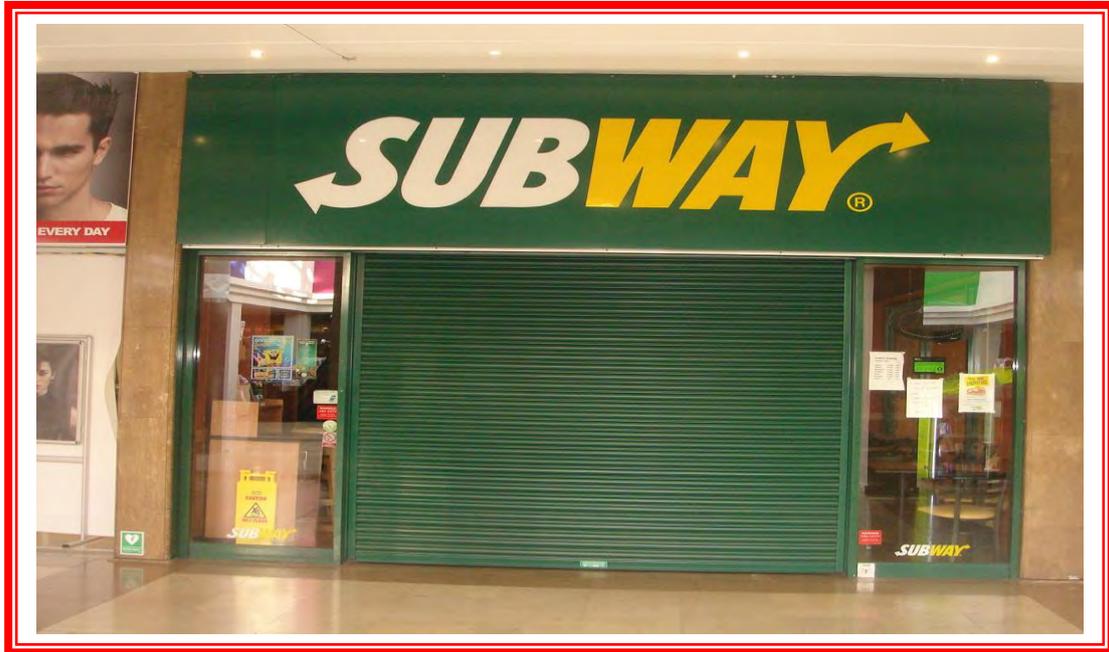
Location: 20 The Mall

Material Description:	No Access	
Identification:	Presumed to Contain Asbestos	
Approx. quantity:	Unknown	
Accessibility	Low	Assessment Score
Product type:	No Access	3
Extent of Damage:	No Access	3
Surface Treatment:	No Access	3
Asbestos type:	No Access	3
Material Assessment Score:		12
Priority Assessment Score:		High
Action:	Further Inspection Required	
Comments:	No Access as still in lease but vacant – No Keys (The Vacant Nightclub)

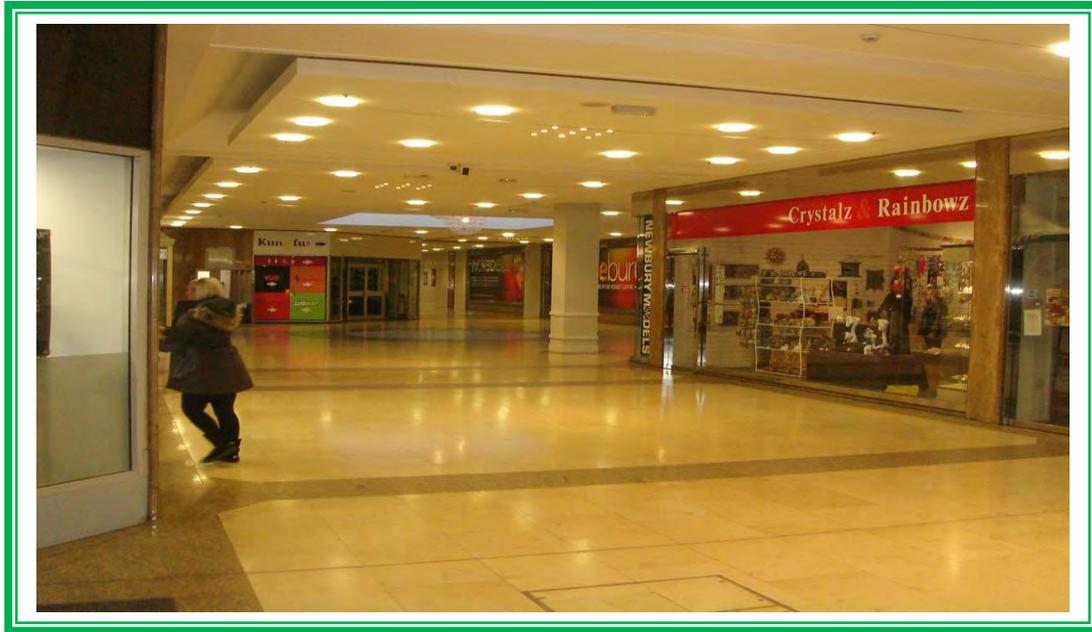
Location: 0/003 The Mall

Material Description:	Visual Inspection – No Suspect Materials Found	
Identification:	N/A	
Approx. quantity:	N/A	
Accessibility	N/A	Assessment Score
Product type:	N/A	N/A
Extent of Damage:	N/A	N/A
Surface Treatment:	N/A	N/A
Asbestos type:	N/A	N/A
Material Assessment Score:		N/A
Priority Assessment Score:		N/A
Action:	N/A	
Comments:	N/A

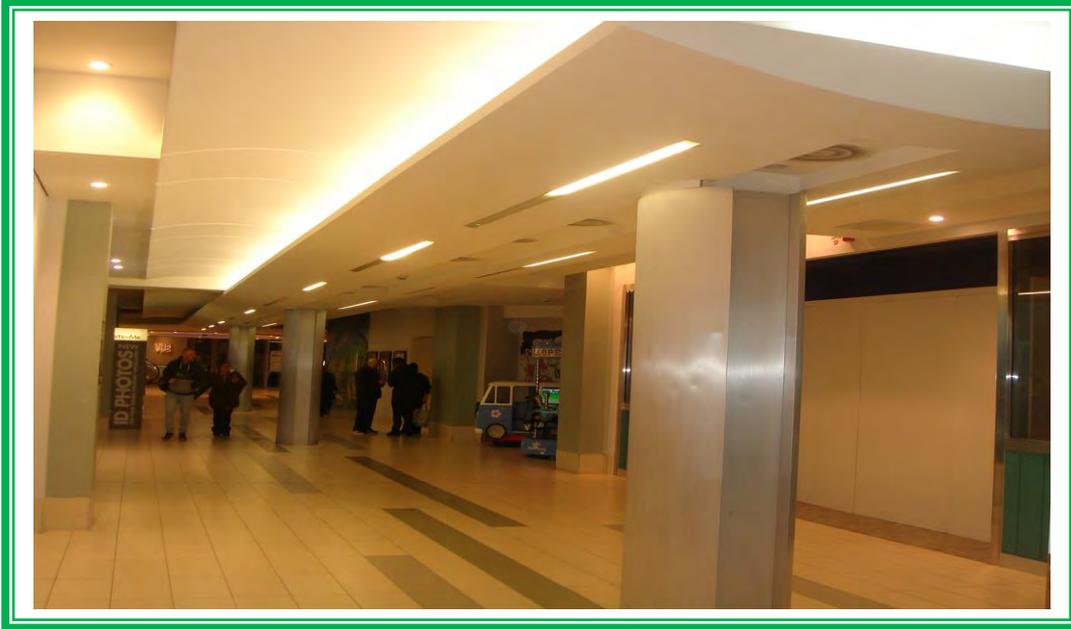
Location: Vue Cinema Area

Material Description:	Visual Inspection – No Suspect Materials Found	
Identification:	N/A	
Approx. quantity:	N/A	
Accessibility	N/A	Assessment Score
Product type:	N/A	N/A
Extent of Damage:	N/A	N/A
Surface Treatment:	N/A	N/A
Asbestos type:	N/A	N/A
Material Assessment Score:		N/A
Priority Assessment Score:		N/A
Action:	N/A	
Comments:	Built in 2009
